Investigation Report

Type of Occurrence:	Serious incident
Date:	22 October 2014
Location:	Frankfurt/Main
Aircraft:	Airplane
Manufacturer / Model:	The Boeing Company / B 747-422
Injuries to Persons:	None
Damage:	Minor damage to aircraft
Other Damage:	None
Information Source:	Investigation by BFU
State File Number:	BFU EX008-14

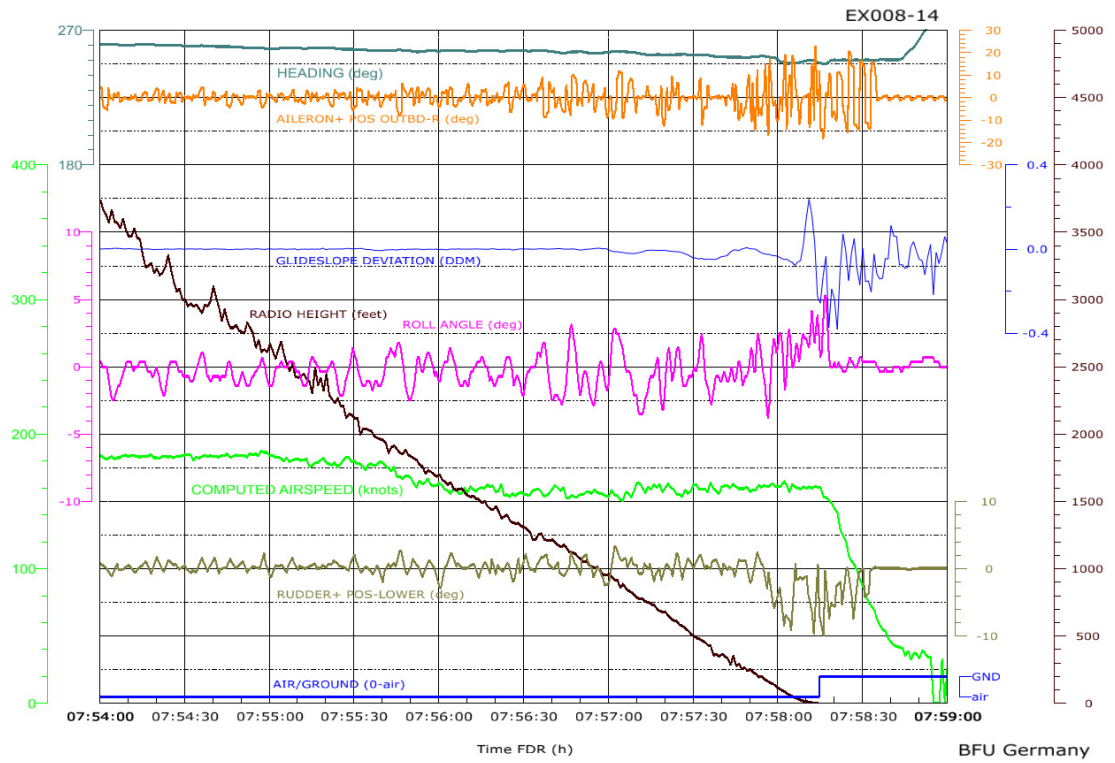
FDR parameter during the approach

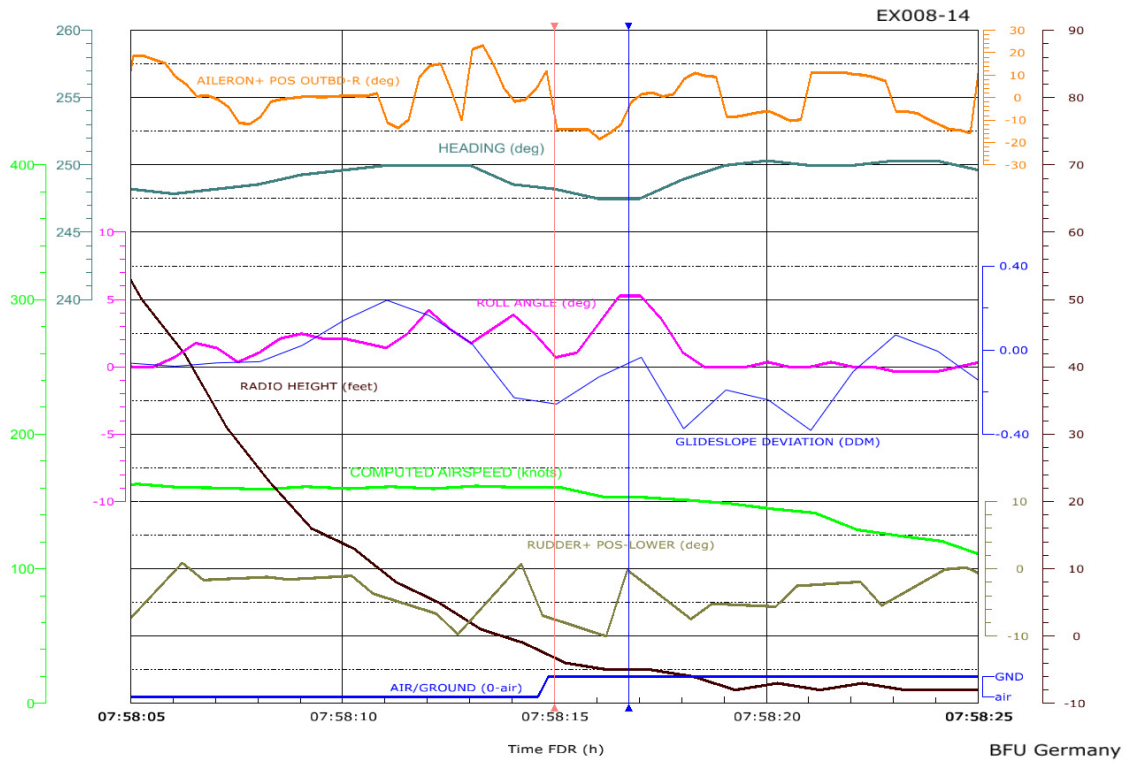
FDR parameter during the landing

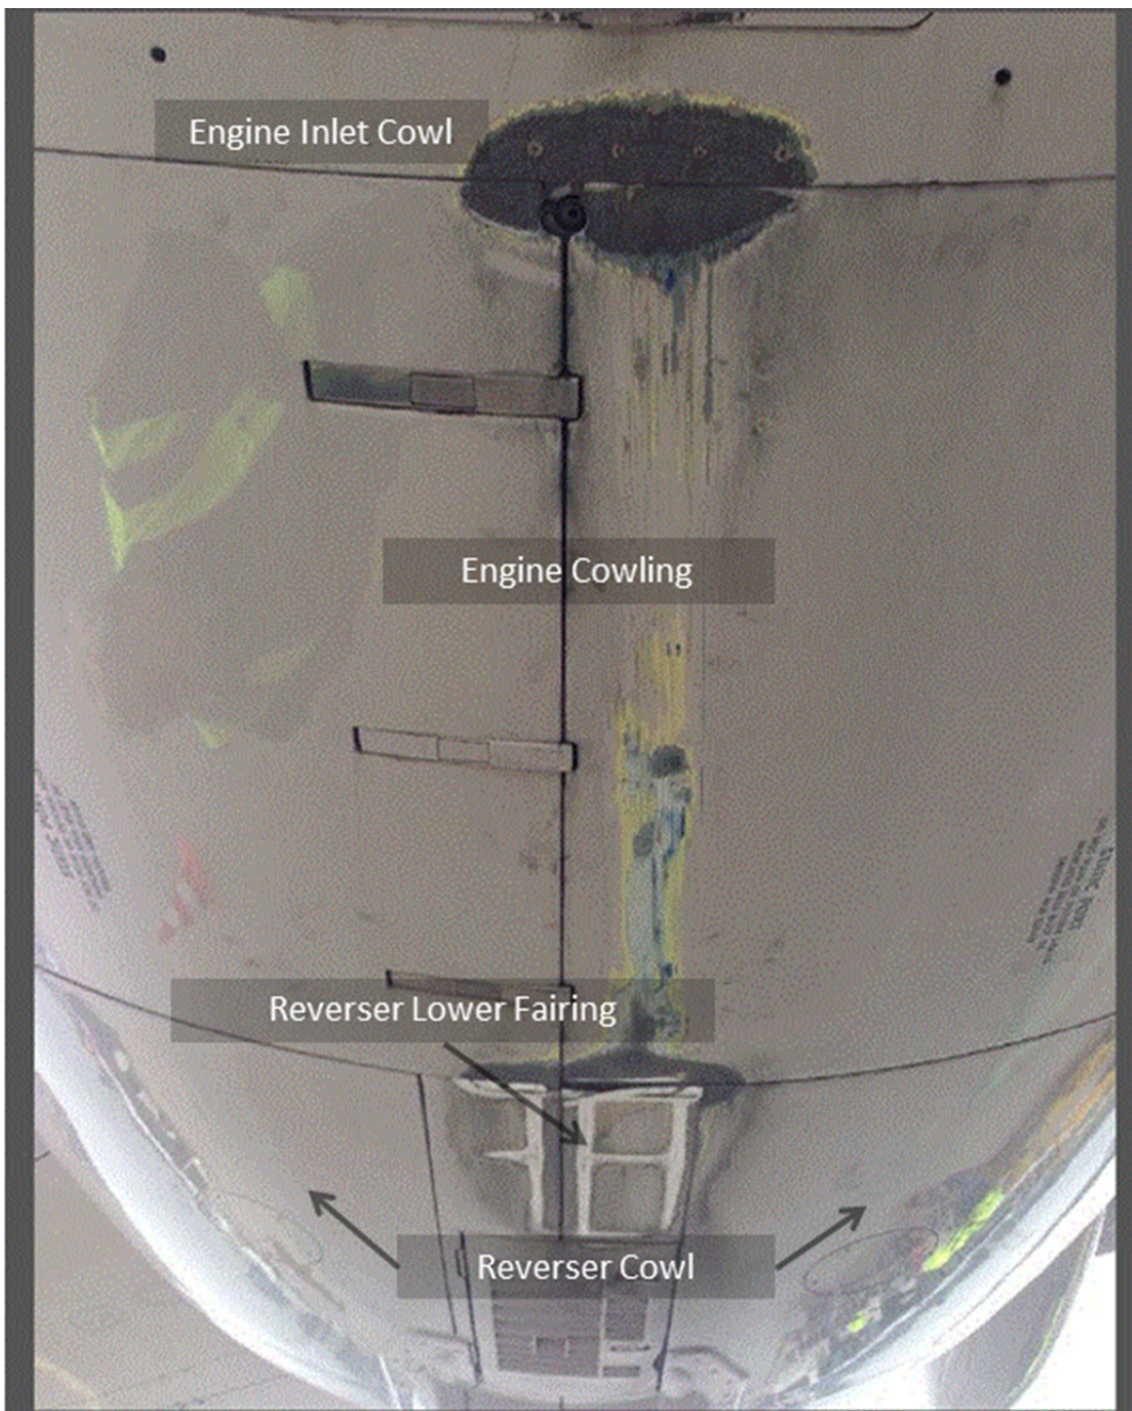
During the landing on runway 25L at Frankfurt Main Airport the lower surface of engine No 4 (outer right) touched the surface of the runway. Thus the engine cowling was damaged. Persons were not injured.

Lower surface of engine No 4

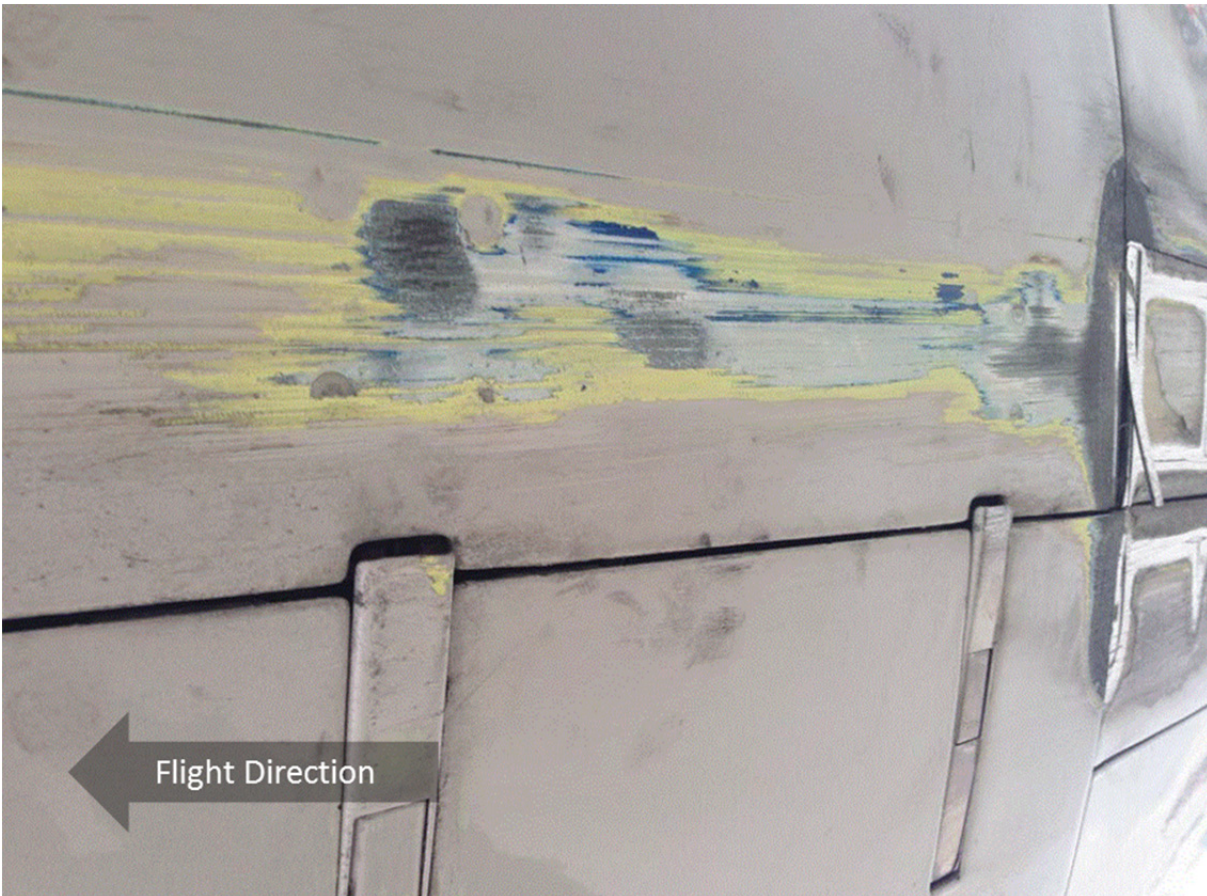
A certified maintenance organisation determined the damages on the lower surface of the cowling of engine No 4. The operator's Engineering Change/Repair Authorization (EC/RA) documented under EC/RA#: 7831-02059 the following damages on the cowling of engine No 4: A scratch mark of 17.8 cm width and 5 cm length on the six o'clock position on the engine inlet cowl; a scratch mark of 28 cm width and 86 cm length on the right lower engine cowling; scratch marks on the reverser cowling of 10 cm width and 35.5 cm length, as well as of 20 cm width and 35.5 cm length, each in the six o'clock position. In addition, the reverser lower fairing showed cracks and torn off pieces (see Appendix).

Damages on the lower engine cowling

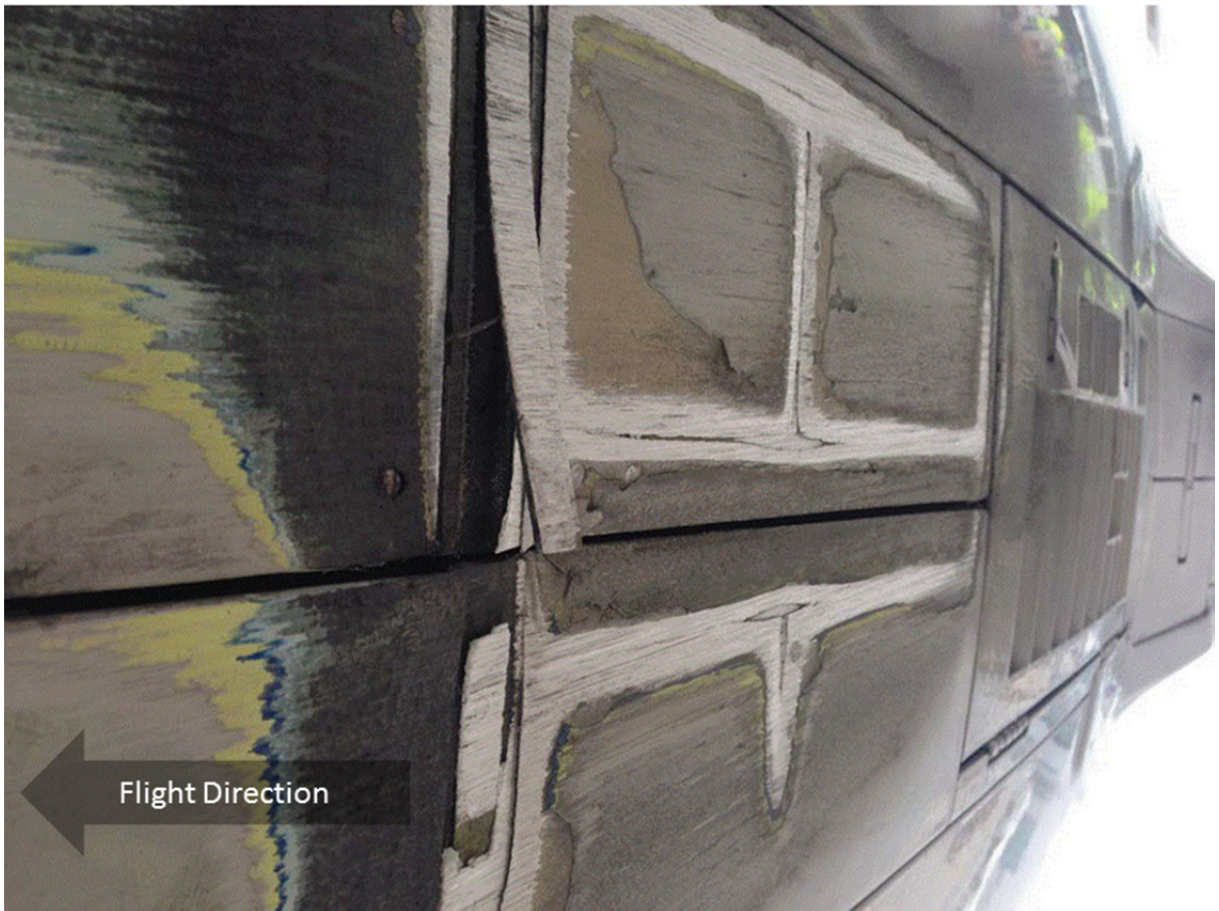
Damages on the reverser lower fairing
