# Investigation Report

Type of Occurrence:	Serious incident
Date:	20 January 2016
Location:	Munich
Aircraft:	Airplane
Manufacturer / Model:	Airbus / A320-216
Injuries to Persons:	None
Damage:	Minor damage to aircraft
Other Damage:	None
Information Source:	Investigation by BFU
State File Number:	BFU16-0055-EX

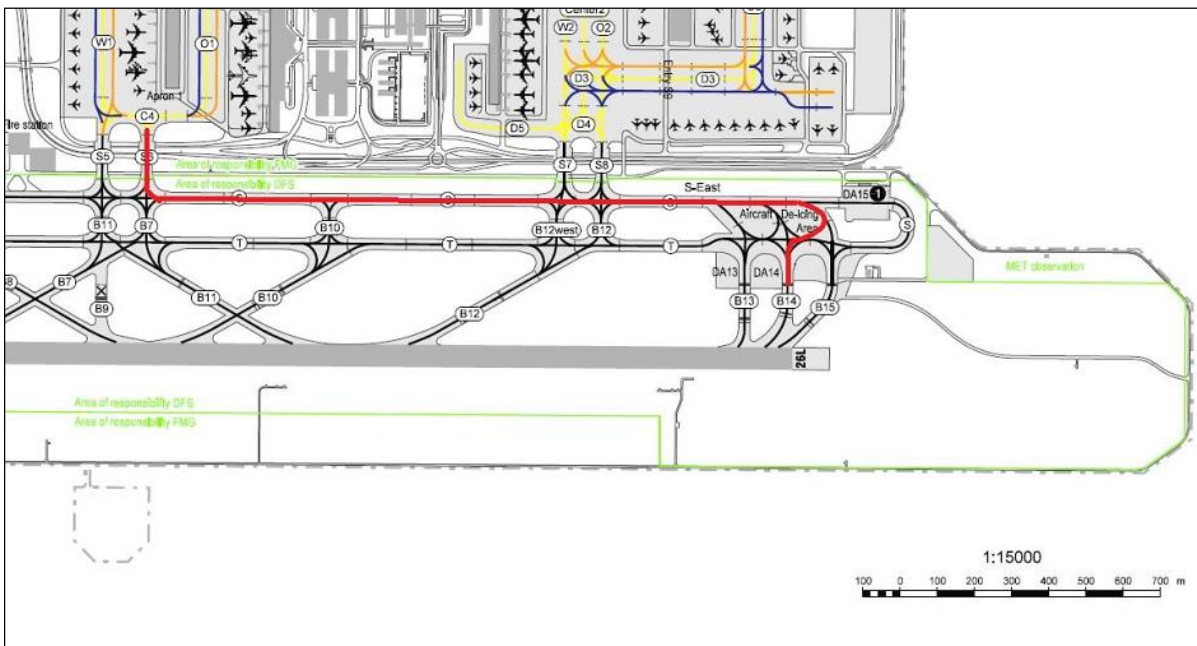
According to the Flight Data Recorder (FDR) data the aircraft taxied on to taxiway S with a speed of about 20 kt. The Cockpit Voice Recorder (CVR) recordings showed that the co-pilot listened to ATIS during taxiing and then informed the Pilot in Command (PIC) about the content while the aircraft at 0745:32 hrs taxied straight past the turn-off to taxiway B14 with approximately 20 kt. About 60 m east of the turn-off the speed of the airplane began to decrease and at 0745:50 hrs had reached approximately 6 kt.

Reconstruction of the taxi distance based on FDR data

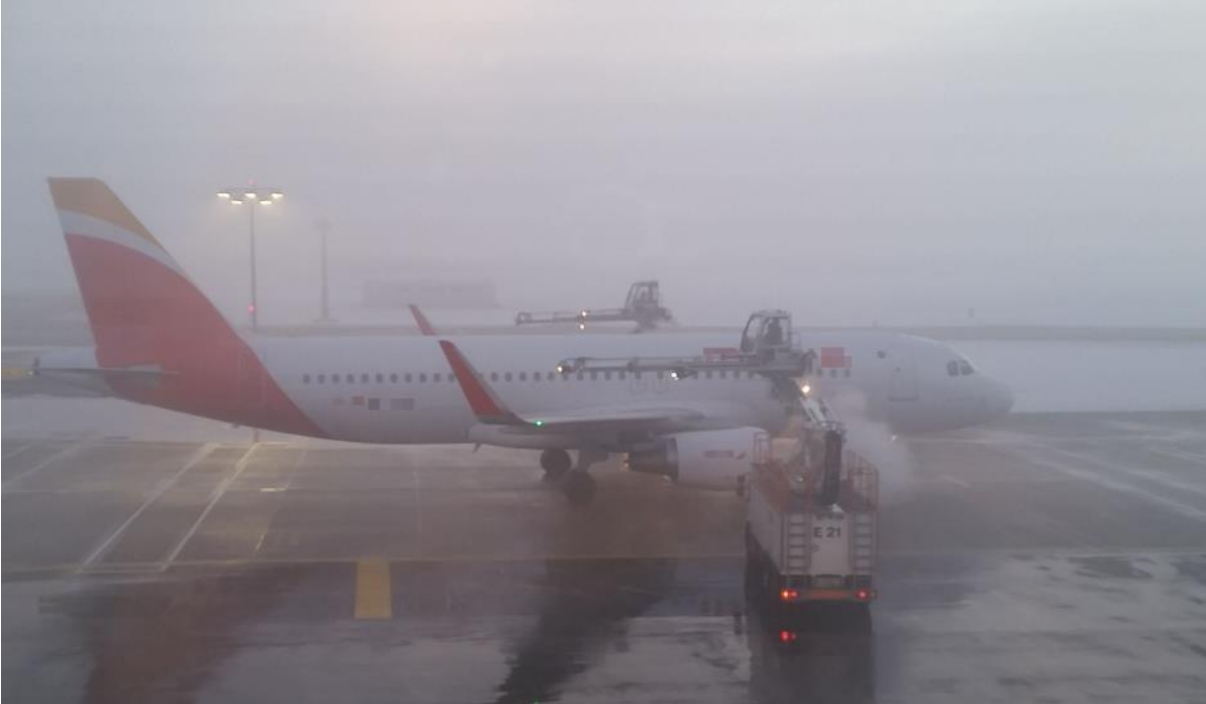
The BFU has a photo, which an employee of the de-icing company took from the adjacent DA13. It documents the positions of the airplane and the de-icing vehicles and the weather conditions at 0752 hrs.

Photo of the DA14 at 0752 hrs; view toward east

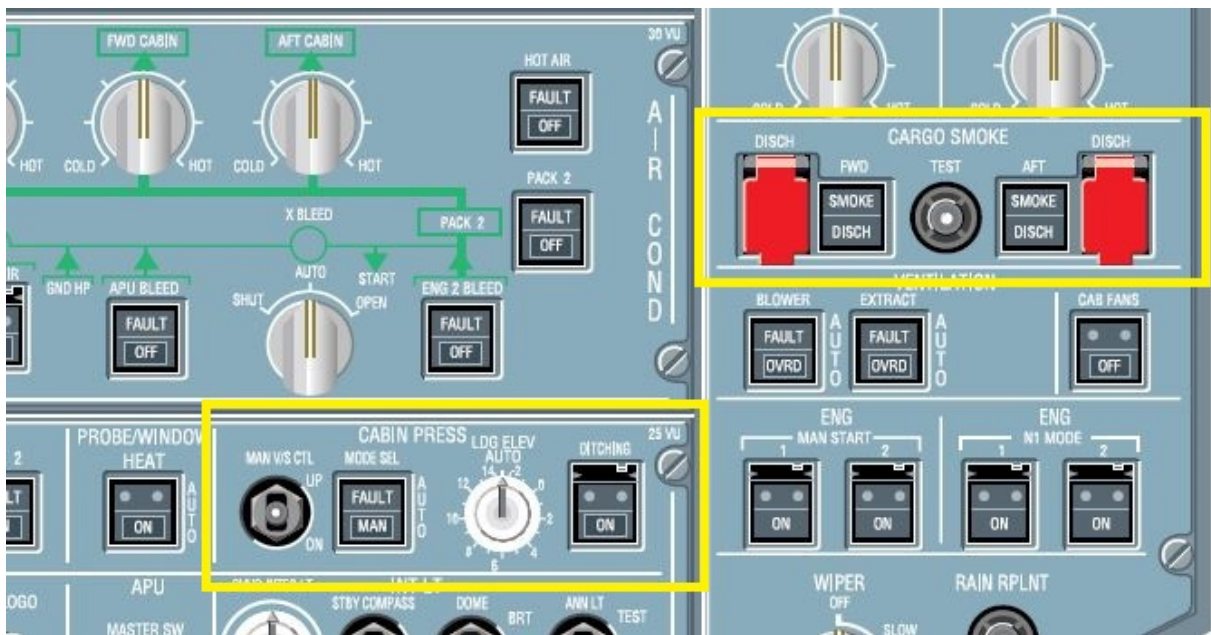
The documentation of the aircraft manufacturer showed that prior to de-icing the outflow valve had to be closed by activating the push-button marked DITCHING at the cabin press panel.

In case of smoke in the cargo compartments (front or aft) the respective fire extinguishing system had to be activated via a switch marked DISCH, protected by a red cover, located on the cargo smoke panel of the overhead panel.

Cabin press panel and cargo smoke panel

A procedure had been established for preparing the aircraft for the de-icing procedure, which the flight crew had to implement by completing the respective checklist. In addition, the DISCH switch had been protected against inadvertent activation by a red cover (red guarded button). The pilots worked together routinely. The BFU is of the opinion that the erroneous activation was caused by lack of concentration of both pilots; the co-pilot as executor and the PIC as pilot monitoring. It is possible that the similarity in lettering (DITCHING and DISCH) aided the mix-up.

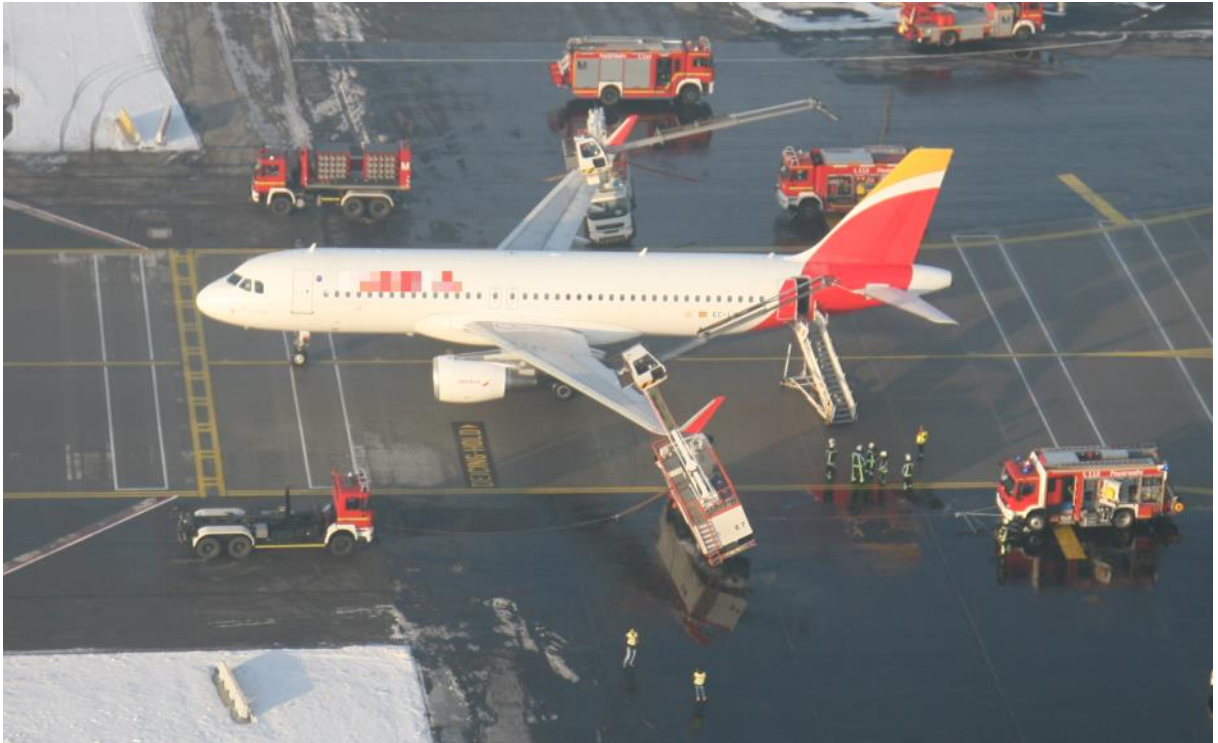
The Serious Incident occurred at DA14 approximately 160 m north of runway 26L.

The aircraft's nose landing gear stood on the centre line of the taxiway. The fuselage nose was immediately north of the CAT II/III hold bar, about 7.5 m behind the de-icing hold marking.

Positions of the airplane and the de-icing vehicles after the collision

The airplane's wings' transition zones with the sharklets had collided with the booms of the de-icing vehicles. Both sharklets of the airplane were slightly damaged.

The drivers' cabs of the de-icing vehicles stood abeam of the corresponding edge marking of the taxiway. The vehicles had tipped by about 20° and therefore stood on their left or right wheels, respectively.

The de-icing company stated that immediately after the occurrence it was stipulated that the de-icing vehicles have to be positioned parallel to the aircraft's longitudinal axis so that in case of collision the vehicles would not topple over.

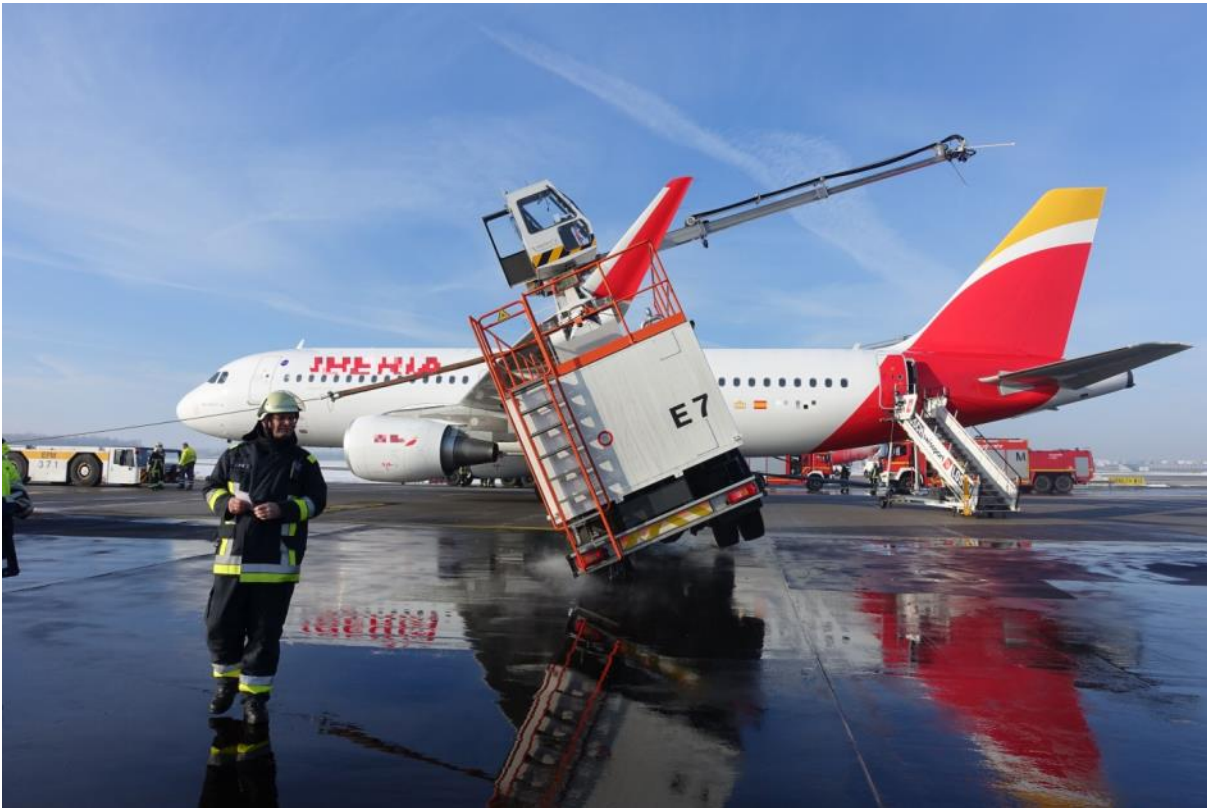
Position of the Aircraft after the collision

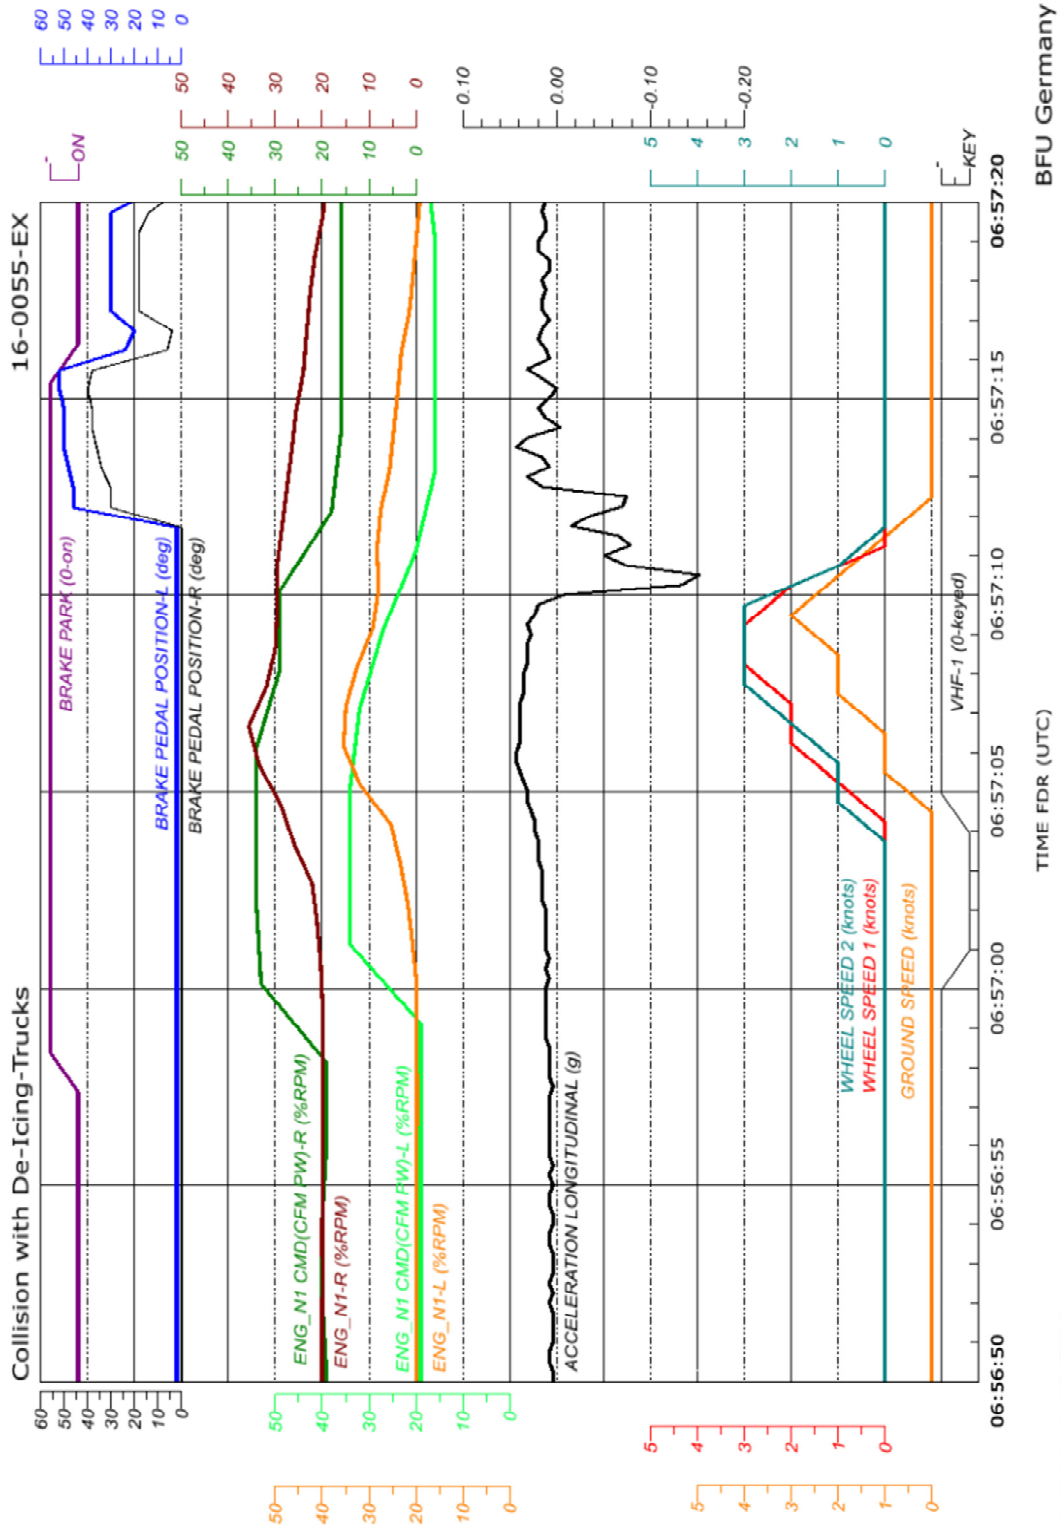
The change in longitudinal acceleration from 0.2 g to -0.15 g recorded at 0757:10 hrs indicates the time of the collision with the de-icing vehicles. The PIC stated that initially he had not attributed this with a collision but actuated the wheel brakes and set the parking brake. Later he recognised the situation due to the shouts of the de-icer.

Excerpt FDR recording
