Investigation Report

Type of Occurrence:	Accident
Date:	2 August 2016
Location:	Oberschleissheim Special Airfield
Aircraft:	Helicopter
Manufacturer / Model:	Agusta S.p.A. / A 109E
Injuries to Persons:	One person suffered minor injuries
Damage:	Aircraft severely damaged
Other Damage:	None
State File Number:	BFU16-1082-3X

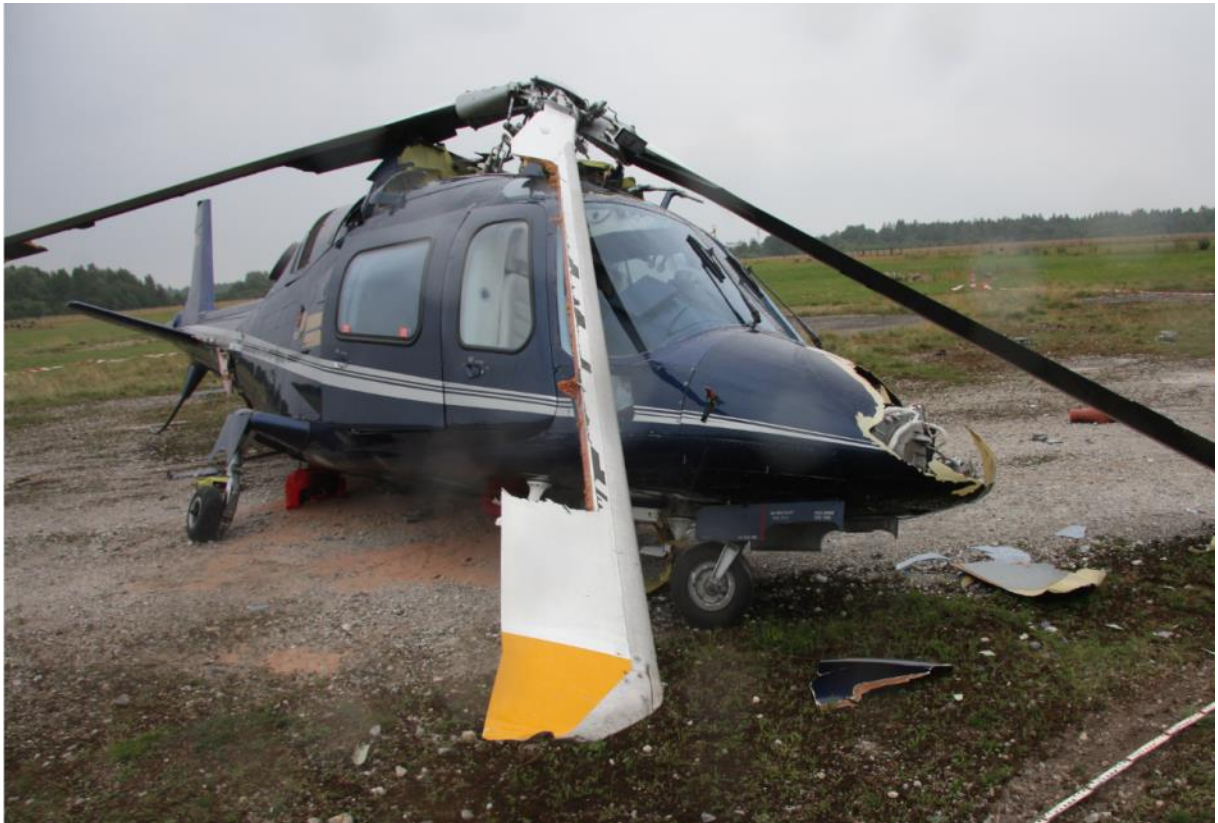
After the helicopter had stood firmly on the ground and the TRI deactivated the OEI training mode, the helicopter suddenly began to swing vertically. Both pilots concluded it had to be ground resonance. The TRI wanted to stop it and therefore pulled the pitch. But the helicopter responded with increased vertical oscillations and added horizontal rocking motions. Finally the helicopter sprang from the left to the right main landing gear and back again. Due to the resulting tilting the main rotor had ground contact. Subsequently, the fuselage yawed and at about 1515 hrs the helicopter reached its final position lying partly on the fuselage after the engines had been shut off by emergency shut-down. The left main landing gear had been torn off.

Overview: damages on the helicopter

The nose was damaged. Individual electronic equipment had been torn out. The right side of the Plexiglas cockpit top was damaged; the pitot tubes on the roof were bent towards the rotation direction of the main rotor. The bracket of the main gear box had penetrated the roof of the cabin. All four main rotor blades and the rotor head were damaged. The four mounting rods of the main gear box on top of the fuselage were fractured. The hydraulic lines of the control servos essentially held the main gear box in place. The tail rotor drive shaft had been torn off the main gear box in the area of the rotor brake. The leading edge of one blade tip of the tail rotor showed an egg-sized spherical indentation.

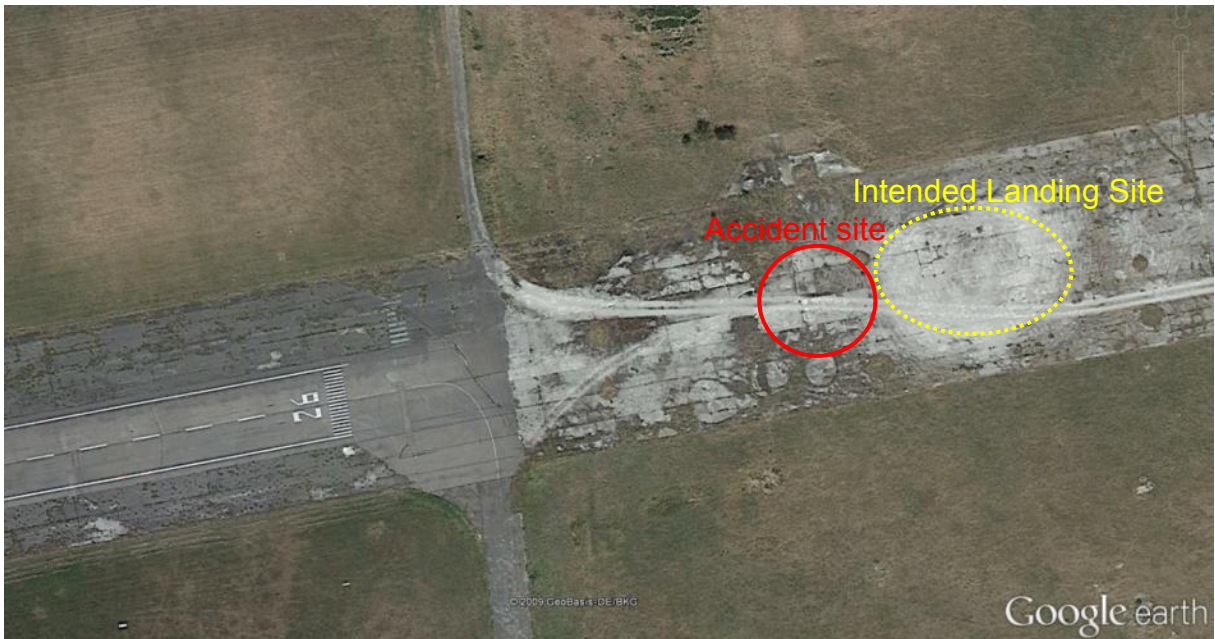
In front of runway 26 parts of the concrete runway surface of the old military airfield still remain. The surface is firm but covered with loose stones, weeds, and larger moss areas, and its surface is slightly rippled.

Overview: Start runway 26, intended touch-down point, accident site

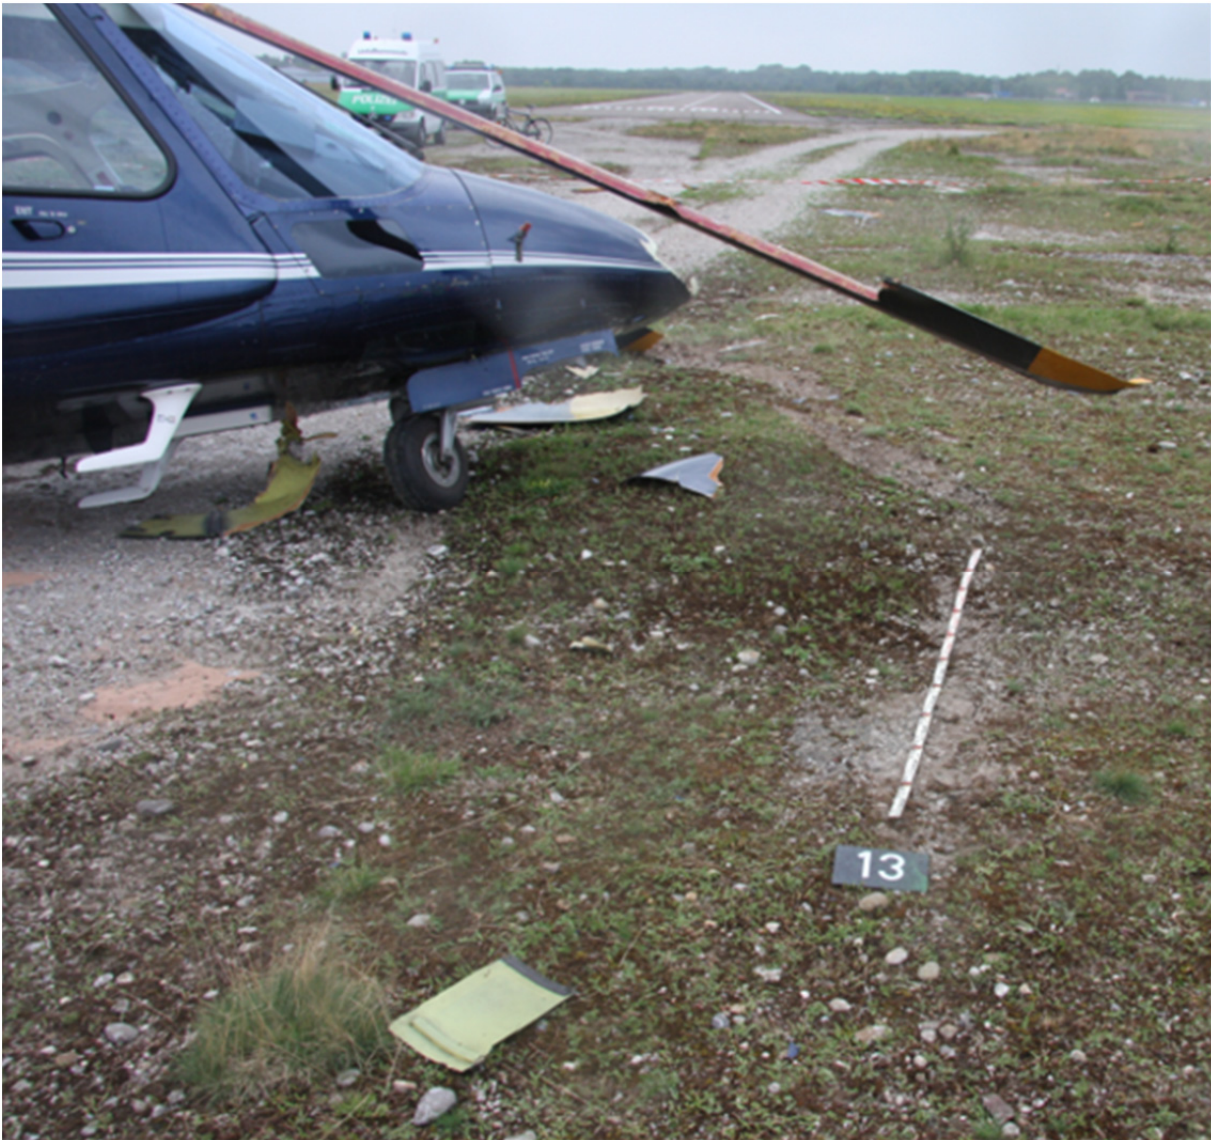
The accident site was located approximately 100 m in front of runway 26 of Oberschleissheim Special Airfield. The helicopter stood upright slightly tilting left towards approximately 320°. The retractable landing gear was extended. The parking brake had been released. The left main landing gear had collapsed outward. The nose landing gear had been twisted to the left. The pin of the nose wheel centre mechanism was not engaged. After the accident, the lever for the nose wheel locking in the cockpit was not completely in the “Lock” position.

Position helicopter, start runway 26, landing area surface

The surface also posed the risk of foreign object damage, e.g. on the tail rotor, caused by stones raised by downwash or landing gear wheels. The egg-sized spherical indentation at one of the tail rotor blades could have been caused by a stone. This stone could then have been thrown upward and caused main rotor blade damage. Main rotor damage could have triggered ground resonance. Due to the number of damages on the main rotor blades this could neither be proven nor ruled out.

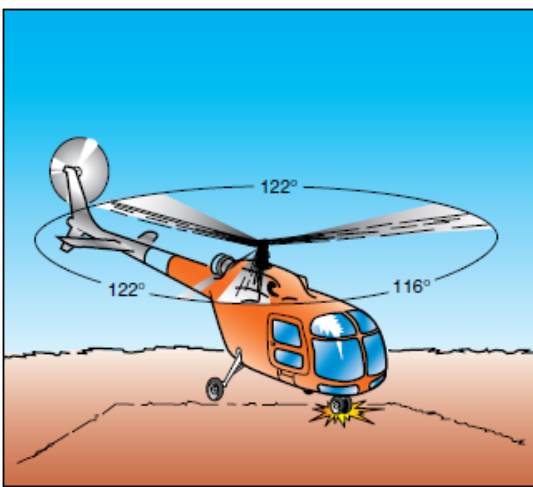
If you allow your helicopter to touch down firmly on one corner (wheel type landing gear is most conducive for this) the shock is transmitted to the main rotor system. This may cause the blades to move out of their normal relationship with each other. This movement occurs along the drag hinge.

Figure 11-5. Hard contact with the ground can send a shock wave to the main rotor head, resulting in the blades of a three-bladed rotor system moving from their normal 120° relationship to each other. This could result in something like 122°, 122°, and 116° between blades. When one of the other landing gear strikes the surface, the unbalanced condition could be further aggravated.

If the r.p.m. is low, the corrective action to stop ground resonance is to close the throttle immediately and fully lower the collective to place the blades in low pitch. If the r.p.m. is in the normal operating range, you should fly the helicopter off the ground, and allow the blades to automatically realign themselves. You can then make a normal touchdown. If you lift off and allow the helicopter to firmly re-contact the surface before the blades are realigned, a second shock could move the blades again and aggravate the already unbalanced condition. This could lead to a violent, uncontrollable oscillation.
