# Final Report

5X011-0/98  
April 2001

| Type of Occurrence: | Serious Incident |
| Manufacturer, Model: | Aerospatiale-Alenia/ATR 42-300 |

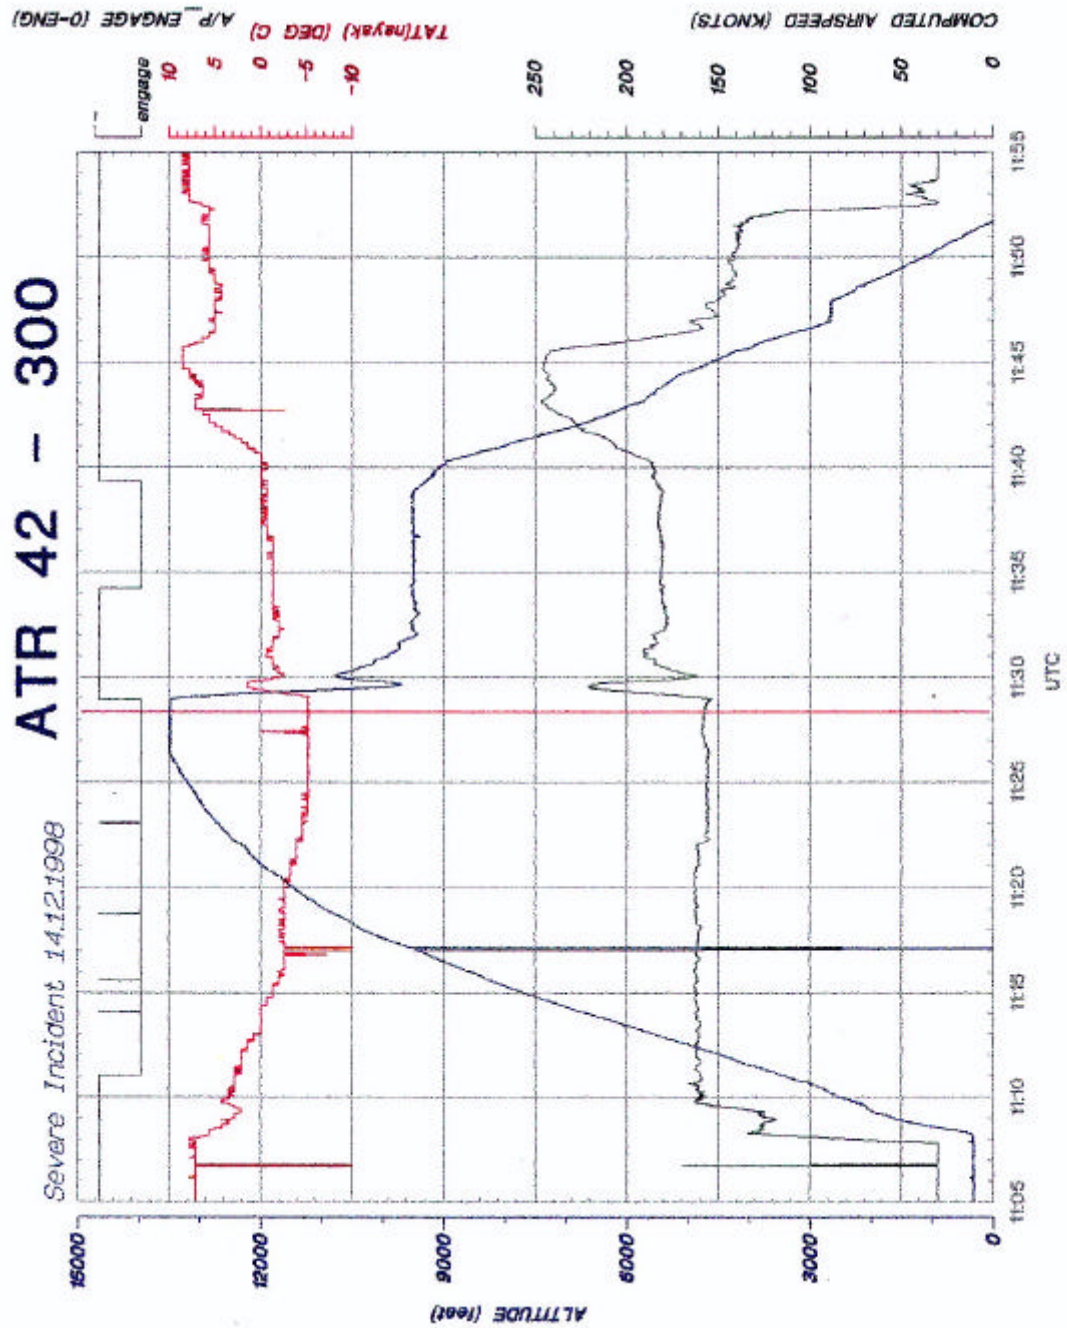
Attachment 2

The evaluation covered the period of time relevant to the incident, from the activation of the ALT HOLD Mode at FL 135 (11:26:20 UTC) until the crew had regained control of the aircraft (11:29:44 UTC (Attachment 2)).

At 11:28:54 UTC after 154 s of flight in the ALT HOLD Mode the AOA-threshold was exceeded so that the stall warning was activated and the AP disconnected. The yaw damper remained in circuit. Immediately the left bank angle increased, the pitch decreased and the aircraft assumed an uncontrolled flight attitude.

- High bank angles changing from left to right counteracted by opposite aileron deflections by the crew with almost identical frequency with extreme values of 103° to the right and 48° to the left, resulting in the so-called wing rocking.

- Rudder deflections coordinated with aileron deflections.
- The AOA did not decrease considerably during the first 43 s - in the meantime it increased to values up to 15° - only at 11:29:37 UTC AOA values below 10° were recorded.
- The elevator position remained nearly unchanged.
- The trim tab was not operated.
- The pitch decreased to a minimum of -17°.
- The airspeed increased to a maximum value of 221 kt.
- The vertical acceleration reached a maximum of +2.16 g.
- The speeds of the propellers remained constant at 86%.
- After 10 s of uncontrolled flight the crew increased the engine torque to approx. 107%.
- The loss of altitude was approx. 3800 ft.
- At approx. FL 110 the aircraft reached warmer air masses (TAT up to +1°C).
- The wing rocking stopped when the speed increase reduced the AOA below the critical value.
- There was no other conflicting air traffic.

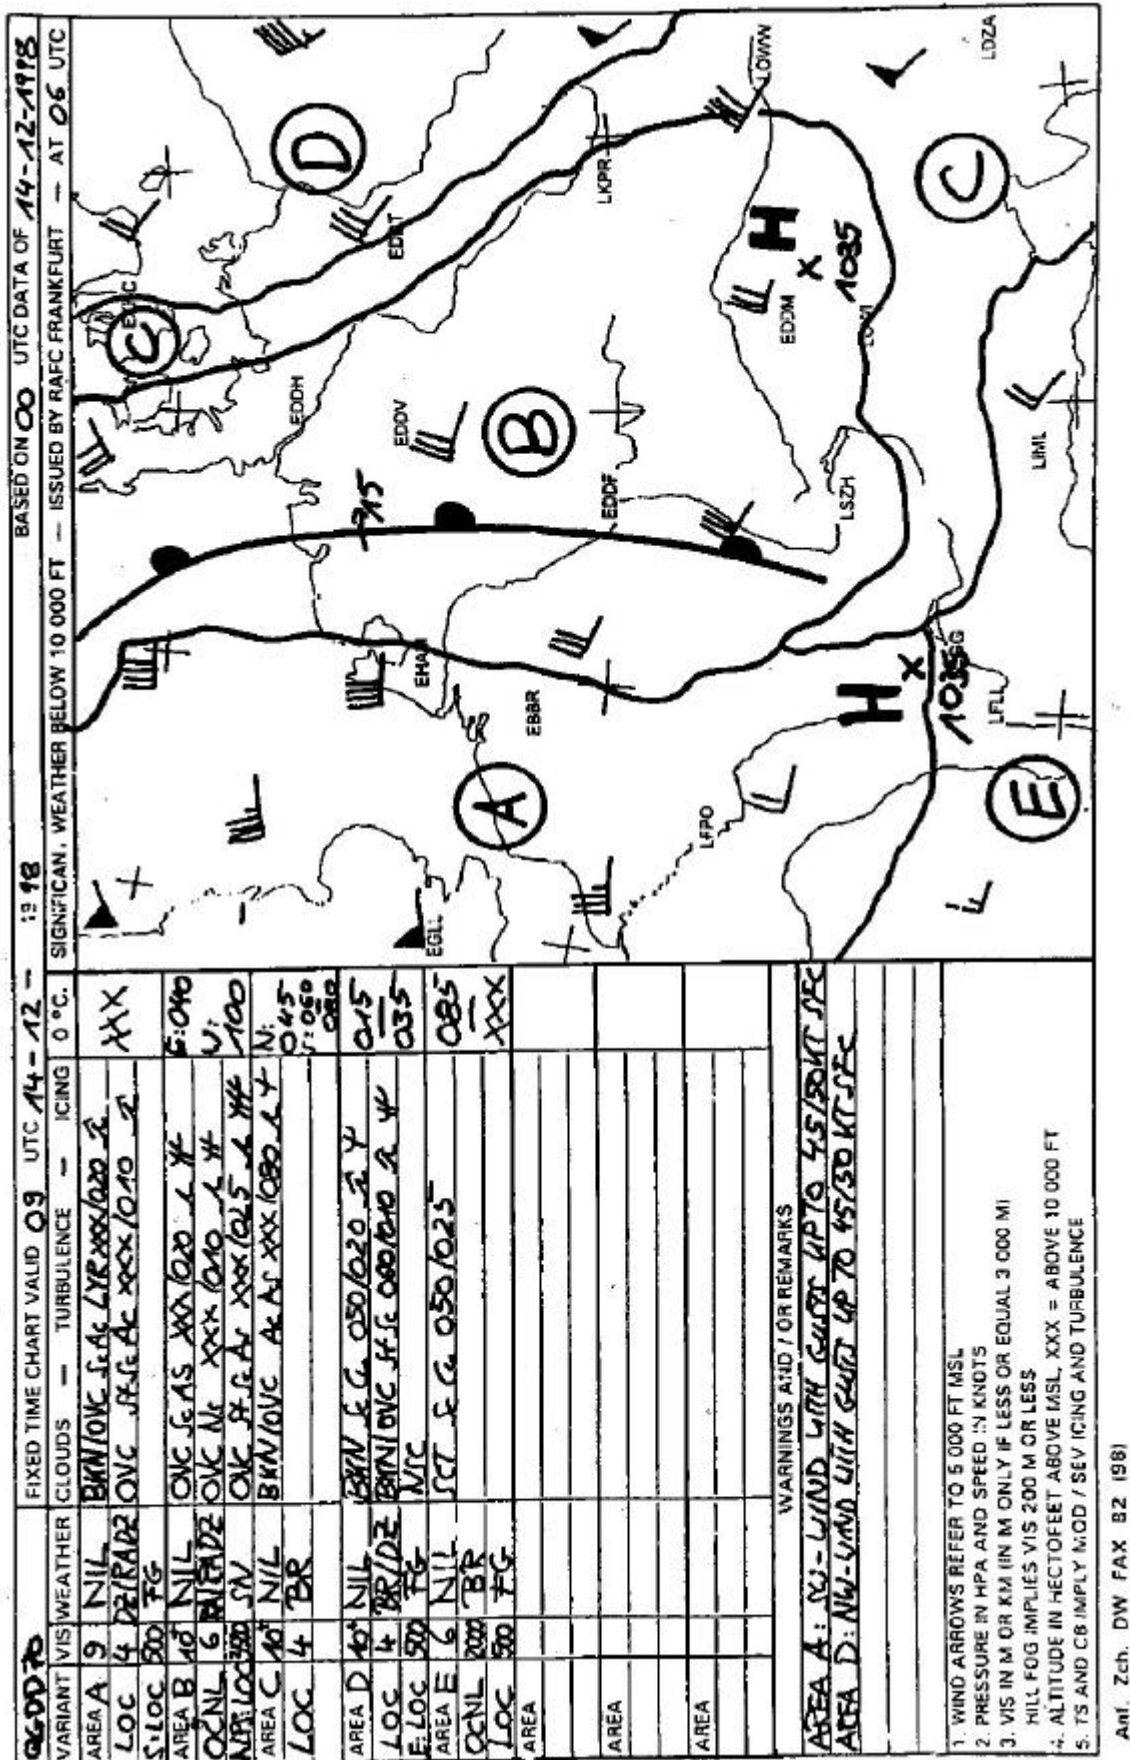
## Attachment 5

AIRMET (Airman meteorological information) no. 2 for the FIR (Flight Information Region) Berlin, valid for the lower airspace up to FL 100, the SWC (Significant Weather Charts) up to FL 100 as well as the SWC for FL 100 up to FL 450 (Attachments 5 and 6).
