Report

CX010-0/98

| Date: | September 4, 1998 |
| Manufacturer/Model: | Kaman K-1200 |

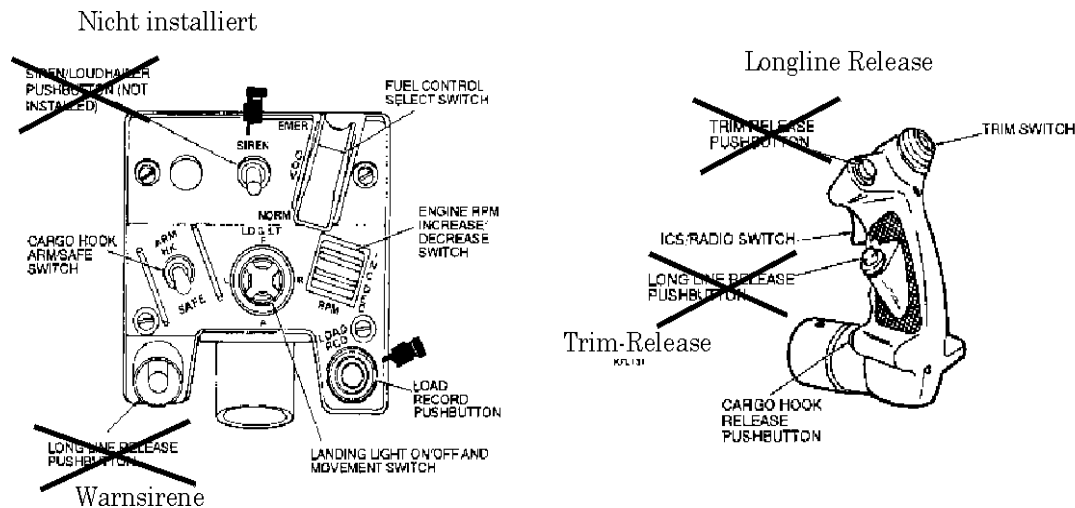
In this regard, this particular K-1200 was modified on the request of the operator without appropriate notification in the flight manual. On the stickhandle, the key of the Longline-Release was switched with the Trim-Release button, which is normally at the head of the handle on the left side. Appropriately altered labels were affixed to the stick. The Longline-Release button at the collective lever was missing entirely. The siren was activated with the button installed in this place. According to the operator this button was labeled accordingly. Anyhow the label was no more evident after the accident.

The operator explained as reason for the modification that the entire fleet of the company, with the exception of the K-1200, consist of helicopters of a French design. The layout of the switches was taken from these helicopters and applied to the K-1200 to facilitate the helicopter pilots.

As described above, on the request of the customer, the control elements on the control stick handle and lever for the collective of the long line release were modified at this K-1200, while the Cargo Hook Release control remained unchanged. The flight manual, chapter emergency measures, states that at a power loss the external load is to be released, recommended using the Cargo Hook Release. However, it also contains the note that the decision to drop the load in an emergency situation is a critical one, when there are persons underneath the helicopter, which was the case here.

- The external load was not jettisoned
- The external load led to an impact of the helicopter in an inverted attitude.
- The button for dropping the external load from the end of the load cable was moved to a place different from the original condition. The location of the actuators for opening the cargo hook release the use of which is recommended in the emergency procedures was unchanged.
