Report

EX002-0/99
September 1999

Translation of the German Investigation Report.

Classification:	Serious Incident
Date of event:	20 th January, 1999
Location:	Airport Frankfurt/Main
Aircraft:	Civil Jet Aircraft
Manufacturer / Type:	Boeing B747-400
Injuries to persons:	none
Damage to aircraft:	severe
Third party damage:	Airport Equipment

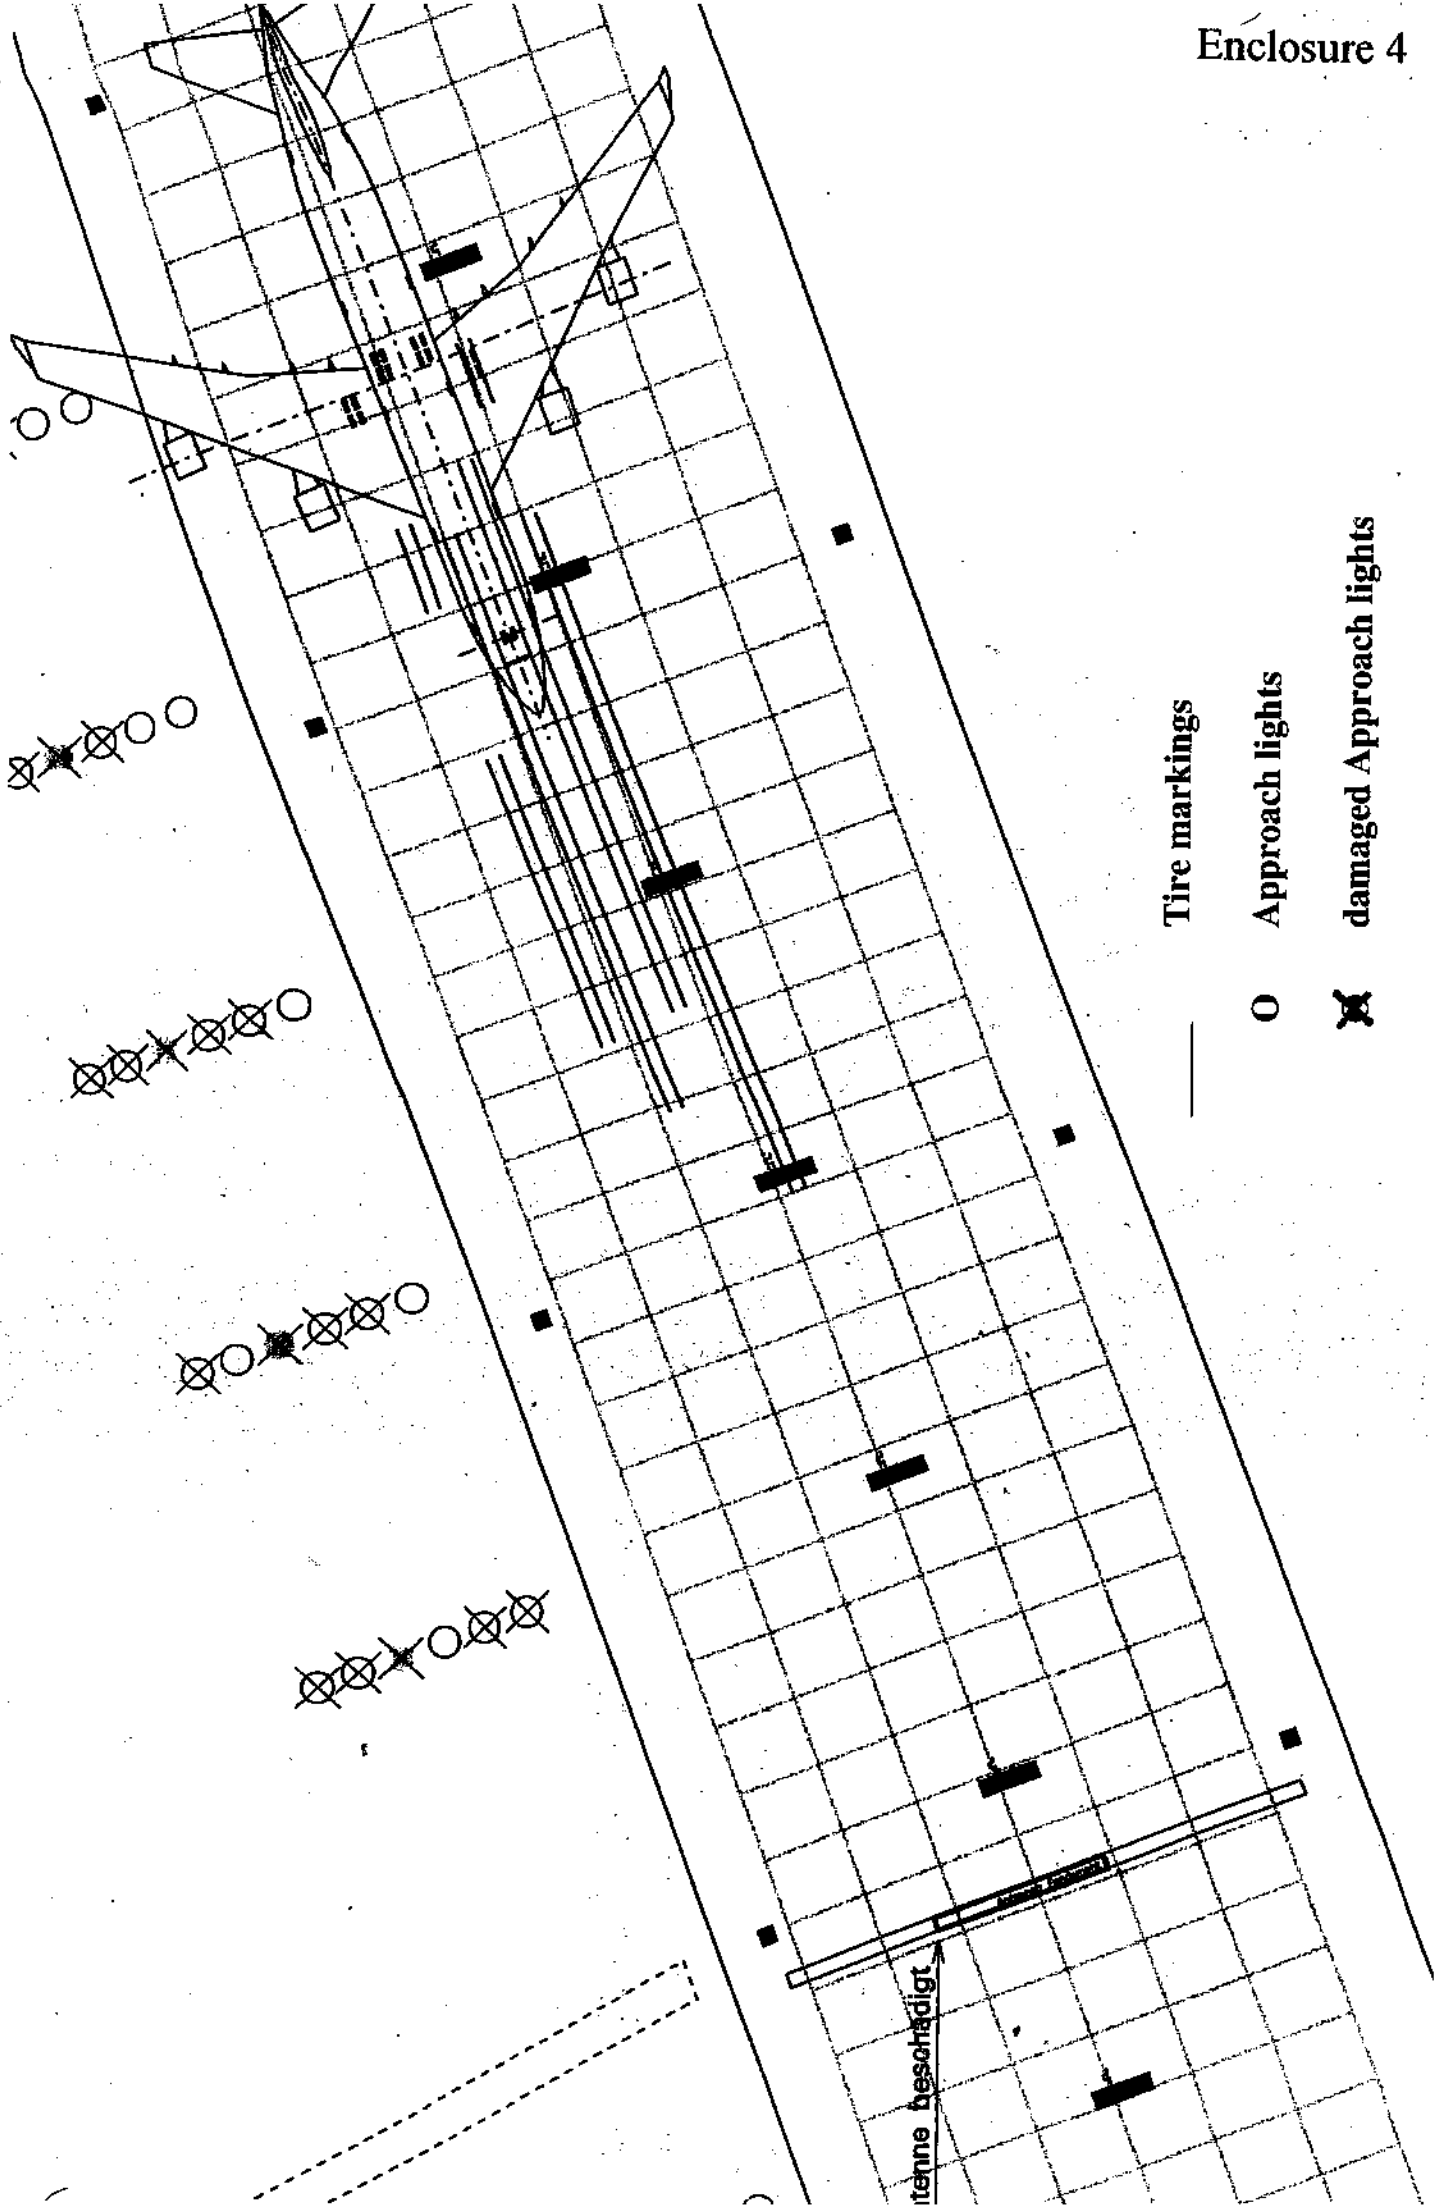
Tire marks with a length of 85 m maximum were clearly visible - 22 lights of the approach lighting system were damaged or destroyed (Enclosure 4). The localizer antenna for Runway 07 R was broken out at a width of about 16 m. So the approach lighting system 25 L and the ILS 07 R of the southern runway were unservicable until further (Enclosure 5).

Tire markings

○ Approach lights

⊗ damaged Approach lights

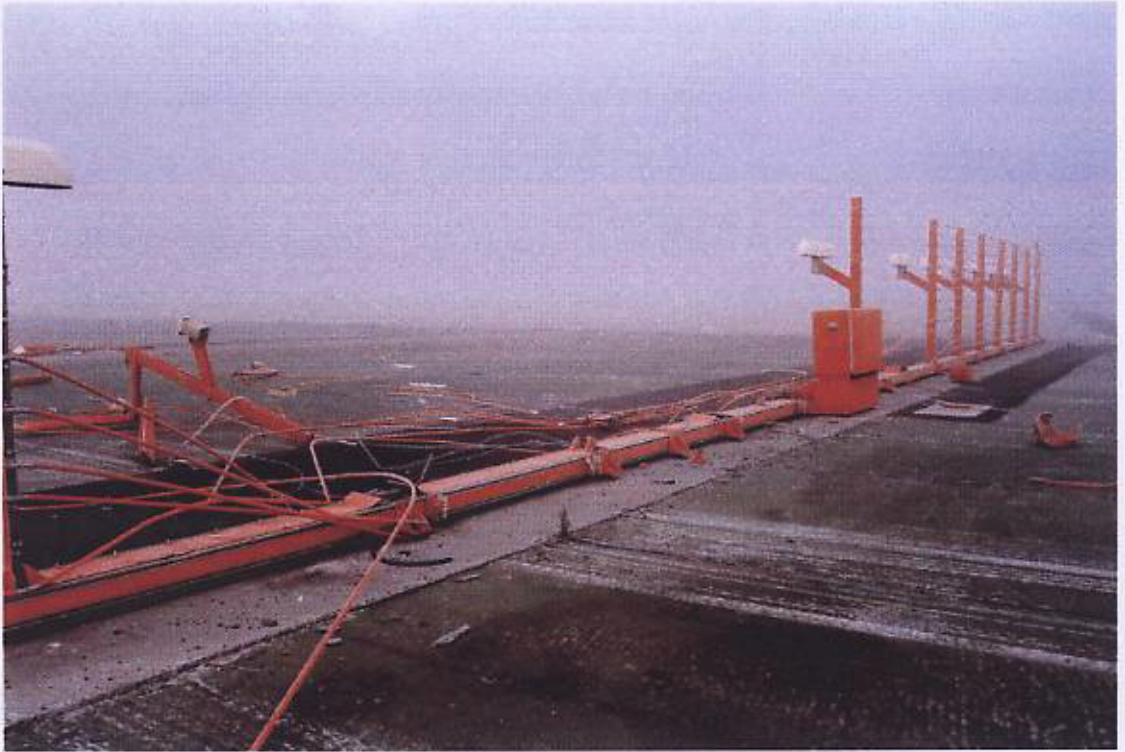
Destroyed localizer antenna of RWY 07R

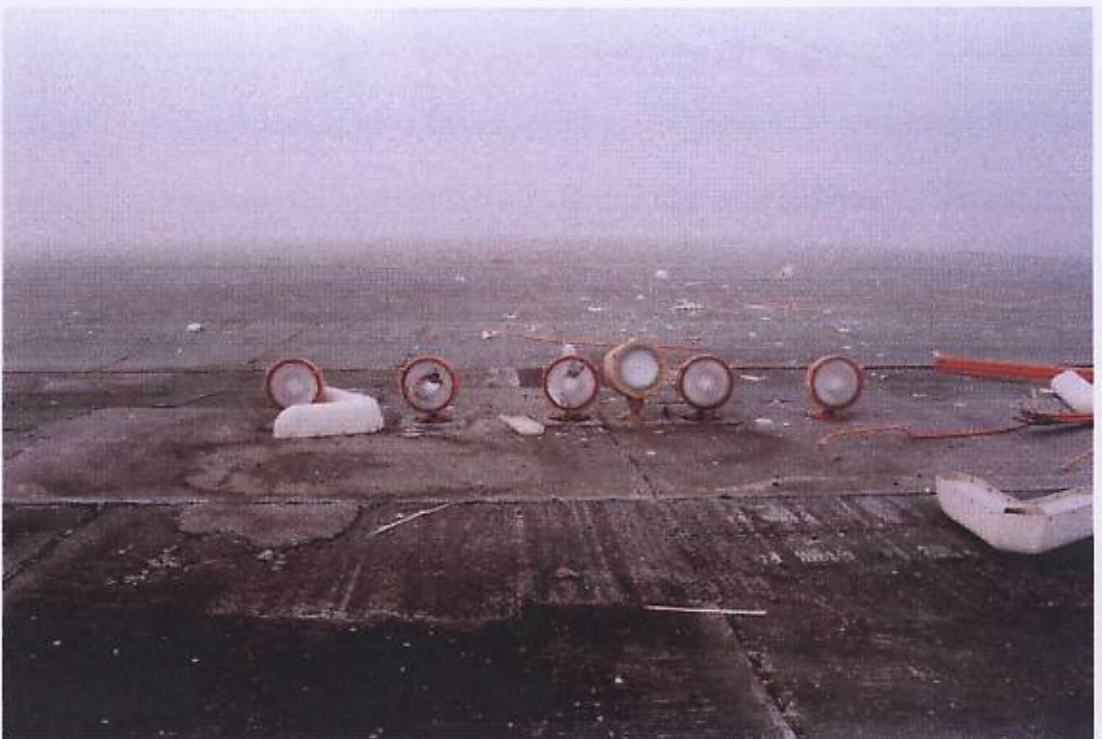
Parts of localizer antenna between the approach lights

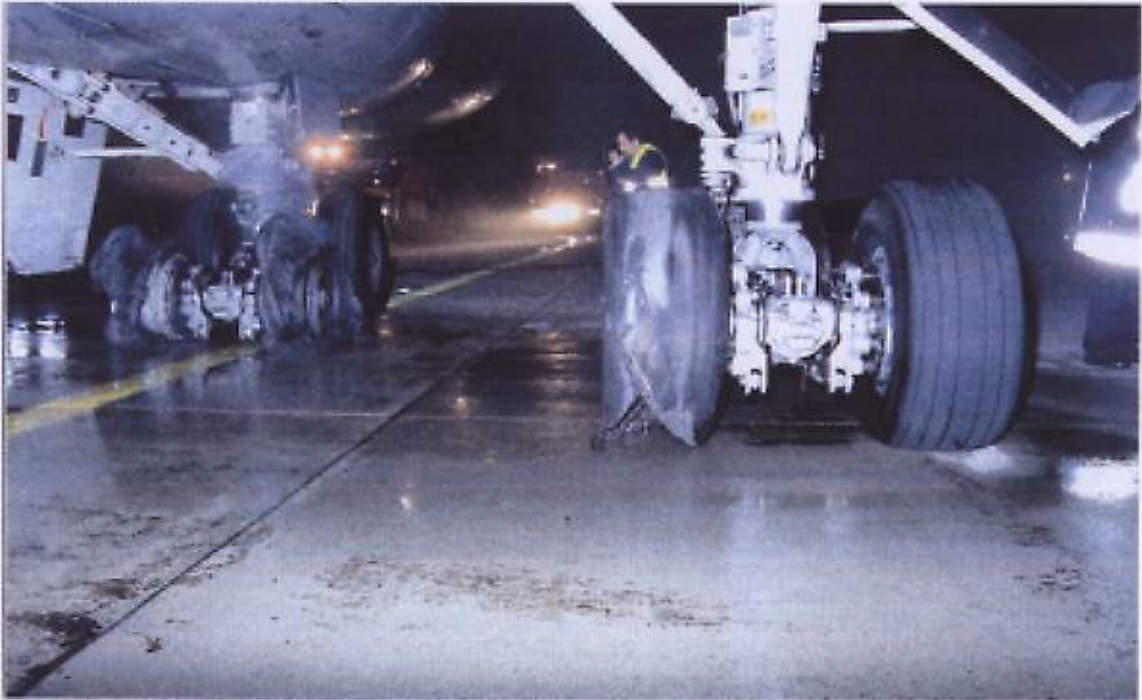
The B747 suffered damages to the main gear because of the collision with the surface equipment, its far spread debris causing damage to two engines and the fuselage as well (Enclosure 6).

The damaged L/H Main Gear and L/H Body Gear

The aircraft underwent the necessary repair in Frankfurt for a ferry flight to Mumbai.

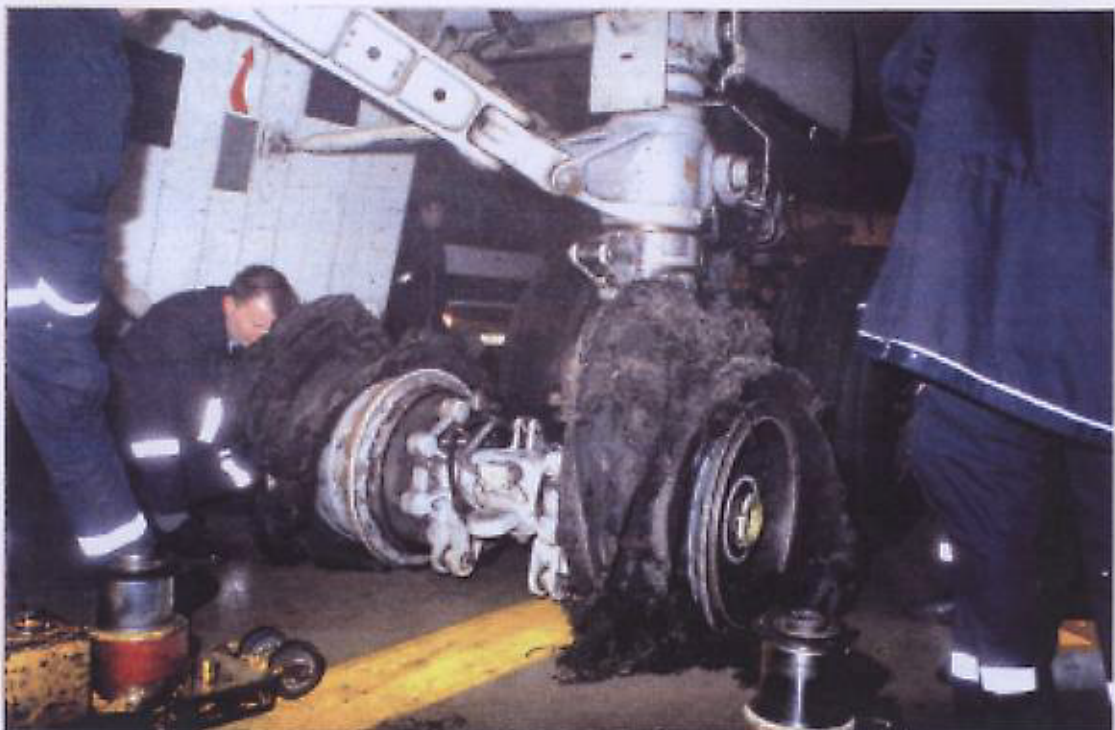
Meanwhile the RVR decreased so that at 16:50 UTC CAT II and from 16:54 UTC CAT III was in force. The second landing was performed at 16:58 UTC on runway 25 R as an automatic landing under CAT III conditions. Some of the previously damaged main landing gear tires started to burn, but were quickly extinguished by the fire brigade standing by. The fire

Details of L/H Body Gear, burned tires
