Investigation Report

Type of Occurrence:	Serious incident
Date:	16 March 2011
Location:	Near Augsburg
Aircraft:	Helicopter
Manufacturer / Model:	Eurocopter / AS 332 L1
Injuries to Persons:	None
Damage:	Minor damage to aircraft
Other Damage:	None
Information Source:	Investigation by BFU
State File Number:	BFU 7X004-11

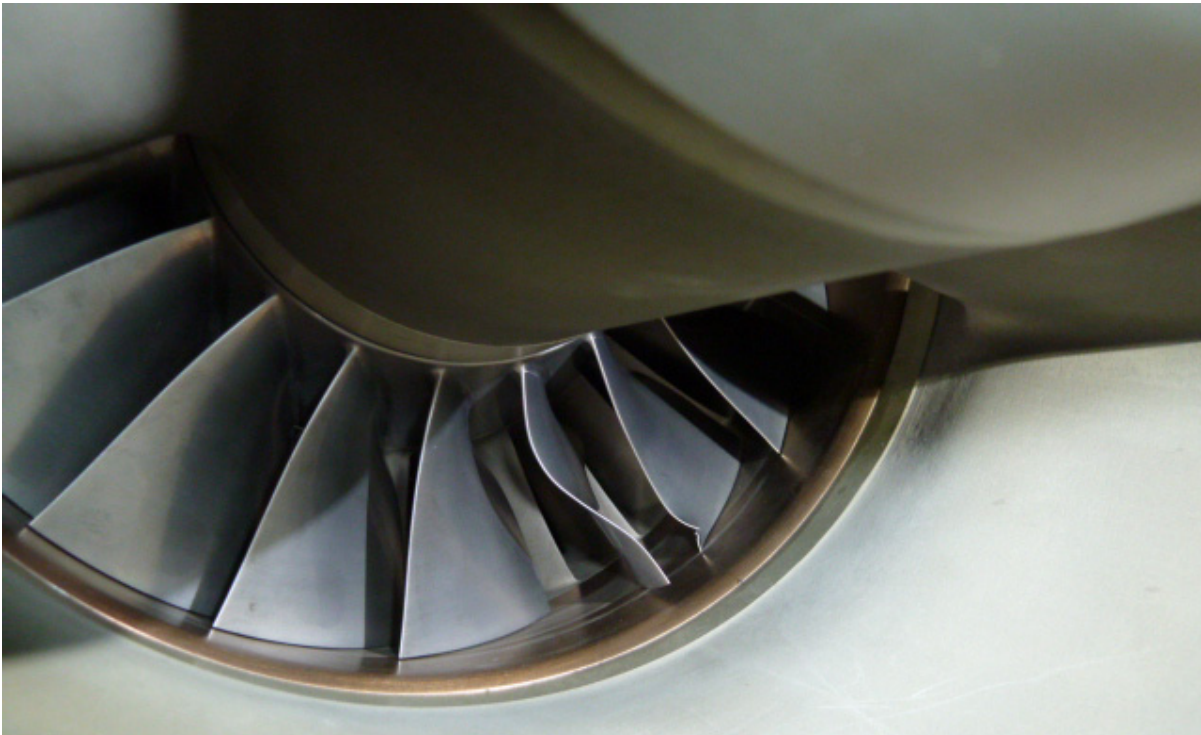
When the BFU staff arrived the helicopter stood on the apron of Augsburg Airfield. The MPAs were closed. For further investigations the helicopter was brought into a hangar. With the support of technicians from the operator and the engine manufacturer, the engines, the air inlets, the magnetic chip detectors and the fuel and main gear box oil filters were examined. A metallic chip at the main gear box chip detector and damage on two compressor blades of the right engine were detected.

Damage on the compressor of the right engine

The helicopter was properly registered and maintained except for the missing flight data recorder. It was as good as new and the 25-hour inspection was almost due. Mass and centre of gravity were within their prescribed limits. It is highly likely that the metallic chip found in the main gear box chip detector was grit which was produced after a new gear box had been put into service. It is likely that the damage found on the compressor blades of the right engine were caused by ice ingestion. The deformation corresponded with those found on engines which had failed due to ice ingestion.

The damage on the engine and the engine failure shortly after the opening of the MPAs do not allow for any other conclusion but an ice accretion on the helicopter or the MPAs.

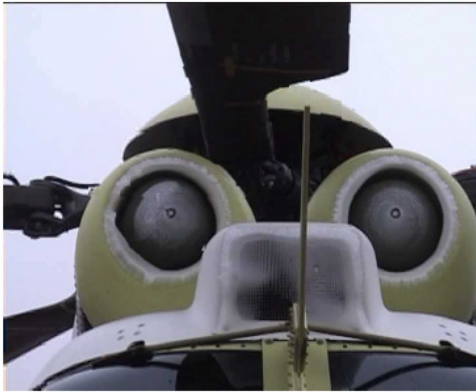
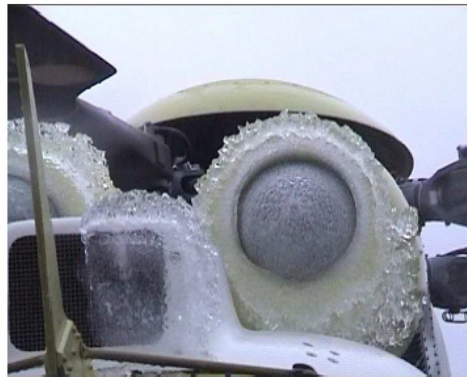
The photos below, which were taken on the ground when the engines were shut down, show examples of possible ice accumulation on the multi-purpose air intakes.

It is therefore also recommended not to reopen the bullets on the ground before the engines are fully shut down, in order to prevent any potential damage to the engines.
