INCIDENT INVESTIGATION REPORT

**QANTAS AIRWAYS LTD.
BOEING 707-338C AIRCRAFT VH-EAD
AT FIUMICINO AIRPORT, ROME
ON 30th APRIL 1970.**

Prepared by:
Air Safety Investigation Branch Melbourne
November 1970.

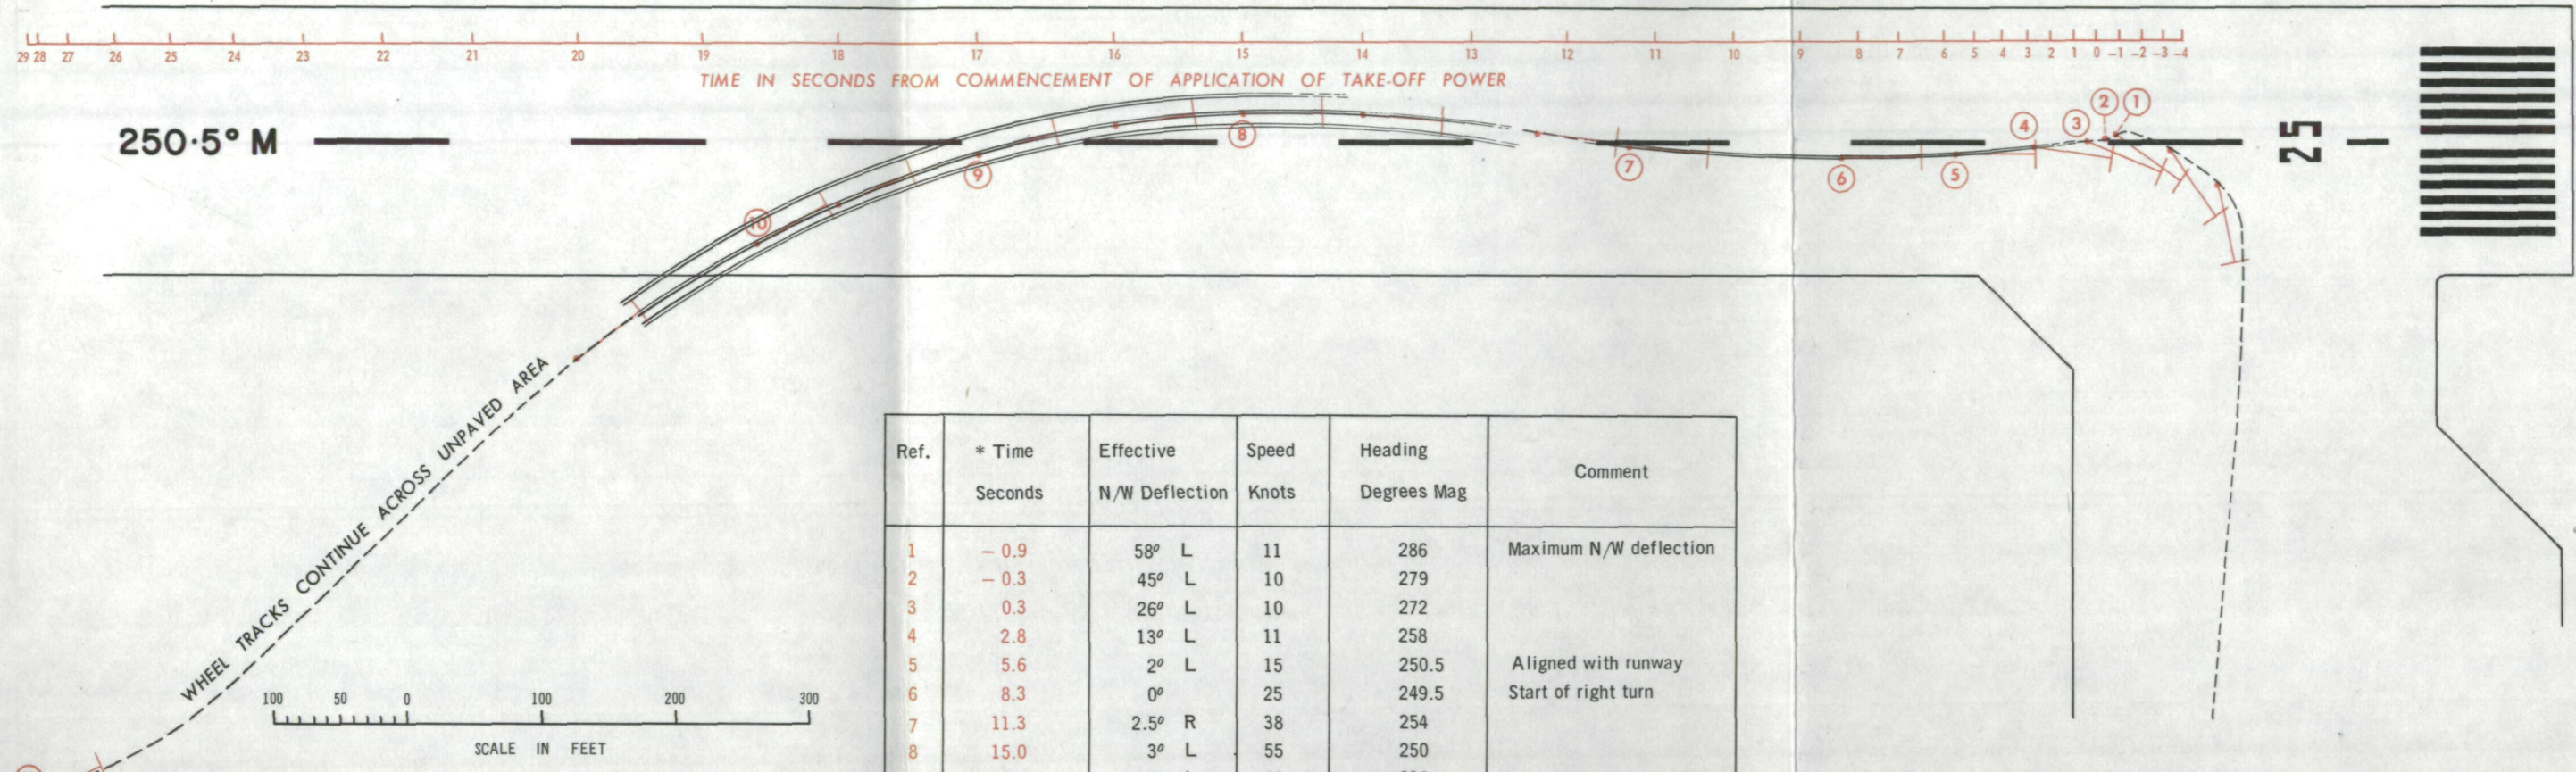
PLAN OF AIRCRAFT PATH AND SKID MARKS
VH-EAD, FIUMICINO AIRPORT, 30-4-70

The most significant skid mark was that commencing approximately at the point marked 3 and extending to just beyond the point marked 7. This was a nosewheel skid mark in which the marks of both tyres were clearly discernible. At the first point at which they could be observed the marks were fairly widely spaced (i. e. of the order of 20 inches centre to centre) and they then quickly converged until they were separated by approximately 14 inches centre to centre. These marks subsequently diverged again, approximately at the point marked 6. The other skid marks, both nosewheel and mainwheel, were consistent with those which are to be expected under the circumstances of high-speed, high-rate turns.

The evidence indicates that the aircraft was travelling quite slowly, probably at less than 5 knots, at the point of entry to the runway. In order to negotiate the turn, however, in the vicinity of the point marked 1 in Appendix A, it is necessary for the aircraft to have either a maximum nosewheel deflection (i. e. 58 degrees) coupled with a nosewheel rolling speed of 11 knots or a higher speed coupled with an appropriate lesser deflection. The evidence favours an hypothesis of maximum deflection and thus a speed of about 11 knots at point 1. To achieve and sustain this speed through the turn at point 1, something more than idling power would be necessary.

In the vicinity of point 2 the nosewheel deflection was reduced to something of the order of 45 degrees and the heading of the aircraft at this time was reducing from approximately 30 degrees to 26 degrees off runway heading. It is probable that the major power-build-up for take-off commenced at about this point.

Over the next $8\frac{1}{2}$ seconds the nominal nosewheel deflection (i. e. the deflection required to achieve the turn without skid) decreased progressively from 40 degrees down to 9 degrees and, during this period, the aircraft continued to approach alignment with the runway although offset some 10 feet to the left of the centreline. Runway alignment was not achieved until just before the point marked 5 was reached and a minimum heading of 249.5 degrees (i. e. 1 degree left of runway alignment) was achieved at the point marked 6.

When the aircraft was finally aligned with the runway it was displaced approximately 10 feet to the left of the centreline and the pilot then initiated an action to regain the centreline. Although he refers to a small right steering input, it is now apparent that, to achieve a right turn in the circumstances that existed, he could have had to, firstly, take off a very substantial degree of left nosewheel deflection and then cross through to a right deflection before he could achieve any degree of right turn. It seems likely that this situation was the source of his expressed lack of confidence in the nosewheel steering and, as he would have lost any sense of "feel" for the turn, this could also explain why the turn to the right was sharper than he had anticipated. Having regard to the speed of the aircraft at this time a right deflection of 2 degrees is all that was required to produce the sharp turn depicted in Appendix A at point 7.

5. Take-off thrust was applied with the nosewheel still deflected some 40 degrees left of centre. As the aircraft accelerated the nosewheel commenced to skid sideways but the resultant of effective forces was such that the aircraft continued to close on the runway heading with a diminishing rate of closure. The fact that the nosewheel was skidding sideways was not detected by any member of the flight crew.
