**ACCIDENT INVESTIGATION REPORT**

**DH104 Series 5 Aircraft VH-WST,  
and PA30-160B Aircraft VH-WWB,  
near Bankstown Airport,  
New South Wales,  
on 13 March, 1974**

Special Investigation Report 74-1

**Skyway Pty. Ltd.  
De Havilland DH104 Series 5  
Aircraft VH-WST and  
Navair Pty. Ltd.  
Piper PA30-160B Aircraft VH-WWB  
at Bankstown, New South Wales  
on 13 March 1974**

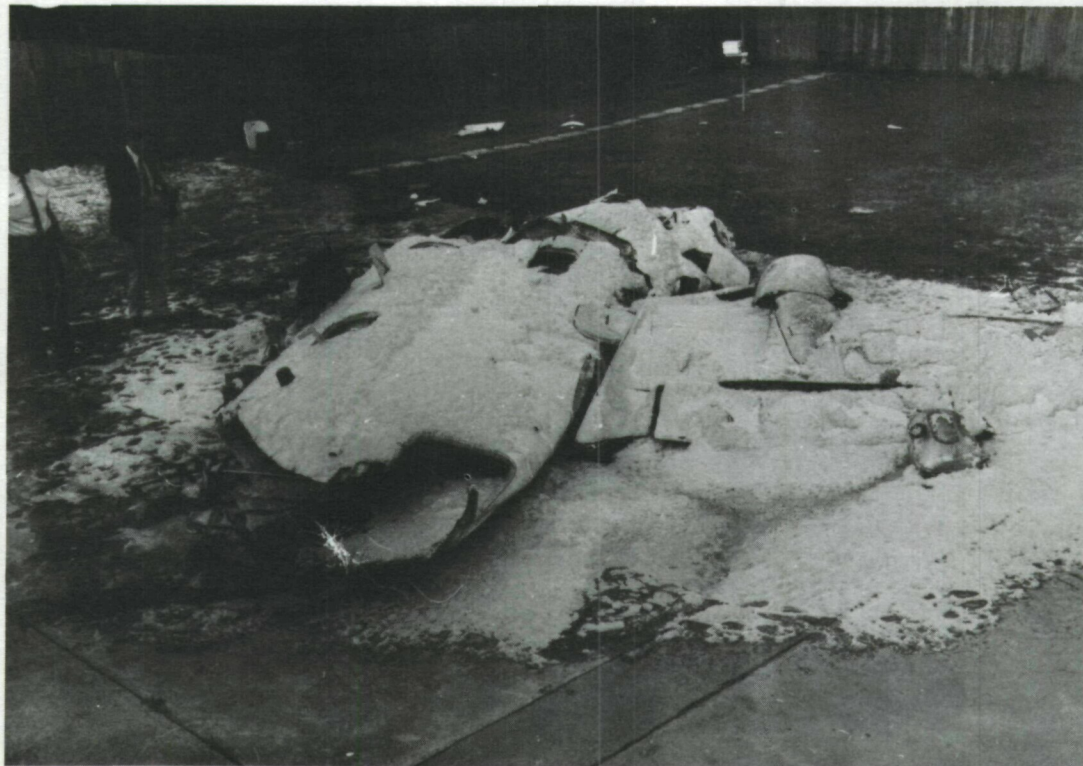
Above: Impact Site of Main Wreckage, DH104 VH-WST.

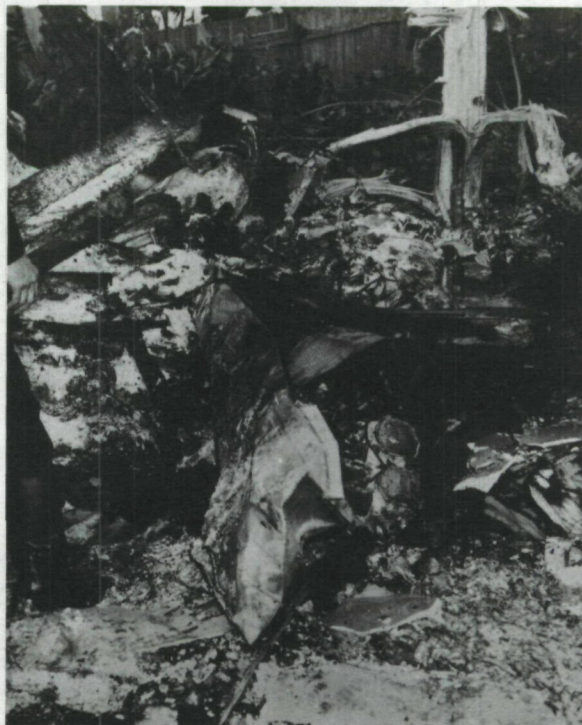
Right: Main Wreckage of PA30-160B VH-WWB.

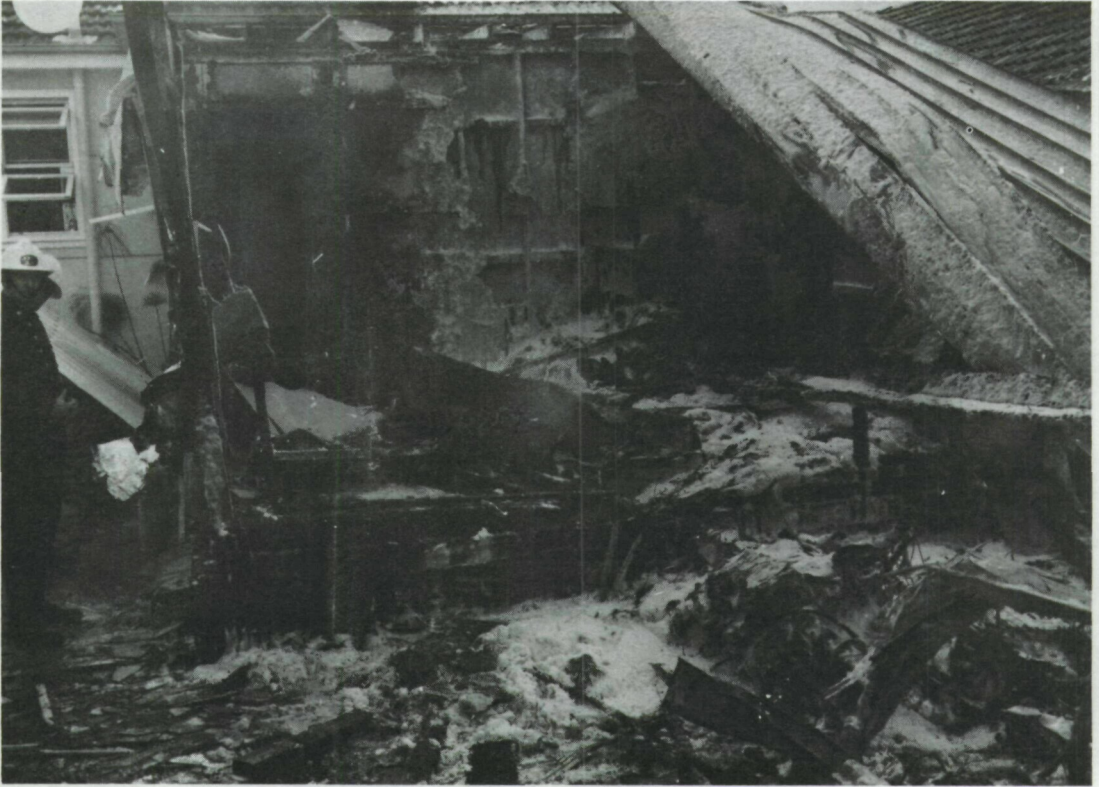
The main wreckage of the Twin Comanche struck the rear section of a private residence. This section of the residence was destroyed by impact and fire but relatively minor damage was inflicted upon the remainder of the residence. Minor damage was inflicted upon several other residences, outbuildings and installations near the accident site.

Above: Impact Site of Main Wreckage PA30-160B VH-WWB, Showing Damage to Residence.

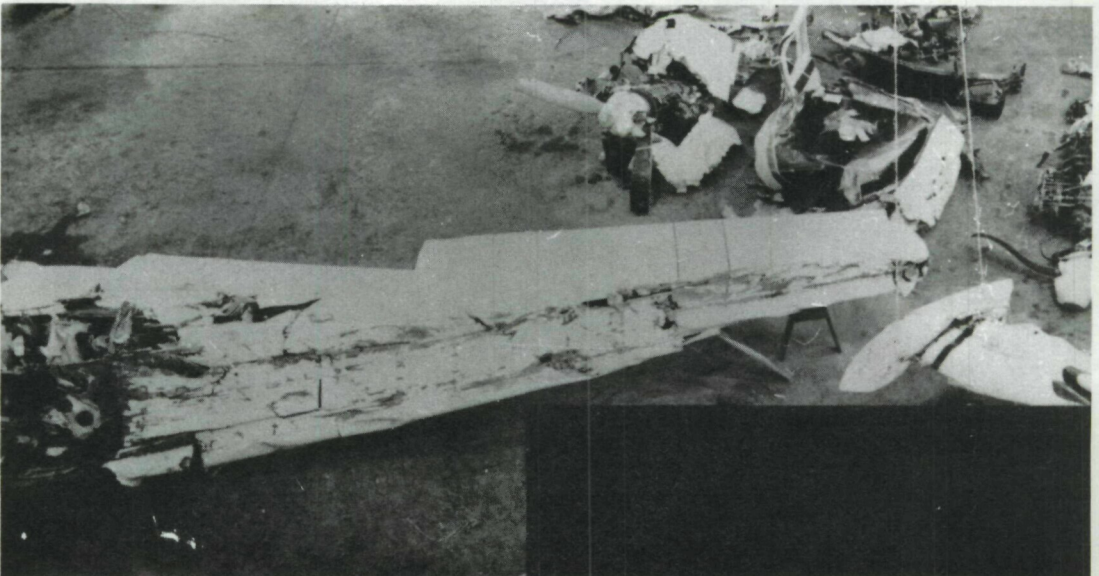
All of the wreckage was removed to Bankstown Airport and there assembled into a three dimensional layout so that the relative positions of the two aircraft at the time of the collision might be determined. Score marks indicated that the initial contact between the two aircraft occurred when the port wingtip of the Dove and the rear outboard end of the Twin Comanche starboard wingtip fuel tank touched. The rearmost portion of the fuel tank was torn off and the deformation adjacent to the fracture matched an indentation on the Dove wingtip immediately adjacent to the navigation light fitting. When these impact marks were matched, the vertical plane of the Twin Comanche wingtip tank was almost perpendicular to the chordwise cover strip on the Dove wingtip; this being consistent with little, if any relative bank existing between the two aircraft at the moment of collision. The position of the Twin Comanche wingtip tank relative to the Dove wing at the first contact indicated that the longitudinal axes of the aircraft differed by about 60 degrees in the horizontal plane.

Below: DH104 Port Wing Tip and PA30-160B Starboard Wing Tip; Approximate Positions at First Contact.

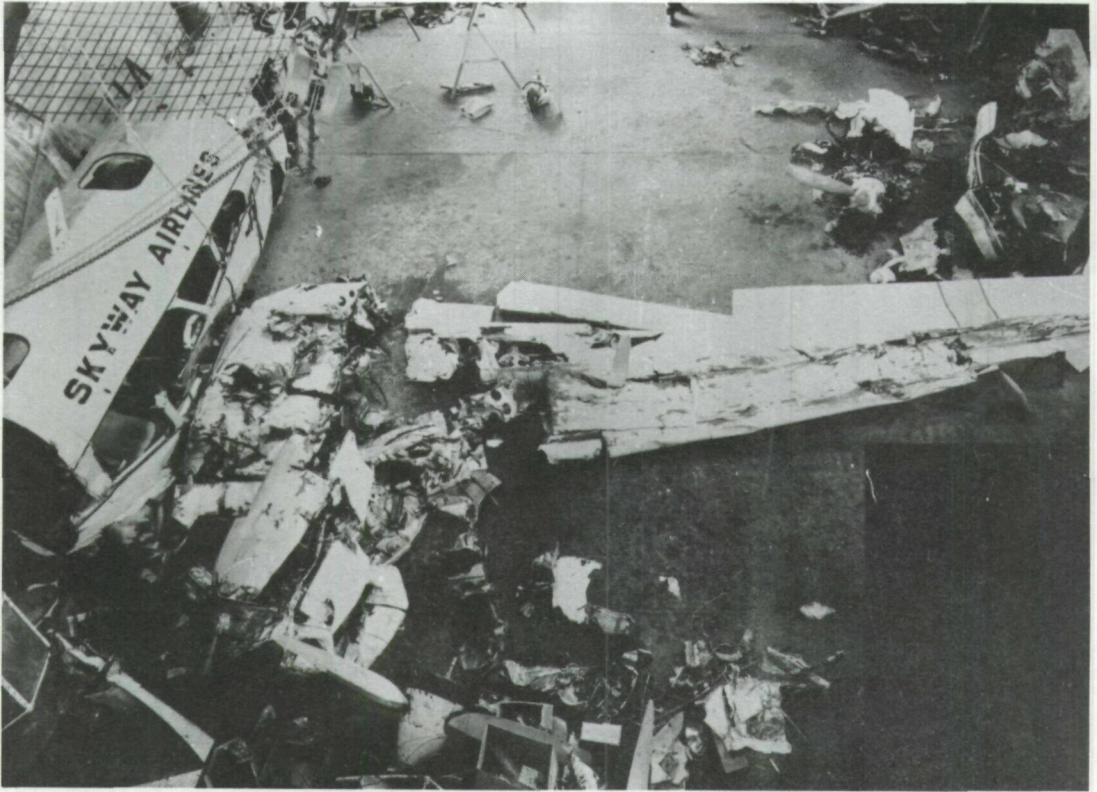
The distribution of major components from each aircraft indicated that neither could have been controllable following the collision. The in-flight contact between the two aircraft resulted in the separation of both engines from the Dove, as well as the port wing outboard of the port engine, and the fuselage aft of the main door. From the Twin Comanche both wingtip tanks were detached, the port propeller, and a substantial amount of the fuselage nose skin as well as nose mounted equipment. The cabin door was broken from its hinges and portion of the right hand side instrument panel coaming separated in flight.

Above: DH104 Port Wing  
Centre Section.

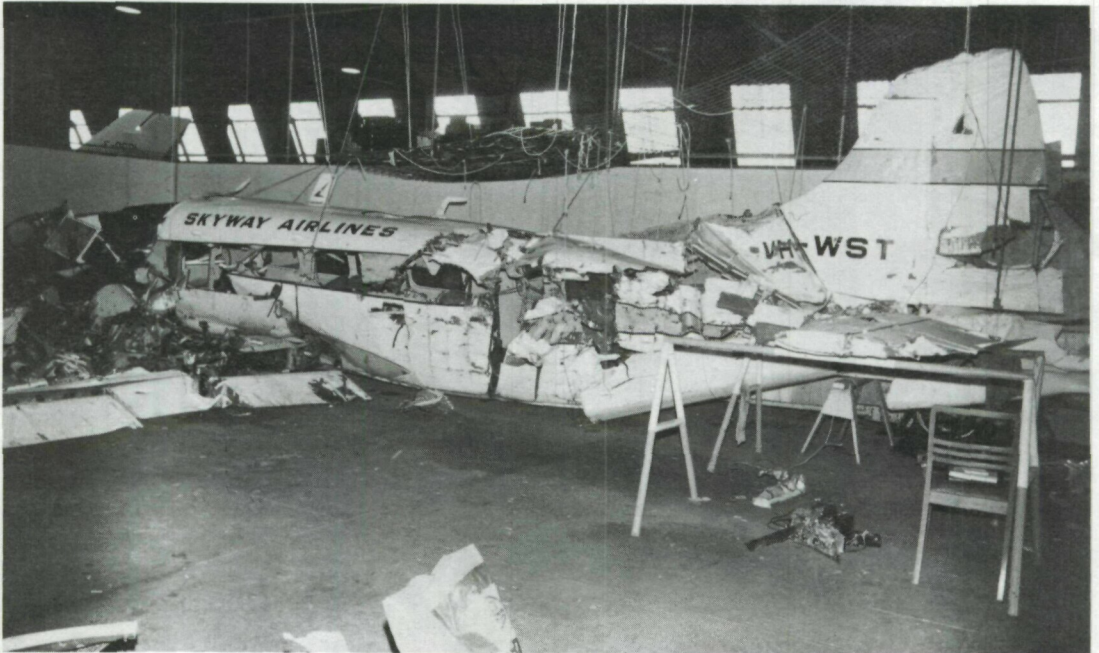
Other marks indicated that, as the collision progressed, the Twin Comanche starboard engine entered the rear fuselage of the Dove and the starboard propeller severed the upper fuselage which subsequently failed and separated from the forward fuselage section.

Below: DH104 Aft Fuselage  
Section.

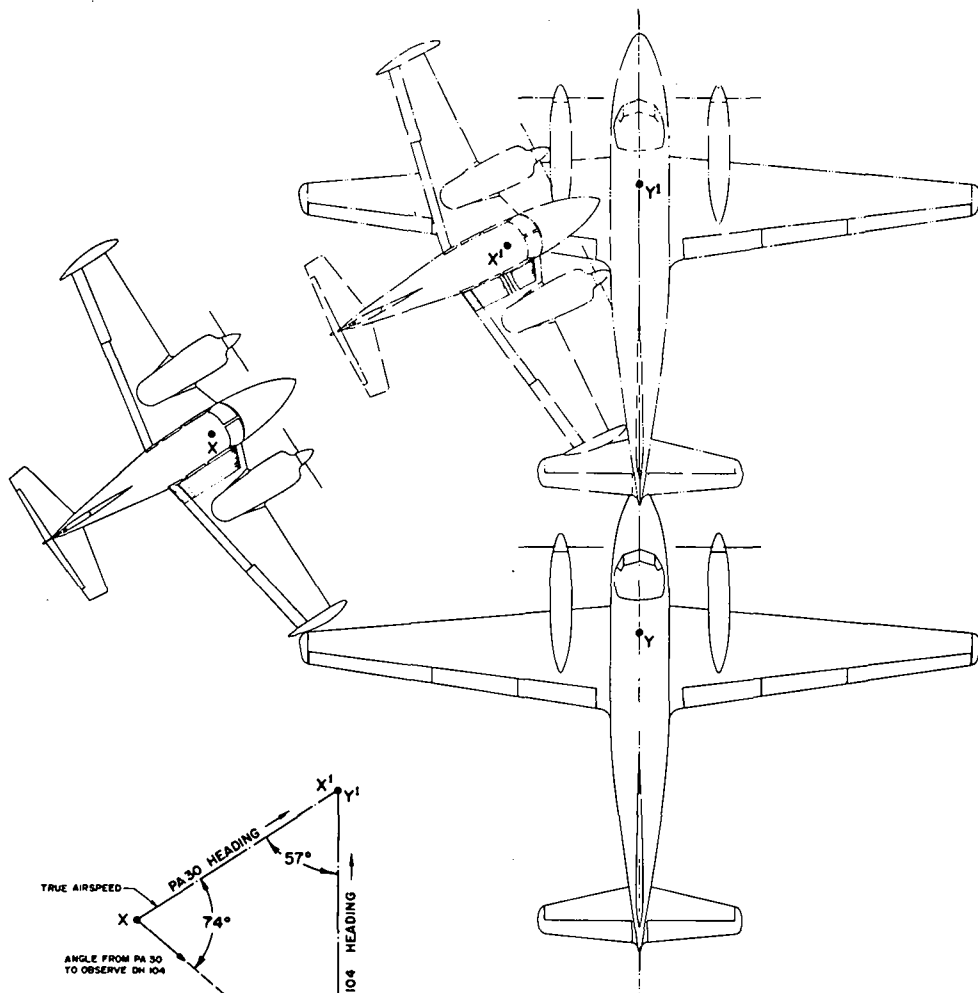
ILLUSTRATION SHOWING INITIAL IMPACT AND ONE SUBSEQUENT POSITION DURING THE IMPACT SEQUENCE

RATIO DH104 TRUE AIRSPEED TO PA 30 TRUE AIRSPEED =  $\frac{\text{DISTANCE } XX'}{\text{DISTANCE } YY'} = 1.28$

**NOTE:** RELATIVE POSITIONS WERE DETERMINED FROM IMPACT MARKS

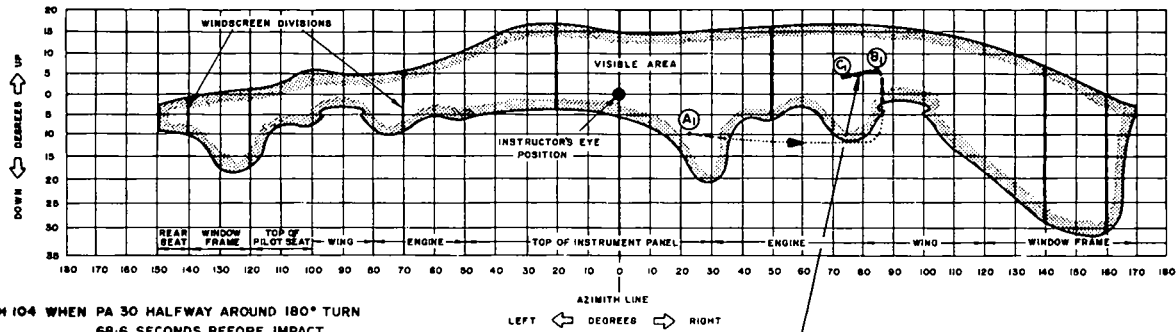
**INSTRUCTOR POSITION - RIGHT HAND FRONT SEAT POSITION**

Whilst the Twin Comanche was flying from Position A to B the Dove would have been obscured (Appendix F). At Positions B and B1 visual reference would have been possible but it would have been necessary for the pilot-in-command and/or the third crew member to scan the relevant area in order to see the Dove. If the Dove was seen from this point and it was still flying a parallel track, again there would have been no cause for immediate concern. Alternatively, if the Dove was then seen to be flying in a south-westerly direction it should have been evident at this time that the aircraft were on collision paths.

- A1) DM 104 WHEN PA 30 HALFWAY AROUND 180° TURN  
68.6 SECONDS BEFORE IMPACT.
- B1) DM 104 WHEN PA 30 EXITS 180° TURN  
38.6 SECONDS BEFORE IMPACT.
- C1) DM 104 AS IT COMPLETES FINAL LEFT TURN  
19.6 SECONDS BEFORE IMPACT.

PROBABLE MOVEMENT OF THE DOVE AS RELATED TO THE TWIN COMANCHE WINDSCREEN

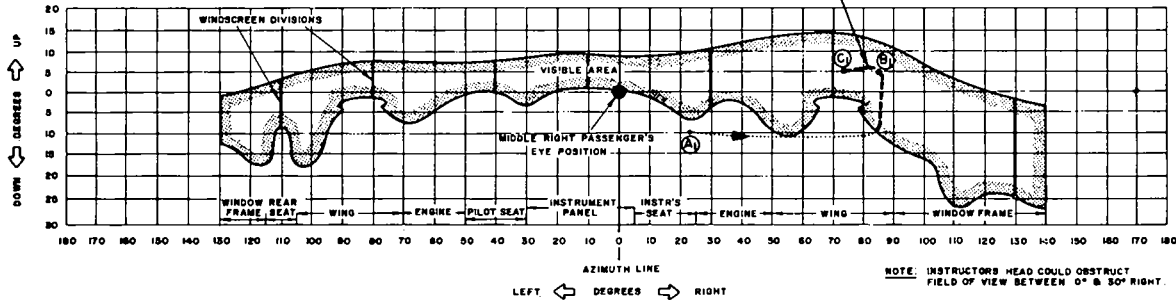
**RIGHT HAND SEAT POSITION, SECOND ROW**

**NOTE:** INSTRUCTOR'S HEAD COULD OBSTRUCT FIELD OF VIEW BETWEEN 0° & 30° RIGHT.
