Breakdown of separation – Boeing 737-438 VH-TJS and Fairchild SA227 VH-MYI

28 km E of Melbourne Airport, Victoria

ATSB Transport Safety Report
Aviation Occurrence Investigation
AO-2012-087
Final

Report No. AO-2012-087

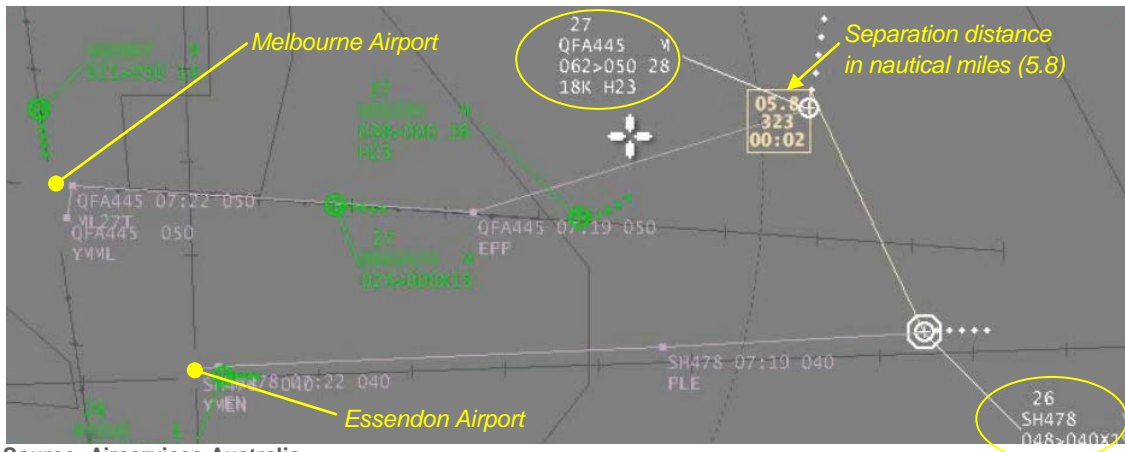
Figure 1: Relative positions of TJS and MYI at 1717:55

At 1717:44, the approach controller (controller) instructed TJS to turn right to a heading of 230°. At 1717:55, the controller instructed TJS to ‘...descend to three thousand you’re cleared ILS² runway 27 approach’. At that time, MYI was inbound to Essendon Airport and located about 6 NM to the south-south-east of TJS (Figure 1).

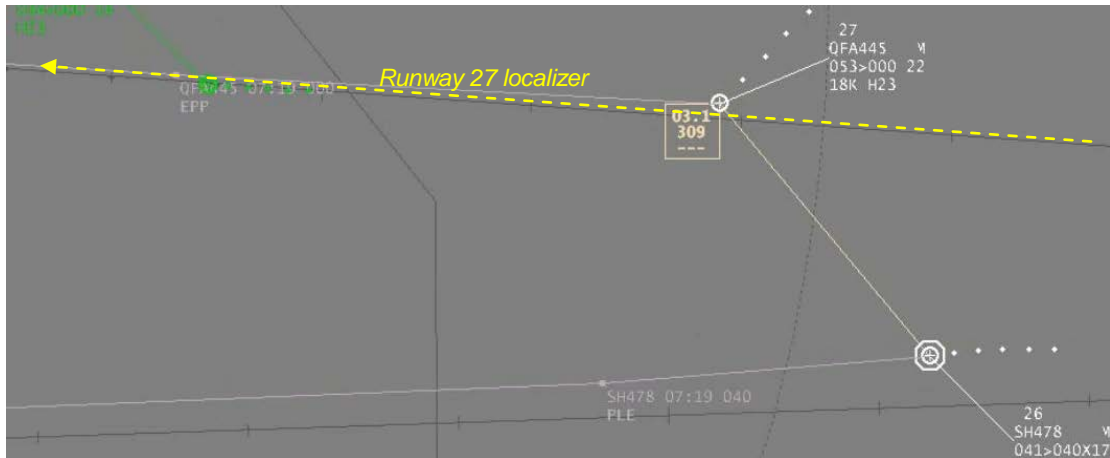
Figure 2: Relative positions of TJS and MYI at 1718:45

Both TJS and MYI were subsequently issued further speed reductions and at 1718:45, TJS was approaching the runway 27 localizer (Figure 2). The separation between the two aircraft at this time was 3.1 NM horizontal and 1,200 ft vertical. However, instead of intercepting the runway 27 localizer, TJS continued through the localizer and, at 1718:53, the controller asked TJS if they were turning right to intercept final. The separation between the two aircraft at that time had reduced to 2.9 NM horizontal and 1,100 ft vertical. In an attempt to maintain the required

separation of 3NM horizontal or 1,000 ft vertical, the controller then reiterated that he needed TJS to turn right and issued MYI with a traffic alert and an instruction to turn left heading 180°.

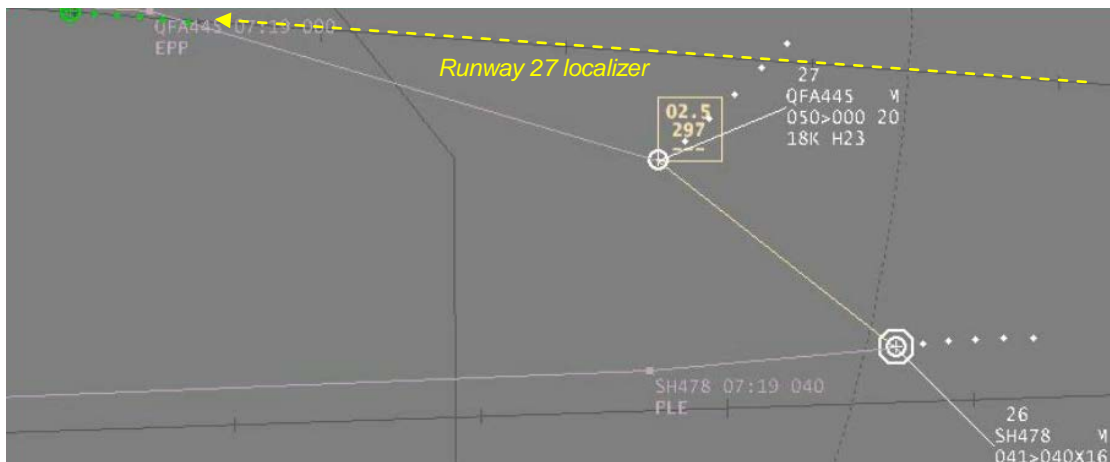
Figure 3: Relative positions of TJS and MYI at 1719:10

At 1719:10, the controller issued TJS with a traffic alert for MYI and instructed TJS to turn right to a heading of 300° to intercept final from the left. TJS was now located about 1 NM to the south of the runway 27 localizer. Separation with MYI had reduced to 2.5 NM horizontal and 900 ft vertical (Figure 3).
