Collision with terrain involving de Havilland Canada DHC-2, VH-AWD

70 km NNE Hamilton Island, Queensland, 13 March 2017

ATSB Transport Safety Report
Aviation Occurrence Investigation
AO-2017-031
Final – 24 May 2017

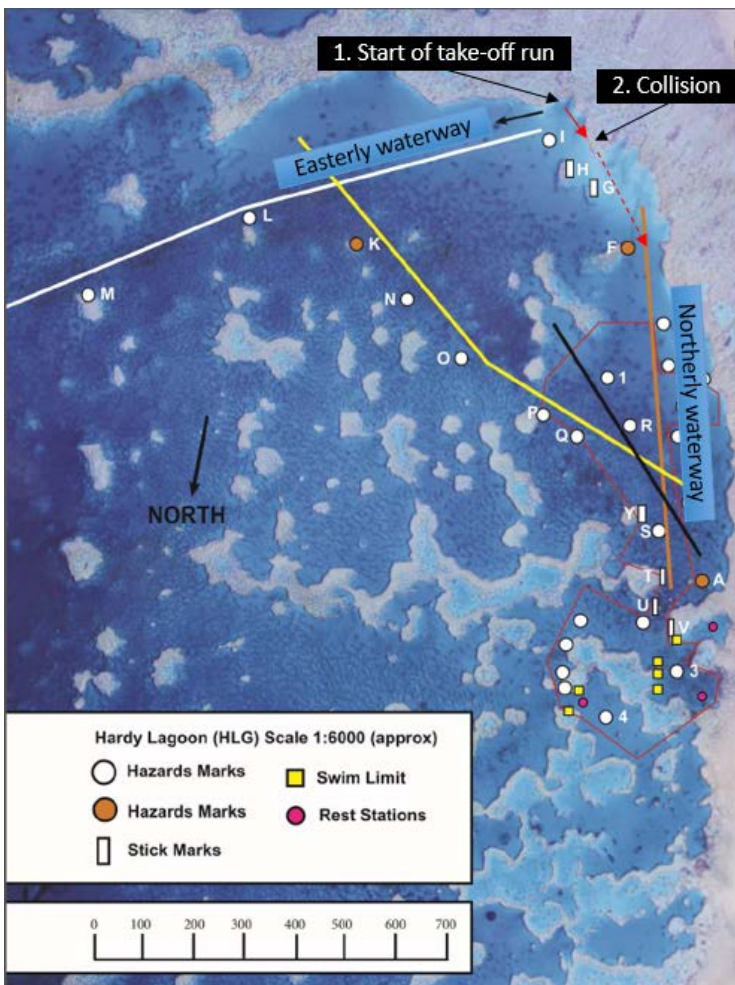
Figure 1: Hardy Lagoon (north pointing downwards)

The wind effect on the aircraft indicated to the pilot that the northerly waterway was the most into wind waterway. In order to maximise the take-off distance available the pilot applied power to start the take-off run from a position to the south-east of the northerly waterway, while aiming to join the waterway at buoy F (Figure 1). Shortly after applying full power, and before the aircraft entered the northerly waterway, both floats struck submerged reef, which brought the aircraft to a stop.

The tide was at 0.6 m at the time of the collision, which occurred outside of the waterways. When the tide is above 2.5 m, the aircraft can manoeuvre around Hardy Lagoon outside of the dimensions of the ALA without striking reef. Below the 2.5 m tidemark, it was known that the reef could be struck when manoeuvring the aircraft outside the dimensions of the ALA. However, the pilot believed that their chosen track from buoy I to buoy F, where they would join the northerly waterway, was clear of underwater terrain. There were no hazard marks on the left side of their track towards buoy F, but this was outside the prescribed waterway.

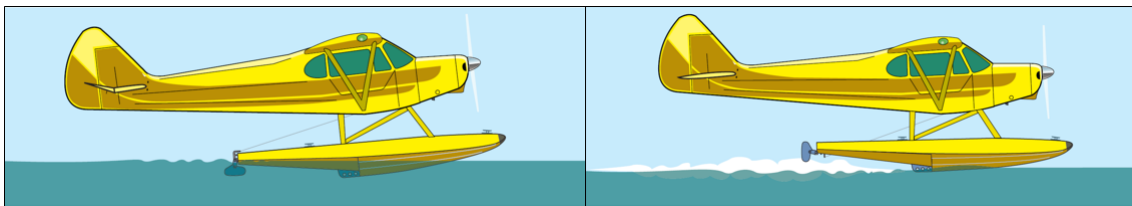
Figure 2: Seaplane in the plow (left) and planing (right)

The application of power to start the take-off pushes the centre of buoyancy aft, due to increased hydrodynamic pressure on the bottom of the floats. This places more of the seaplane's weight towards the rear of the floats which sink deeper into the water. This results in a higher nose attitude, reduced forward visibility, and creates high drag, which requires large amounts of power for a modest gain in speed (Figure 2 left). This phase of the take-off is known as in the plow.

As speed increases, hydrodynamic lift on the floats and the aerodynamic lift of the wings supports the seaplane's weight instead of the buoyancy of the floats. This allows the pilot to lower the nose attitude, which raises the rear portions of the floats clear of the water (Figure 2 right). This is the planing position, which reduces water drag and permits the seaplane to accelerate to lift-off speed. The pilot reported this was about 25-30 kt for the DHC-2.

At the time of the attempted take-off, the tide was close to the low point, but the reef struck by the aircraft was still submerged. The sun angle was low, which increased the amount of sunlight reflected from the water surface. At the speed of the collision, the aircraft nose attitude was at the highest angle for the take-off run, which combined with the sunlight reflection to severely restrict the pilot's ability to detect submerged reef.
