FINAL REPORT
A-047/CENIPA/2016

OCCURRENCE:	ACCIDENT
AIRCRAFT:	PR-HCT
MODEL:	AS 350 B2
DATE:	18MAR2016

This is the Final Report of the 18MAR2016 accident with the AS 350 B2 aircraft, registration PR-HCT. It was classified as “Collision with Obstacle In-Flight”.

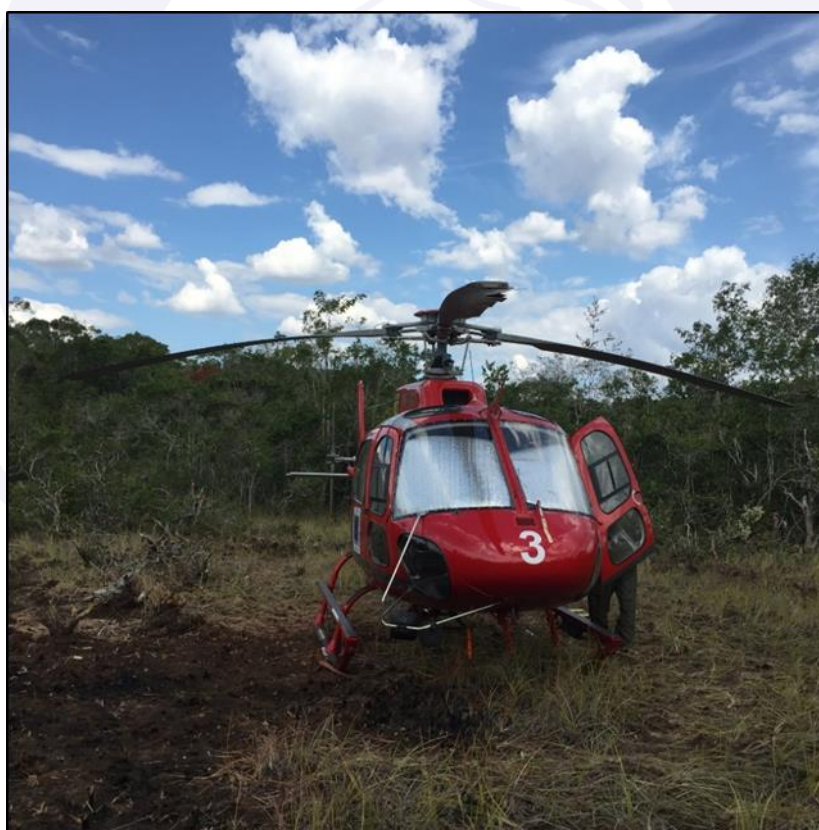
After the collision, the crew noticed a slight right turn. The pilot was able to control the aircraft and make the landing in the restricted area, approximately fifteen meters from the impact site.

Figure 1 - Aircraft landing site after collision.

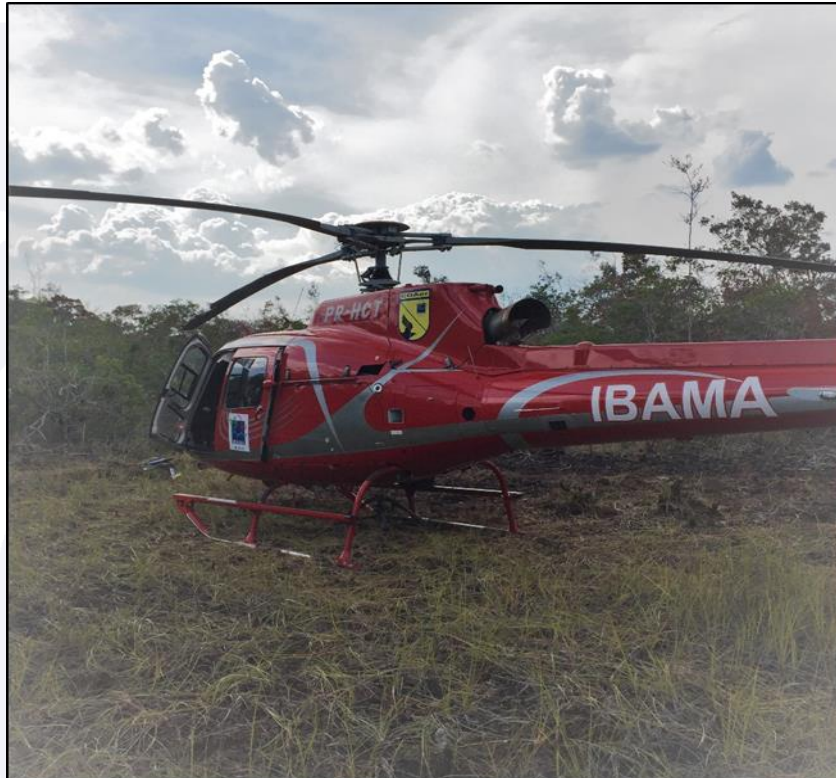
The aircraft had substantial damage to the blades of the main rotor and tail rotor assemblies with dents on their surfaces (Figures 2 and 3).

Figure 2 - Overview of the aircraft and damage to the tip of the main rotor blade.

The aircraft had substantial damage on two main rotor blades and minor damage on the other blade, in addition to minor damage to the two blades of the tail rotor.

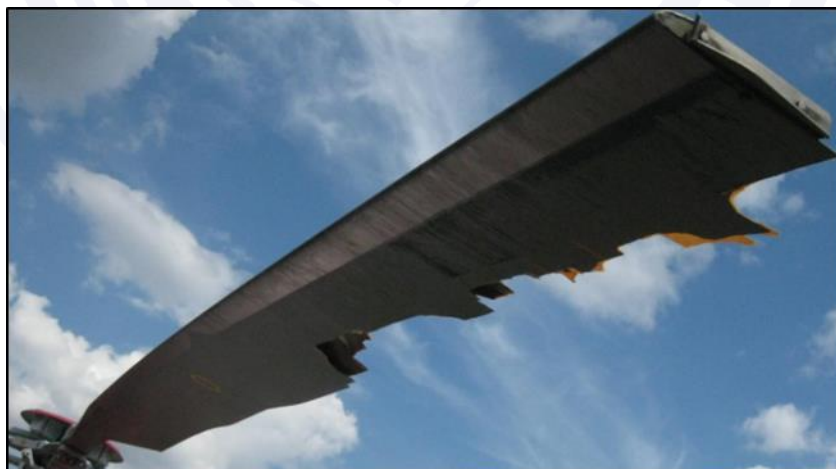
Figure 3 - Extension of damage to the main rotor blade.

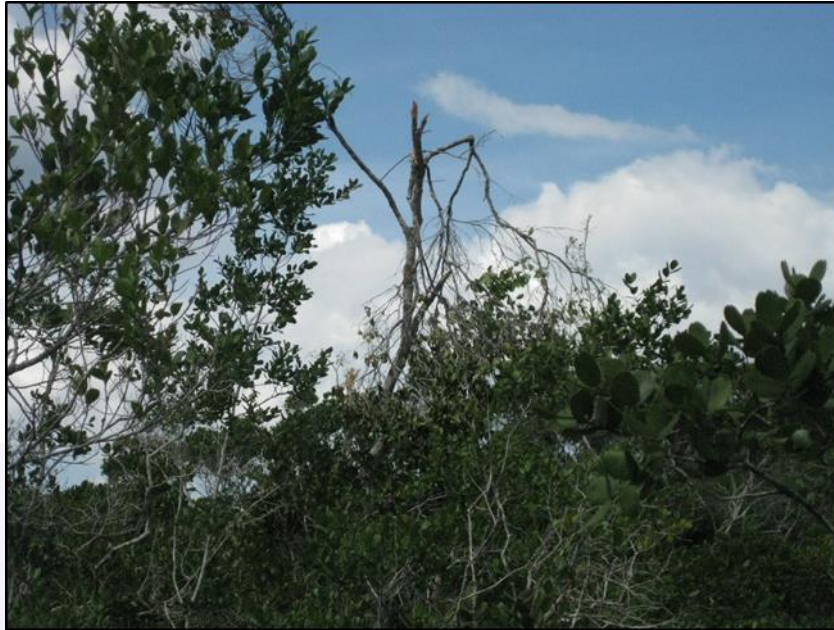
In the final approach, the aircraft's course was 253°, and the collision occurred in a tree approximately 15m high (Figure 4), located in the approach sector.

Figure 4 - View of the location of the first impact (tree) of the aircraft during the final approach to the landing point.

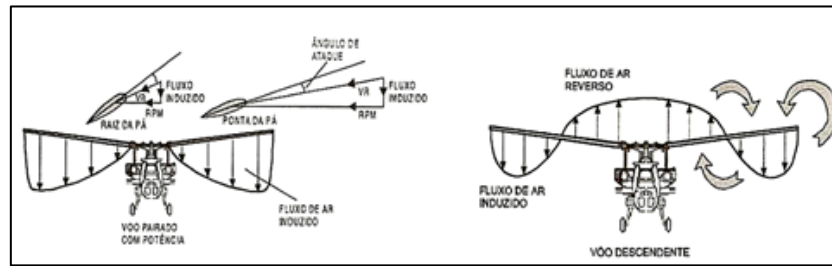
Figure 5 - Characteristics of air flow induced during hovering flight with power and descending flight.

This causes the reverse airflow to return through the central part of the blades where there is still induced airflow (Figure 5). Depending on the intensity of the central vortices and blade tip, the turbulence generated may involve the entire rotor and cause vortex stalls. Such condition is more frequent during tailwind approaches or in areas of turbulence.

Thus, with the gradual reduction of speed during approach and under the action of the tail wind, was with a considerable intensity at the moment, about 10 kt. The aircraft reached a condition in which the reverse airflow, passing through the central part of the main rotor, already turbulent because of the action of the induced airflow, began to envelop the entire rotor, causing a vortex stall.
