**FINAL REPORT**  
**A - 155/CENIPA/2014**

<b>OCCURRENCE:</b>	<b>ACCIDENT</b>
<b>AIRCRAFT:</b>	<b>PR-TOT</b>
<b>MODEL:</b>	<b>172-R</b>
<b>DATE:</b>	<b>07SEPT2014</b>

This is the Final Report of the 07SEPT2014 accident with the 172-R aircraft, registration PR-TOT. The accident was classified as "Collision with Obstacle in Flight".

During the go-around procedure, the aircraft collided with power grid cables near threshold 33 of the Comandante Gastão Aerodrome (SDVI).

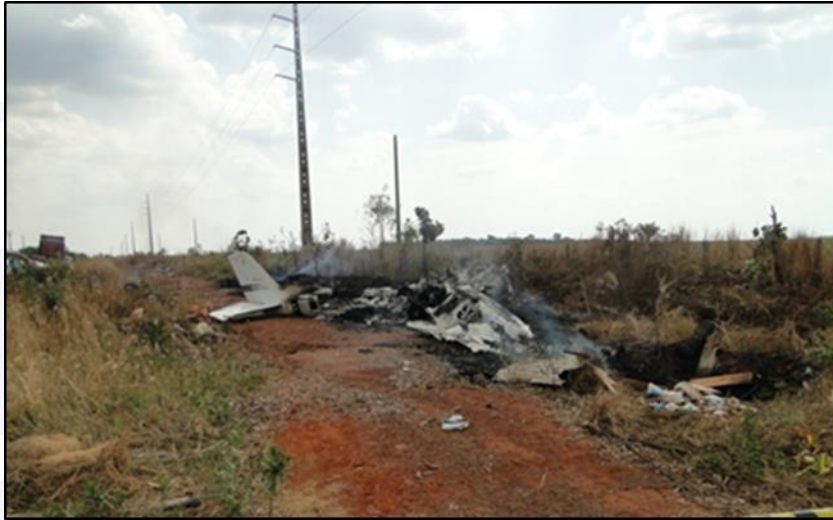
The wreckage was concentrated near threshold 33 of the Comandante Gastão Aerodrome (SDVI), under the power grid in which the impact occurred (Figure 1).

Figure 1 – Aircraft's wreckage.

The analysis of the wreckage indicated the impact of the right wing against the power grid and the impact of the left wing tip against a small natural elevation. This caused the aircraft to rotate about 160 ° anticlockwise and had a sudden stop. Due to the collision against the ground, there were ruptures of the wings and pipes, with consequent leakage of fuel, causing the fire that consumed the whole aircraft.

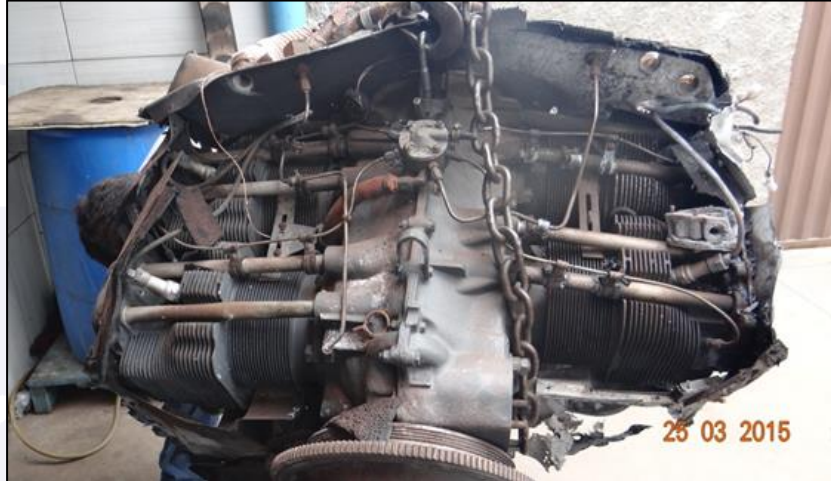
The Lycoming IO-360-L2A, n / s L-27055-51A engine, belonging to the Cessna 172R SKYHAWK aircraft, registration PR-TOT, was disassembled and inspected by the DCTA (Figure 2).

Figure 2 - Top view of the Lycoming IO-360-L2A engine, n / s L-27055-51A.

The research carried out on this engine did not find anything that could have influenced in its normal operation.

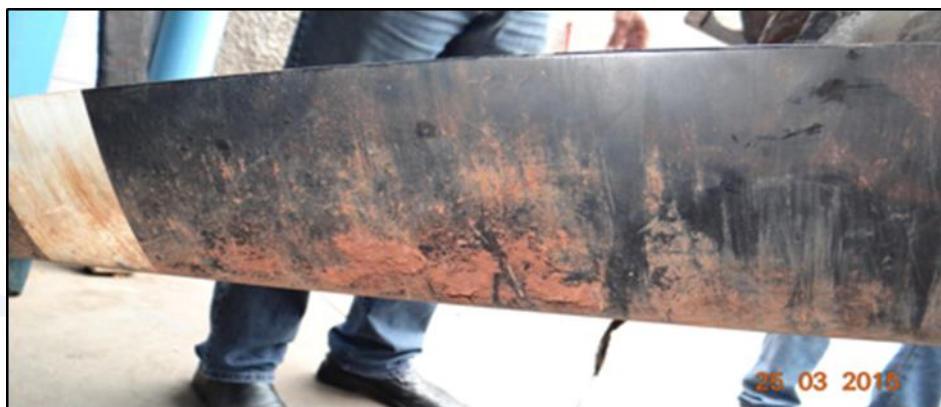
Other evidence that the engine was running at the instant the aircraft was involved in the accident could be identified by the presence of dirt deposited along the propeller blades and the scratches existing in the transverse direction of these blades (Figure 3).

Figure 3 - View of the propeller with dirt deposited along the blades.

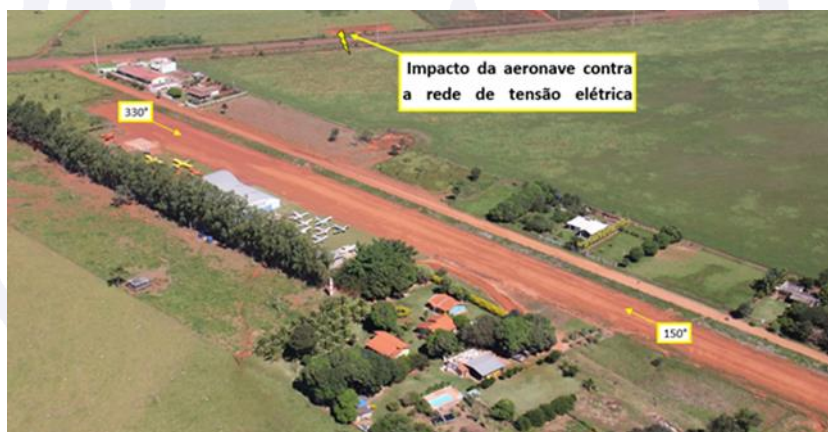
Figure 4 - Photo of the runway, with the sign of the accident site.

However, the existence of power cables, which could affect the safety of operations, near threshold 33 were not included in either the ROTAER or the Notice to Airmen (NOTAM) of the locality.

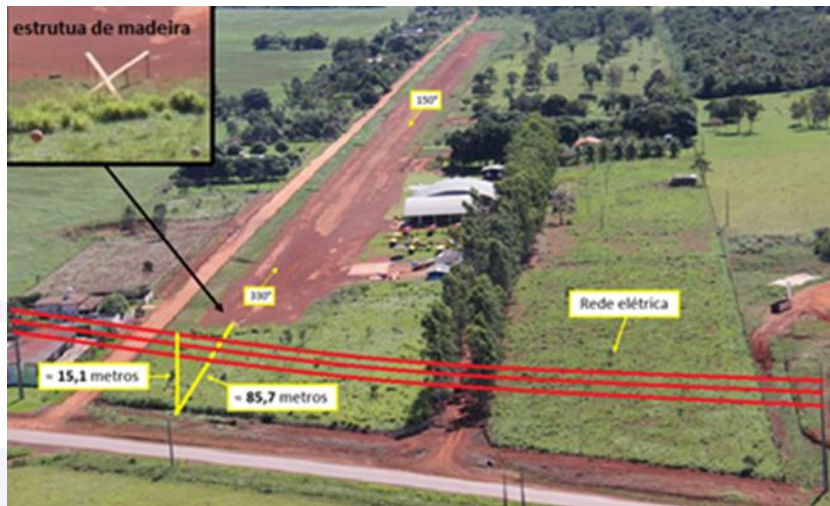
However, as the power grid restricts the approach to threshold 33, the pilot decided to proceed to threshold 15. This restriction can be evidenced by the existence of a wood marking represented by the letter "X" and placed close to threshold 33. (Figure 5).

Figure 5 - Aerial photo of the runway. The “X” marking is highlighted.

The power grid installed near the threshold restricted the approach to runway 33. The wood marking installed in this threshold and represented by the letter "X" (Figure 5) sought to guide the unfeasibility of the landing from that place.

Evaluate the interference of the presence of the power grid, located near threshold 33, in the operation of the Aerodrome and, if necessary, take the appropriate actions within the competence of the DECEA.

Issue an NOTAM regarding the existence of a power grid located near runway's threshold 33 of SDVI.

Analyze the pertinence of including in the ROTAER the information of the presence of a power grid located near runway's threshold 33 of SDVI.
