FINAL REPORT
A-040/CENIPA/2014

OCCURRENCE:	ACCIDENT
AIRCRAFT:	PR-VPI
MODEL:	T-210L
DATE:	19FEB2014

This is the Final Report of the 19FEB2014 accident with the T-210L aircraft, registration PR-VPI. The accident was classified as "Engine Failure in Flight".

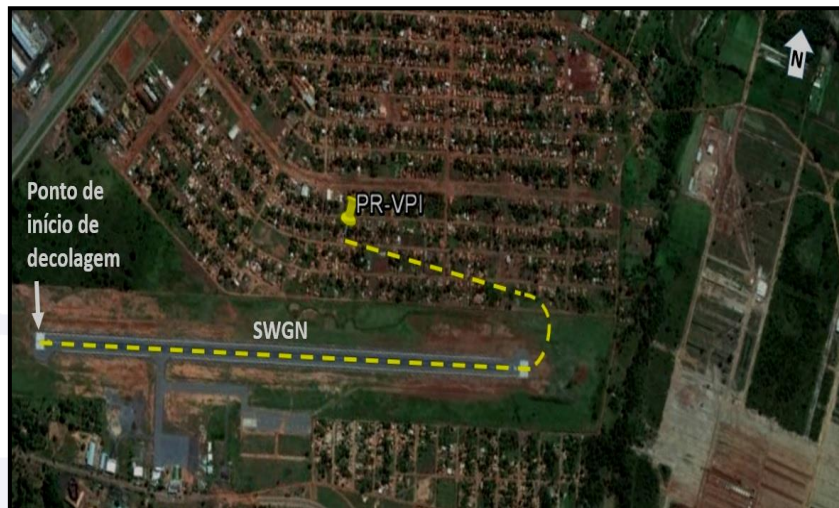
The impact occurred about 310 meters North of Araguaína Aerodrome (SWG N), on a residential neighborhood, at the approximate bow of 290°, according to the trajectory described in Figure 1.

Figure 1 - Site of the forced landing in relation to the Aerodrome SWGN. Trajectory made based on pilot's information.

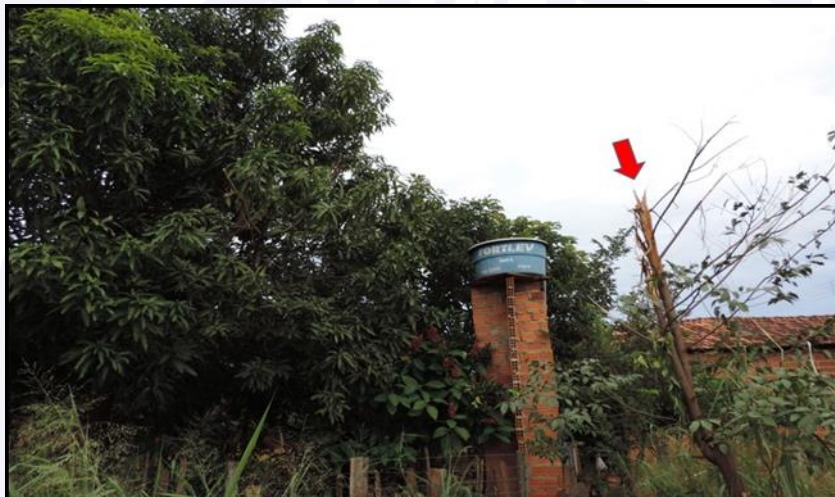
Shortly before touching the ground, the aircraft hit a small tree, breaking it, at approximately 3 meters high, according to Figure 2.

Figure 2 - Obstacle hit by the aircraft before touching the ground.

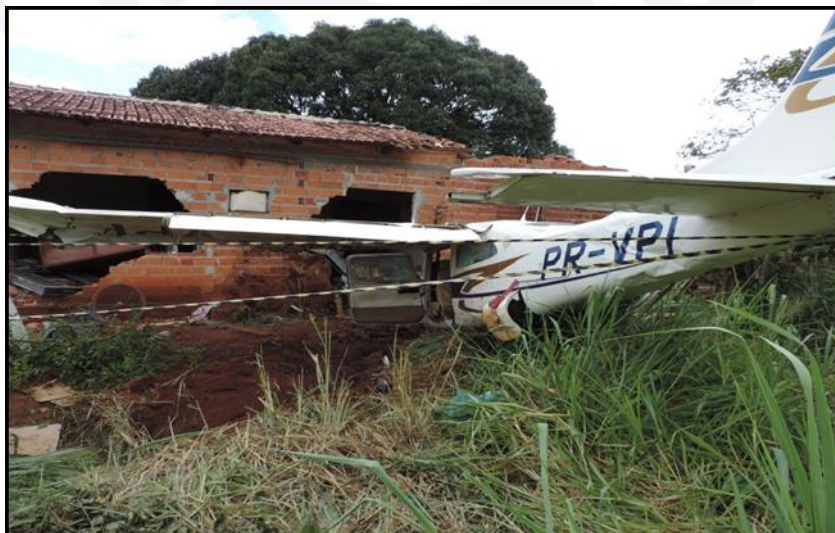
The aircraft hit the side of a residence, breaking down part of the walls and destroying the furniture inside two rooms, according to Figure 3.

Figure 3 - Damage to the residence.

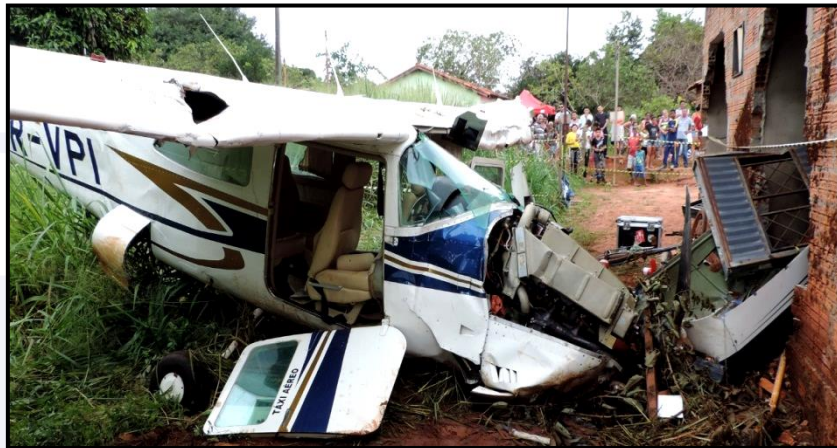
After the touch of the main landing gear on the ground, there was a displacement of less than 2 meters until the total stop of the aircraft. In this dynamic, the leading edge of the left wing hit the victims and the entire wing structure collided against the residence, according to Figure 4.

Figure 4 - Damage to the front section and the wings.

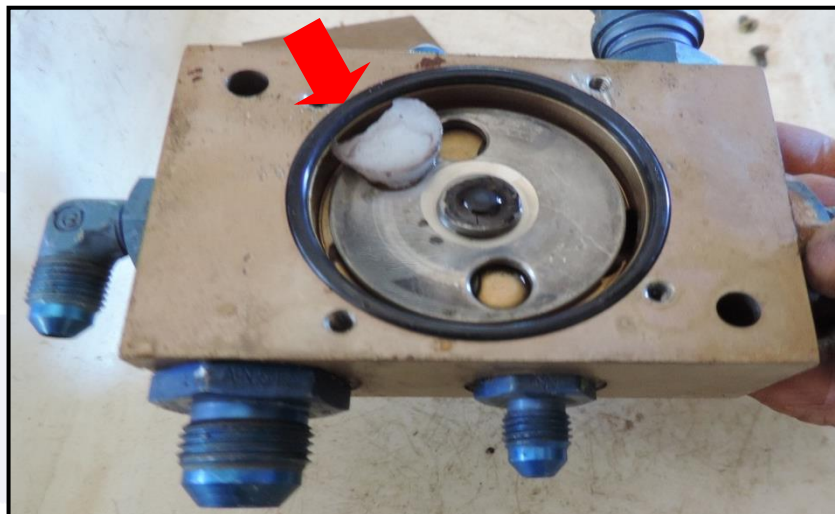
In the course of this research, it was verified the existence of a foreign body inside the fuel selector, according to Figure 5. The material was sent for laboratory analysis in the DCTA.

Figure 5 - The red arrow indicates the foreign body found inside the fuel selector valve.

In the research done on the components of the fuel system, even during the first action, a foreign body was found inside the fuel selector valve. The dimensions of this body were sufficient to obstruct the output of the fuel selector valve to the engine power line.

In the take-off phase, the power regime requires high flow of fuel for engine power. With the fuel selector valve's outlet partially or totally obstructed, the amount of fuel has become zero or insufficient to meet the engine's demand, causing it to fail.

Although the investigation was not conclusive with respect to the origin of the foreign body, it is possible that the failure of the engine at takeoff has elapsed from the obstruction of the exit of the fuel selector valve to the engine power line by that material. There is a possibility that some non-conformity in the maintenance services performed on the aircraft has contributed to the foreign body being deposited in the fuel selector.

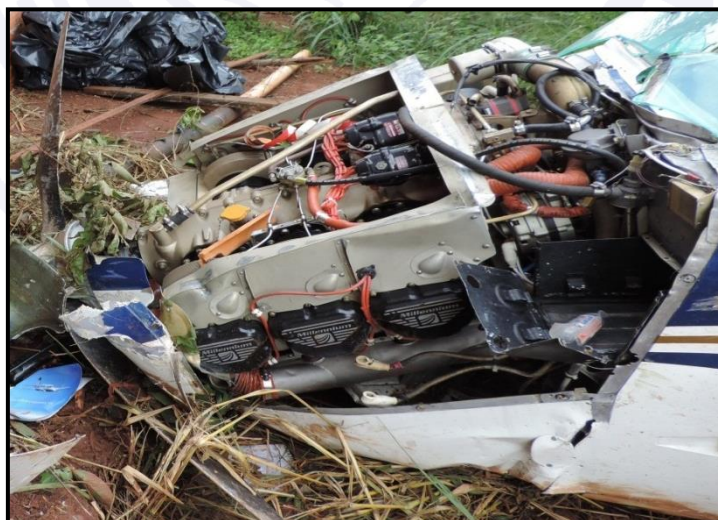
The engine, due to damages (Figure 6), could not be installed in the test bench or other aircraft to perform the functional test.

Figure 6 - Situation of the engine after impact.

The damage to the engine due to the impact impaired its test in the test bench (operation without disassembly). However, its components were disassembled in an appropriate shop and analyzed on a bench by the engine research engineer, who is part of the research team. These tests did not indicate abnormalities that could affect the correct functioning of the engine.

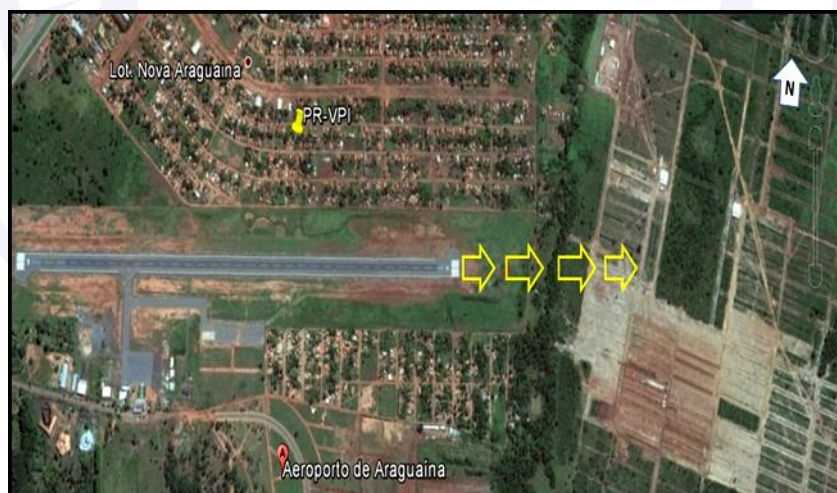
Figure 7 below shows the top view of the SWGN Aerodrome, highlighting the landing location of the PR-VPI and the condition of the land, free of residences or constructions on the takeoff line (yellow arrows).

Figure 7 - Top view of the SWGN Aerodrome.
