COMANDO DA AERONÁUTICA
CENTRO DE INVESTIGAÇÃO E PREVENÇÃO DE
ACIDENTES AERONÁUTICOS

FINAL REPORT
A-162/CENIPA/2016

OCCURRENCE:	ACCIDENT
AIRCRAFT:	PT-REI
MODEL:	EMB-721D
DATE:	07DEC2016

This is the Final Report of the 07DEC2016 accident with the EMB-721D aircraft, registration PT-REI. It was classified as (SCF-PP) “System/Component Failure or Malfunction (Powerplant)”.

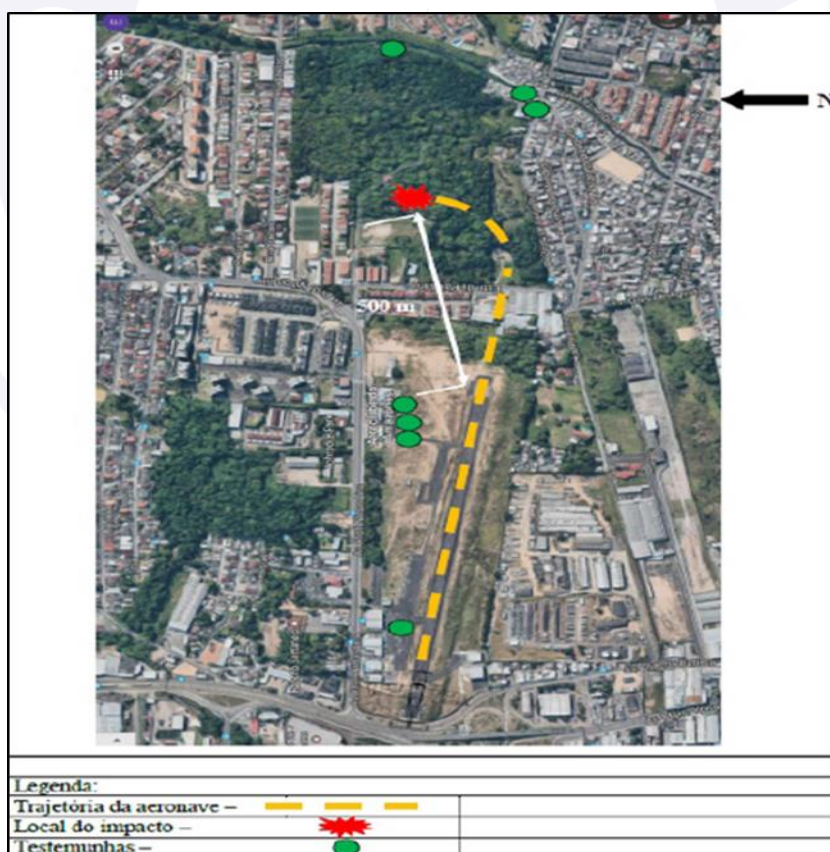
Figure 1 - Sketch of the accident.

After take-off from the Flores Aerodrome (SWFN), runway 11, the aircraft lost altitude, entering a left turn, falling in a forest area, 500 meters from the threshold, opposite to the take-off one.

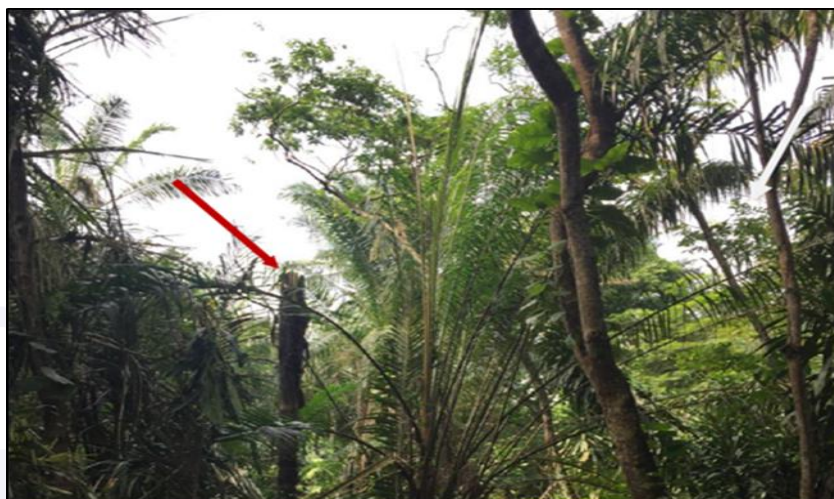
The first impact of the aircraft occurred with the trees of the local vegetation, followed by a collision against the ground, overturning and stopping upside down.

Figure 3 - The arrow indicates the first point of impact of the aircraft.

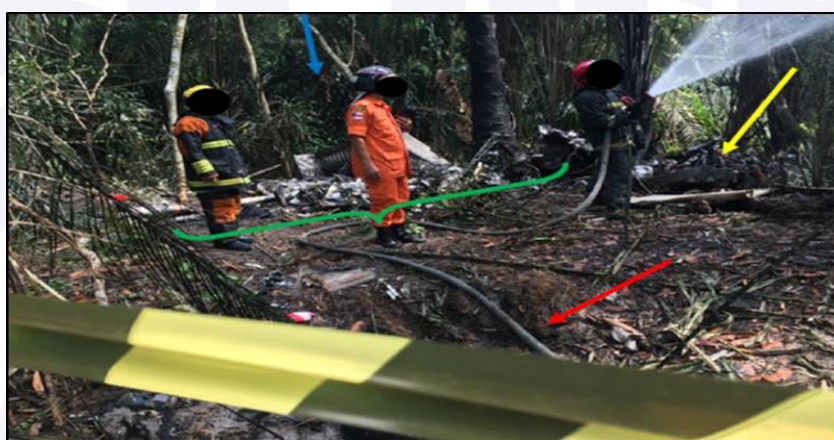
With the force of the impact, the pilot was thrown out of the aircraft, which exploded in sequence.

Figure 4 - View of the wreckage of the aircraft. The red arrow indicates the ravine, site of the second collision; the yellow arrow indicates the engine and propeller assembly; the green bracket shows the place where the passengers were found and the blue arrow shows the place where the pilot was found.

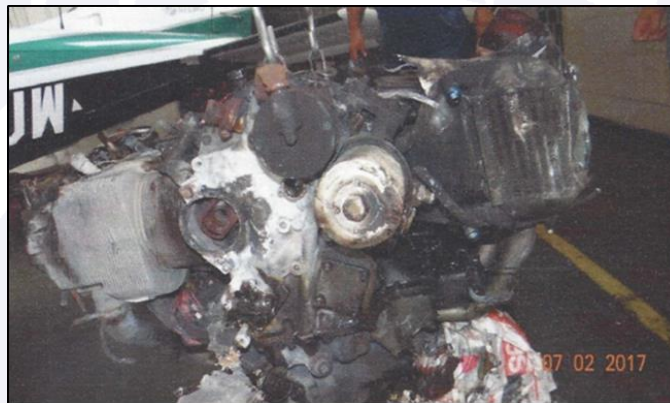
Figure 5 - Rear view of the engine.

The aircraft engine was sent for examination and testing in an approved shop. The Investigation Committee (CI) accompanied the event with a professional from the Aeronautics Science and Technology Department (DCTA) accredited in Material Factor. During the tests, it was observed that the engine had severe damages due to the fire that happened due to the fall of the aircraft (Figure 5).

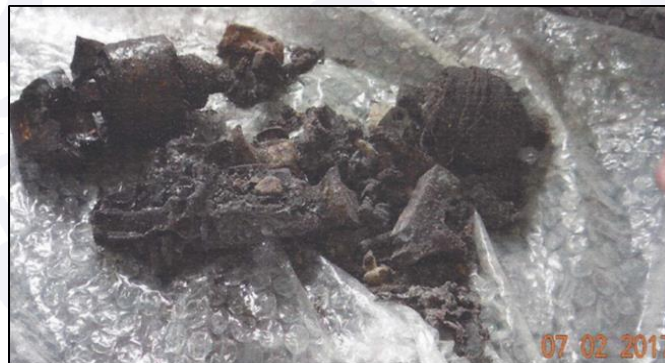
Figure 6 - Fragments of what remained of the engine magnets.

There were doubts as to the operation of the magnets of the engine, since they were found carbonized, preventing any functional test or analysis of its components.

Although the tests performed on the aircraft engine have not identified the actual cause of the power loss, the operator or contracted maintenance company may have contributed to the accident, since the failure of the springs of the magnetos pulse couplings could have caused the loss of power found.

Act together with *Tiarte Comércio e Manutenção*, in order to check the conformity of the maintenance actions performed by such organization, especially with respect to the compliance with the Airworthiness Directive No. 97-10-07R1 of 15JAN1998 (or of another that comes to replace it).

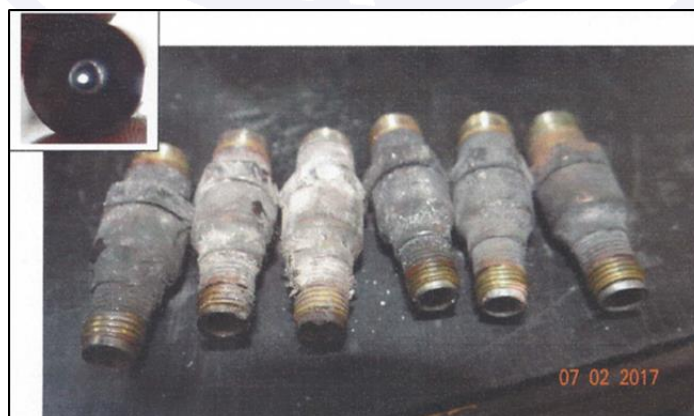
In the nozzles, no obstructions were found that could compromise the operation of the cylinders. They were individually inspected and, as shown in Figure 7, were with the fuel passageway clean.

Figure 7 - View of the engine nozzles. Highlighting one of the unobstructed nozzles.

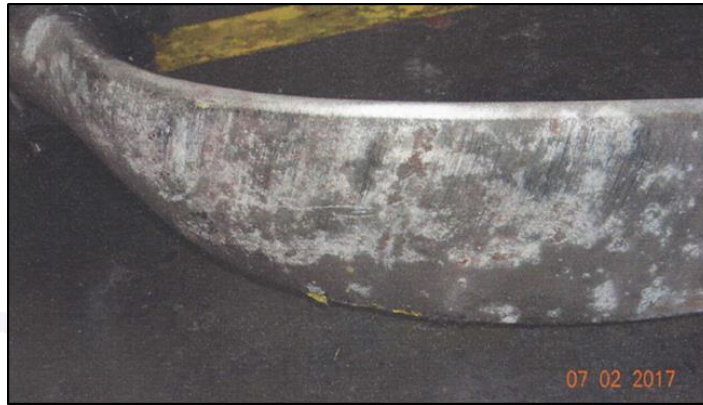
Evidence found in the propeller denoted that the engine was running low, idle compatible or residual rotation at the time of impact. This could be observed through the transversal scratches on the back of only one of the blades, shown in Figure 08, indicating that the engine shutdown was immediate, as it did not affect the third blade that was intact.

With this, it was also shown that the engine did not develop power at the moment of impact.

Figure 8 - View of the blade with the transversal scratches.
