AVIATION INVESTIGATION REPORT

A01P0194

COLLISION WITH TERRAIN

DE HAVILLAND DHC-2 C-GVHT

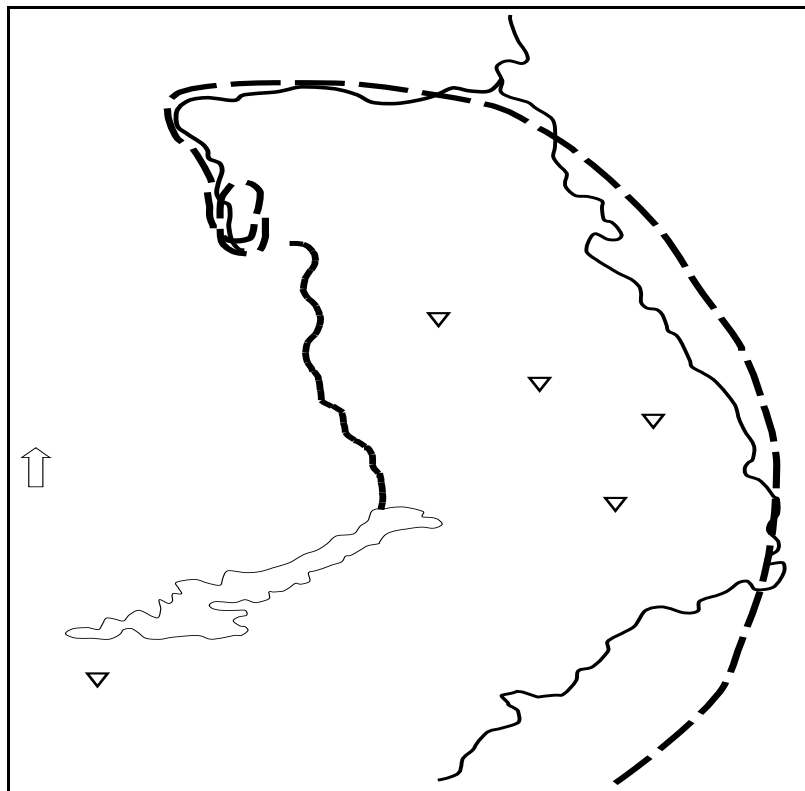
One of the managers of the camp, who was on a logging road in the south valley, advised the pilot to come to the Frederic Creek area because it was clear of cloud. The pilot then flew northeast to Wakeman Sound, where he advised that he could descend below the cloud to the Frederic Creek inlet. The aircraft flew west along Frederic Creek until turning left toward the pass in the south Frederic Creek valley. The pass crosses a north-south divide (saddle); the valley to the east of the divide turns south immediately and descends to Mackenzie Lake. (See Figure 1.)
