## **AVIATION INVESTIGATION REPORT A13H0001**

**CONTROLLED FLIGHT INTO TERRAIN  
7506406 CANADA INC.  
SIKORSKY S-76A (HELICOPTER), C-GIMY  
MOOSONEE, ONTARIO  
31 MAY 2013**

## Aviation Investigation Report A13H0001

Sikorsky S-76A (helicopter), C-GIMY

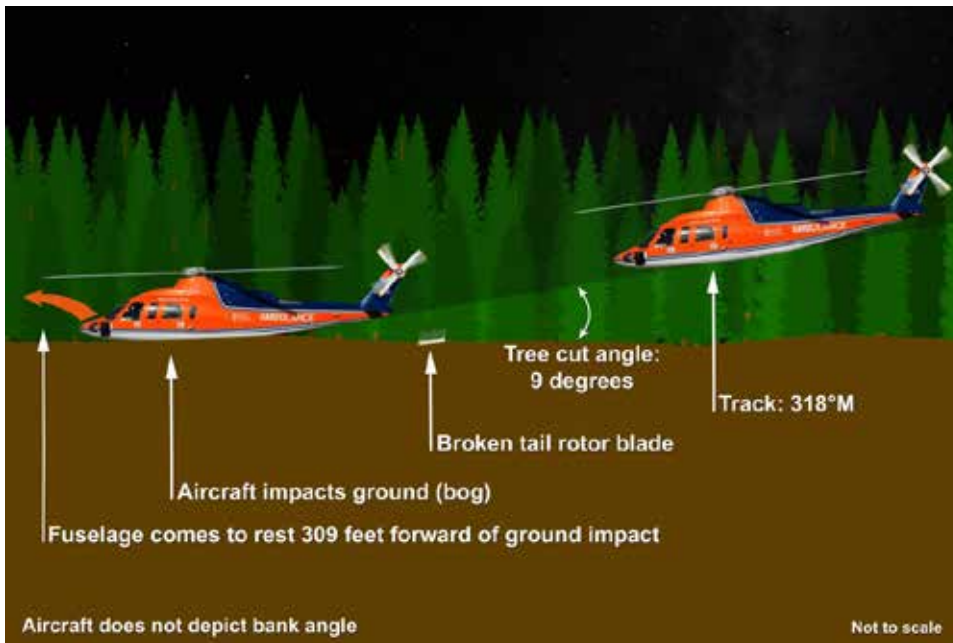
Figure 2. Depiction of C-GIMY's descent (side view)

The wreckage was located in densely wooded, swampy terrain approximately 0.8 sm from the end of Runway 06, on a bearing of 020°M (Figure 1). Based on damage to surrounding trees and ground scars, investigators determined that the aircraft collided with the ground in a steady, shallow descent angle (approximately 9 degrees), in a left-banked (approximately 20 degrees) attitude (Figure 2 and Figure 3). Although it was not possible to determine the exact speed of the helicopter at the time of the accident, the damage to the surrounding terrain and trees, length of the wreckage trail, and extent of aircraft breakup during the impact sequence indicated a high-energy state (consistent with the helicopter being at or near cruise speed) upon impact with the ground.

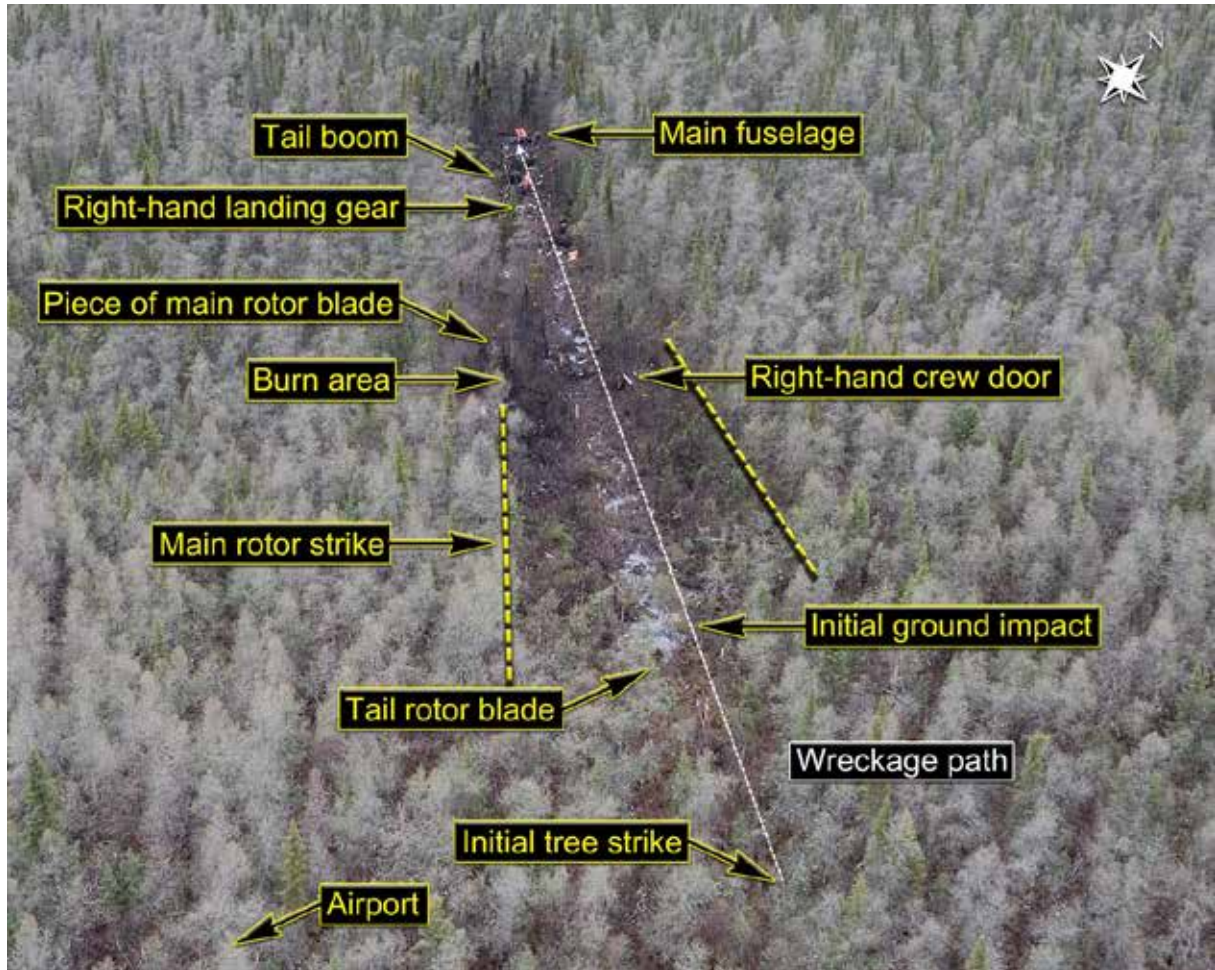
Figure 4. Overhead view of the wreckage path: 405 feet, 318°M track

The length of the crash swath path, from the first indication of contact with the trees to the location of the main wreckage, was approximately 405 feet. At the point of ground impact, the swath path was approximately 40 feet wide, gradually narrowing to approximately 20

feet, and then widening out again to form a circular, burned-out area approximately 35 feet in diameter (Figure 4).

The point of initial impact was approximately 96 feet past the first indication of damage to the tops of the trees. Between the first indication of damage to the trees and the impact point, there is a definitive pattern of cut trees. The trees are cut to within 3 feet at the lowest point, corresponding with a left-bank attitude as the aircraft descended into the trees and the fuselage made contact with the ground.

At the location of the initial ground impact, a visible crater in the swampy terrain was evident, and the area was heavily saturated with fuel. In the crater and surrounding area were pieces of the fuel tanks and some of the fuel system components. As the fuel tanks and associated hardware are located in the belly of an S-76A helicopter, these observations indicate that the structure of the helicopter was compromised at that point. One of the helicopter's 4 tail-rotor blades was discovered just before the main impact location. The tail-rotor blade had broken off at the root. The loss of an S-76A tail-rotor blade would have introduced a yawing moment, causing the helicopter to rotate to the right.

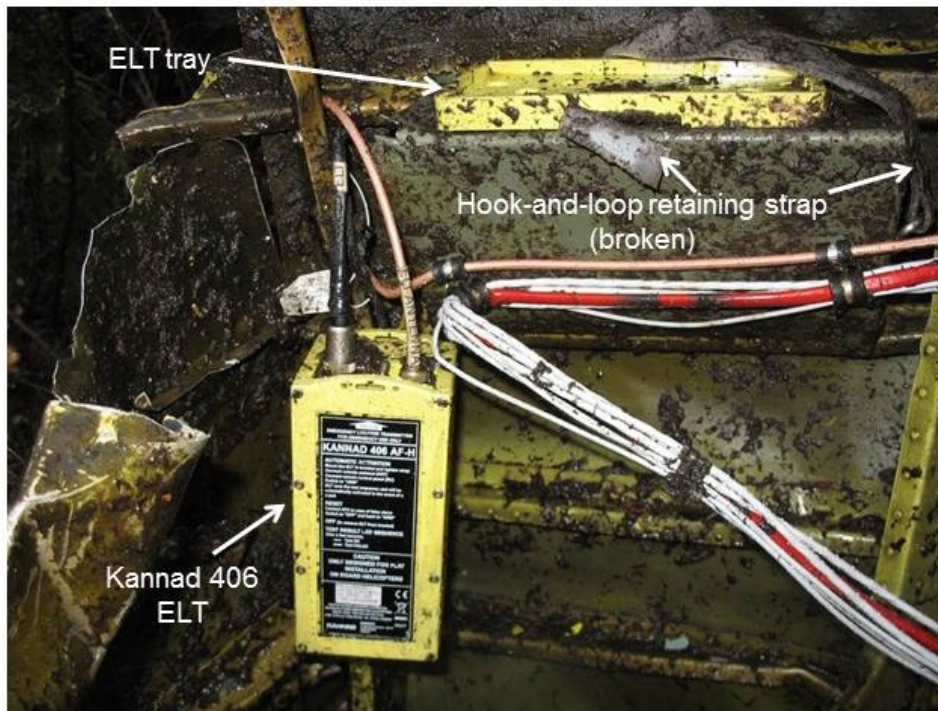
Figure 5. The occurrence aircraft's Kannad 406 MHz automatic fixed helicopter (AF-H) emergency locator transmitter (ELT) hanging by its wires

The Kannad 406 MHz AF-H ELT has a 3-position switch on the body of the ELT that allows for selection of "arm", "off", and "on". The ELT switch was found at the accident site in the "arm" position. The ELT unit, which was held in position by a hook-and-loop retaining strap, was found hanging by its wire harness by search-and-rescue (SAR) personnel. The strap was ripped near the bottom of the tray, allowing the unit to hang freely (Figure 5).

The Kannad 406 MHz AF-H ELT exhibited minor damage to its case. Functional tests were performed to determine the serviceability of the ELT. Using the internal battery, the ELT did not provide a status indication, nor did the device produce any transmissions. However, when an external power supply was used, the ELT's status light flashed repeatedly,

This is not the first TSB investigation in which a Kannad 406 MHz ELT has come free from its hook-and-loop mounting strap. There have been several accidents in which an ELT antenna broke off during the impact sequence or the wire to an antenna was damaged, and no signal was received by SAR personnel.<sup>17</sup> In TSB Aviation Investigation A11W0151, a Kannad 406 MHz AF-H ELT was ejected from its mounting tray during the impact sequence, and the external antenna was broken off due to ground impact. That investigation identified the importance of ensuring that the hook-and-loop retaining strap is tight; otherwise, the ELT can easily slide out of the tray if enough force is applied to it.

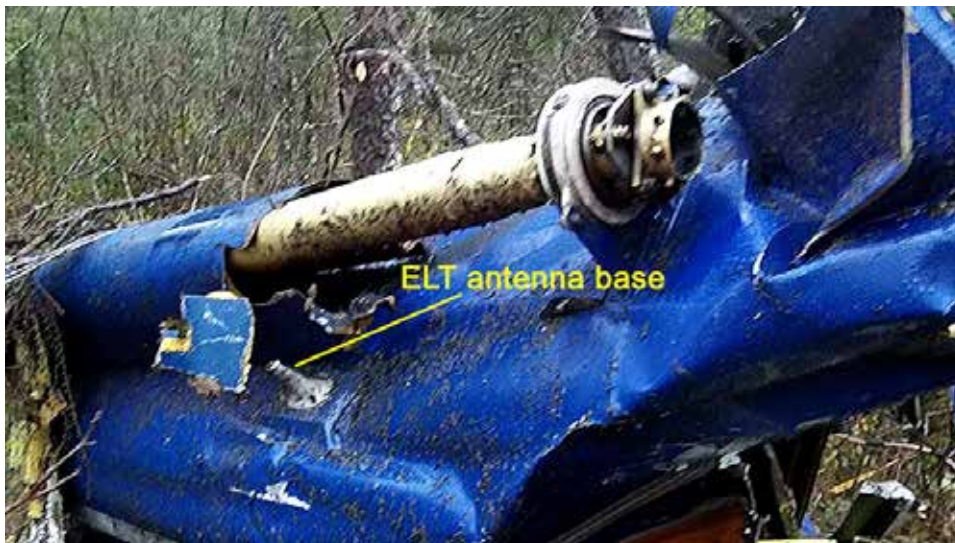
Figure 6. A frame grab from a field video of the wreckage showing the severed emergency locator transmitter (ELT) antenna

In addition to the detachment of the unit from its mounting tray, the external antenna located on the tailboom had been severed due to ground impact forces (Figure 6).

Additional testing of the ELT confirmed that it would be activated when subjected to impact forces that were within the specified “g” range of the unit. This confirmation, in conjunction with the fact that the ELT’s battery pack was depleted, strongly suggests that the device did activate on impact and did transmit a signal. However, no signal was received due to the damaged antenna.
