**AVIATION INVESTIGATION REPORT
A99P0006**

CONTROLLED FLIGHT INTO TERRAIN (CFIT)

DOUGLAS DC-3C C-GWUG

MAYNE ISLAND, BRITISH COLUMBIA

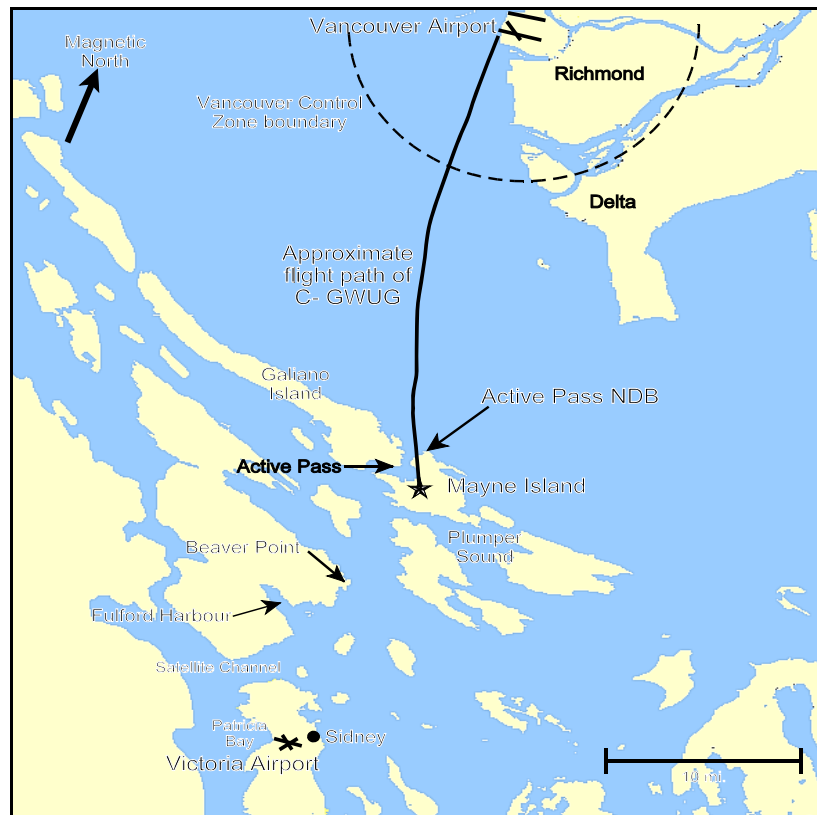
Figure 1 - Aircraft routing and crash site

At 0633:04, the aircraft descended to 800 feet asl for about nine seconds. The last radar data show the aircraft at 900 feet asl and 130 knots. The last radar-depicted position of the aircraft is on a bearing of 189 degrees (true) and 21.8 nm from the Sea Island radar source, coincident with the crash location.
