FINAL REPORT

HCLJ510-000330	Accident		
Aircraft:	Cirrus SR20	Registration:	N901SR
Engine:	Continental IO-360-ES6	Type of Flight:	Ferry flight, IFR
Crew:	1 – fatal injuries	Passengers:	None
Place:	60 39 56N 46 41 44W, Greenland	Date and Time:	2.2.2007 at 1811 hrs UTC

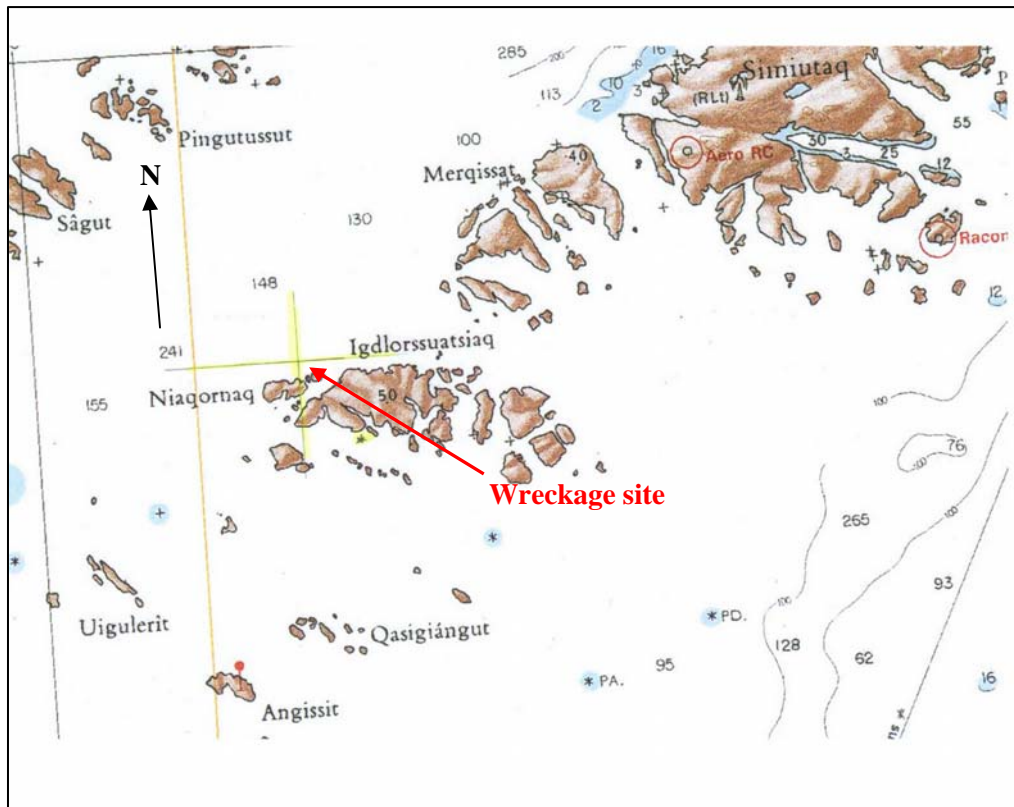
1.12.2 Wreckage site.

The aircraft ditched and sank at a position approximately 3 nm west southwest (60 39 940N 46 41 740W) of SI NDB. In January 2008, the Danish AIB without success tried to salvage the wreckage.

Arriving at the accident site, the flight crew of the S61 observed that the tail of N901SR was broken and bent approximately 45° to the left and that the left entrance door floated nearby. There were no observations of a dinghy in the water.

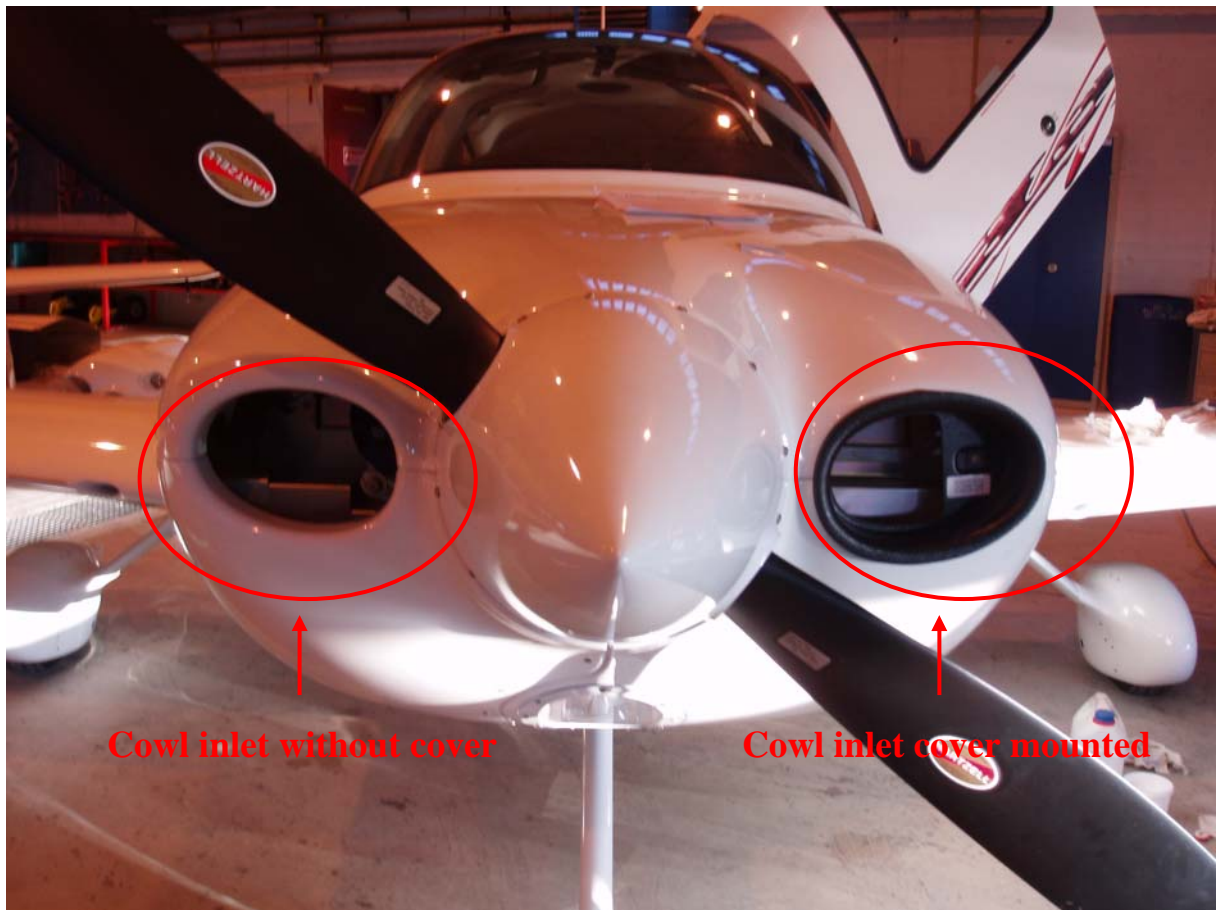
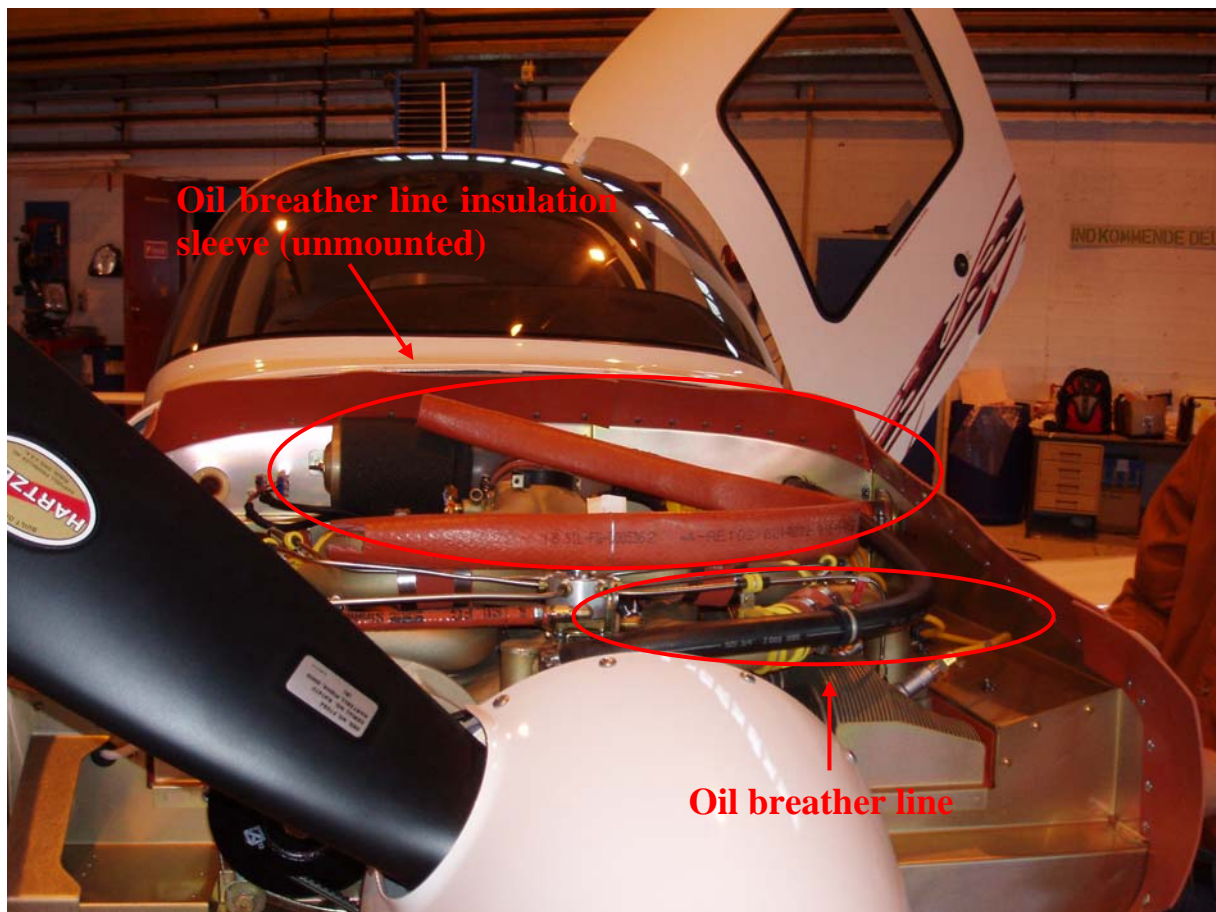
1.12.4 Cowl inlet covers and oil breather line insulation sleeve installation.

The inspection revealed that with reference to Service Bulletin SB 2X-71-04 R4, Service Bulletin SB 2X-71-10 and the Winterization Kit AFM Supplement P/N 11934-S25, neither cowl inlet covers nor the oil breather line insulation sleeve were mounted.

The technical status of N901SR was not in compliance with the above-mentioned SB recommendations and the POH requirement.

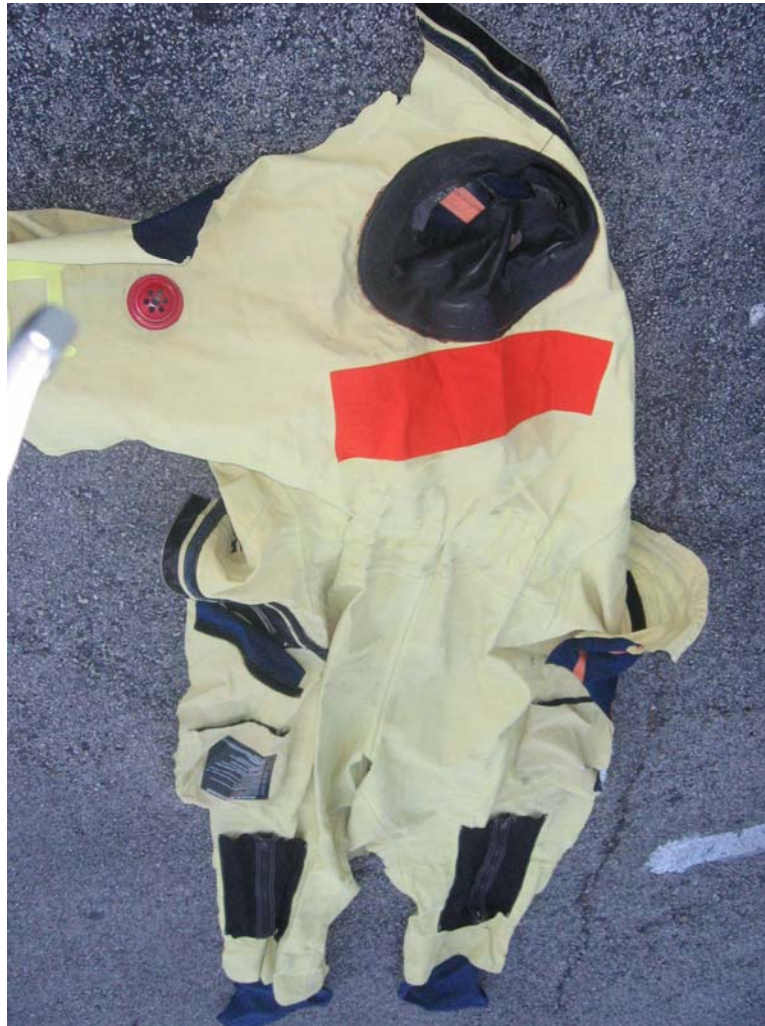
1.15.1 On board survival equipment.

There was a dinghy onboard the aircraft. The pilot wore a one layer non-insulated dry suit without flotation capability.

The pilot wore a one layer non-insulated dry suit without flotation capability. Due to the lack of a proper immersion suit providing insulation and flotation, the Danish AIB finds that the body of the pilot probably was exposed to a hypothermia shock (water temperature at or below 2°C), which led to unconsciousness and drowning.
