REPORT

HCLJ510-000356	Accident		
Aircraft:	Sikorsky S-61N	Registration:	OY-HGZ
Engine(s):	2 - CT58-140-2	Type of flight:	Charter, VFR
Crew:	3 – no injuries	Passengers:	24 – no injuries
Place:	Kangia, Greenland	Date and time:	18.4.2007 kl. 1715 UTC

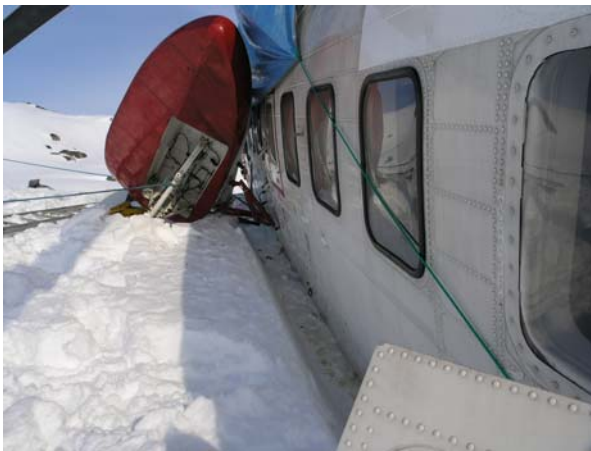
The landing gear was in its down and locked position and the helicopter had suffered substantial damage to the left gear, sponsons and support tubes. All support tubes on the left side were fractured due to overload and the absorption strut was separated from the sponson. Two of the sponson support tubes were fractured

Left sponson and support tubes.

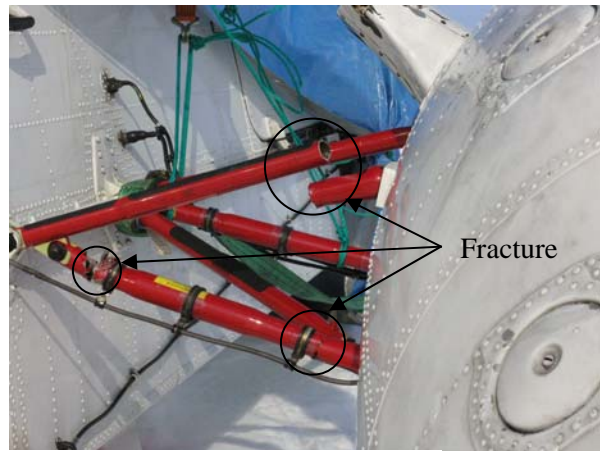
due to overload on the right side. The lower forward and mid lower fuselage was substantially damaged.

Right sponson and support tubes.

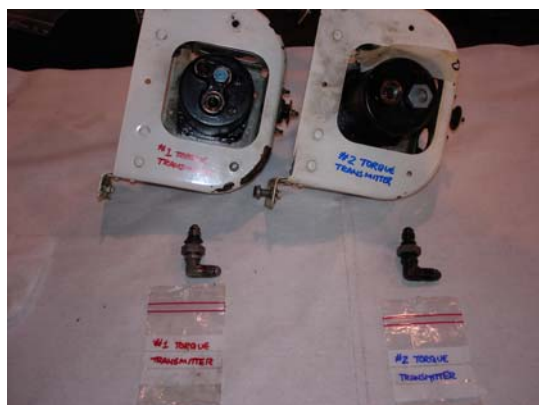
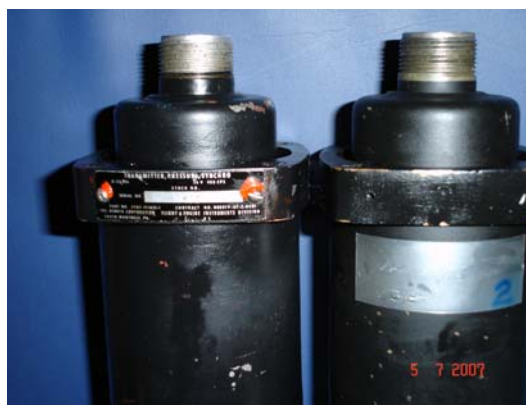
The torque sensing unit transmitter (TX) for engine number two was found to have an external restrictor installed in the adjacent elbow fitting (pn. SS49PB833-4-22Y). The yellow dot on the fitting indicated that there was a restrictor installed (see photo). The number one engine did not have the external restrictor installed. Both the TX's were tested in a test cell and were found to operate correctly without the restrictor. With the restrictor installed the TX's had a tendency to lead and lag on the pressure gauge and had a little slower reaction time on the gauge needles, but they still showed the correct figures. If the elbow fitting

was screwed too far into the TX, which was possible, the restrictor in the fitting and the internal restrictor in the TX could more or less make contact against each other. The result was that the pressure gauge did not show the correct figures; even it was possible to make zero reading.

Furthermore, the position 2 TX data plate was missing and was replaced by an unauthorized label. The IPC prescribes that there should be installed an external restrictor in the elbow fitting.

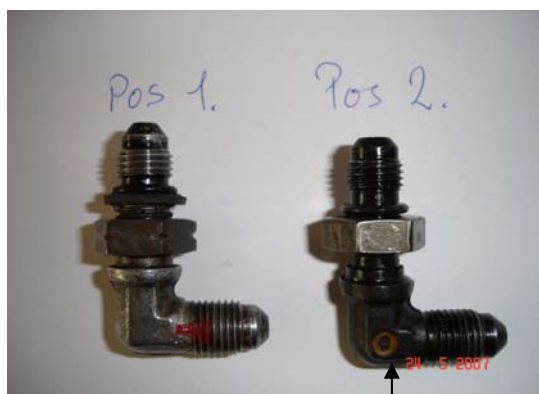
Elbow fittings

Yellow dot.

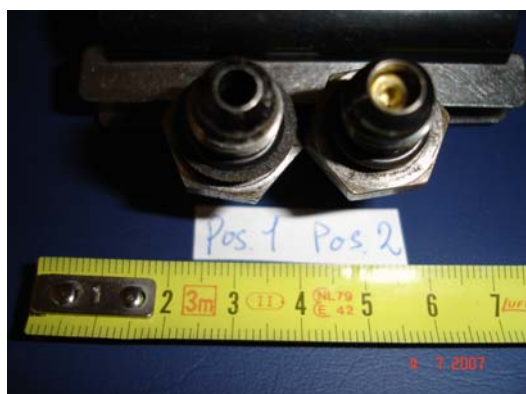
Restrictor in elbow fitting pos. 2

The missing external restrictor in the elbow fitting on engine number one torque sensing unit, did not influence the sequence of events.

However, installation of the elbow fitting with the restrictor was not made in a failsafe manner as possibilities to screw the fitting against the torque sensing unit's restrictor needle existed.

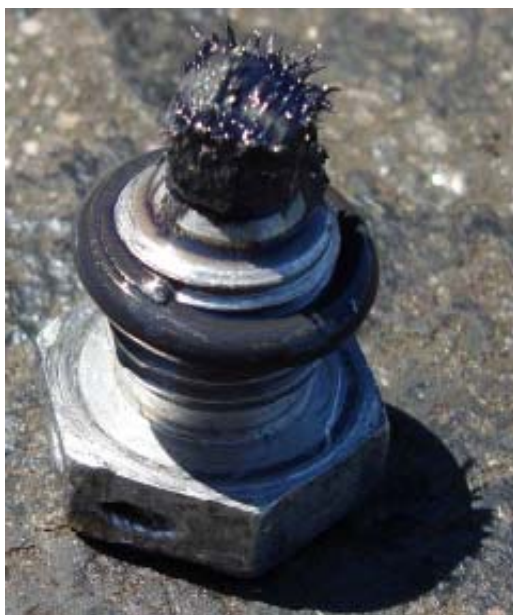
The four magnetic drain plugs were removed and all found to be contaminated with fine metallic debris. The oil filter was found to be clogged with fine metallic debris. See figure below.

The four magnetic plugs and the oil filter were scanning electron microscope (SEM) analysed and the results revealed that the debris was consistent with cold section bearing material (copper alloy, iron and silver. Material match: AISI 52100) and gear tooth material (case hardened steel. Material match: AISI E9310). No other materials were found.

Magnetic plug for accessory drive gear box and main bearing number

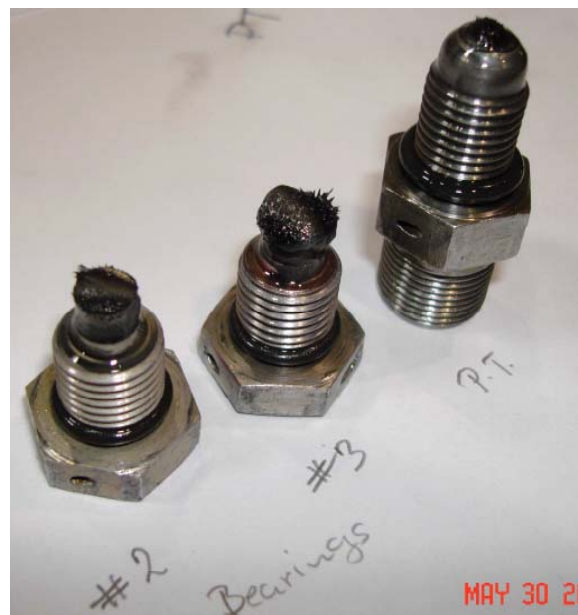
Magnetic plugs for main bearing number two and three and power turbine.

All magnetic plugs and the oil filter were contaminated which indicated an internal failure in the engine. The oil filter was found to be clogged with fine metallic debris. This indicated that the oil filter had likely gone into bypass. The debris was consistent with cold section bearing material and gear tooth material.

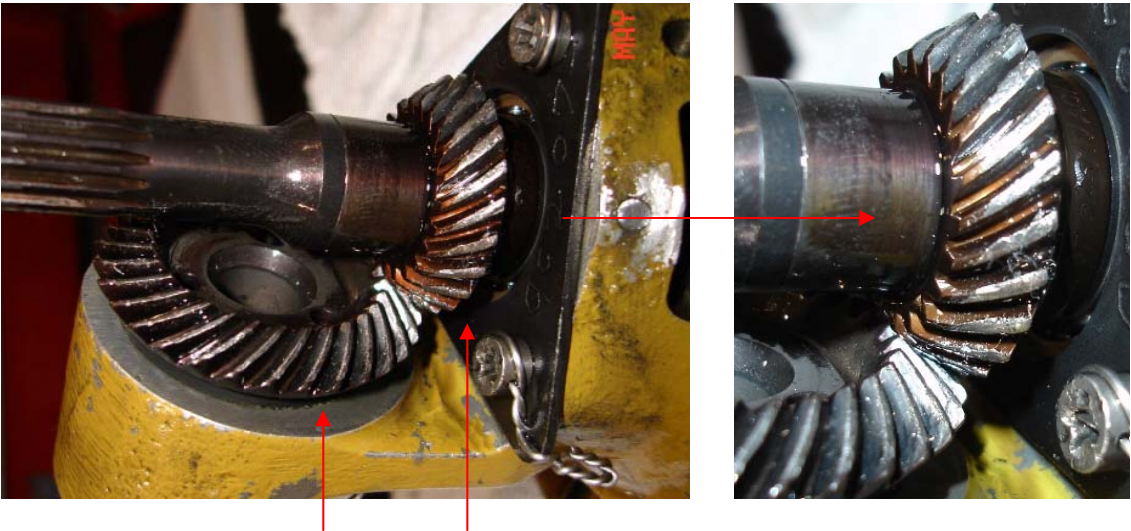
The tear down of the FFAD and the ADG revealed that this loss of drive to the ADG was due to disengagement of the pinion and bevel gears of the FFAD. Wear and damage was observed on the teeth on these gears. See figure below.

The FFAD pinion and bevel gear teeth had the most extensive wear and damage. The tooth contact pattern was inconsistent with the Overhaul Manual.

FFAD bevel and pinion gear.

The bevel gear teeth were found to have contact with the pinion gear teeth almost to the bottom of the roots as far as it was possible due to the design of the teeth.

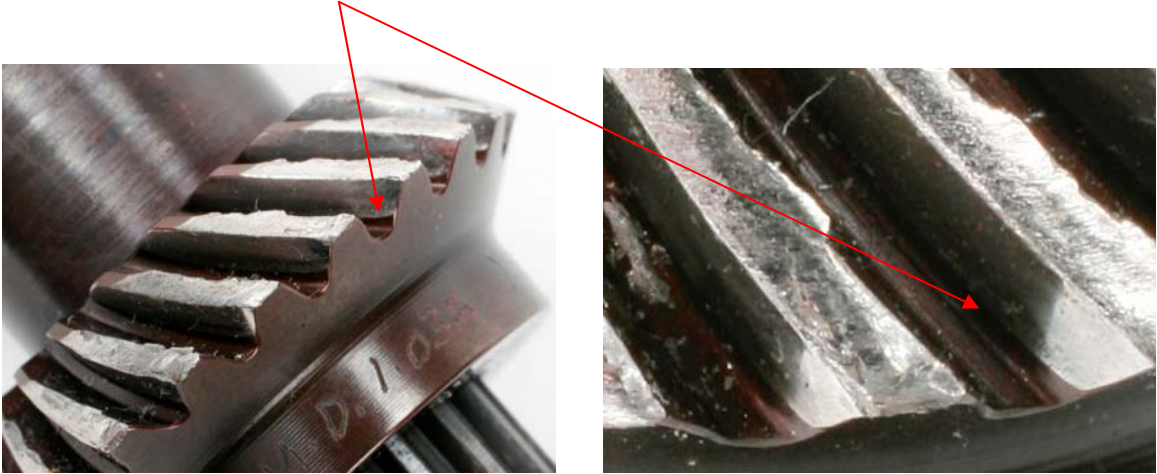
FFAD pinion gear

The pinion gear was supported by a starter drive bearing. The bearing was found to be in a normal condition.

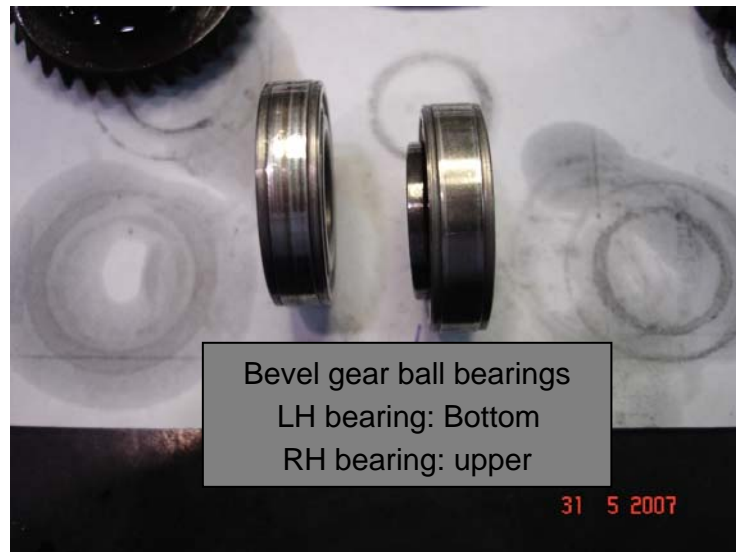
The bevel gear was supported by two bearings in the FFAD housing, s/n HPCRCS01046. Of the two bevel gear assembly bearings, the upper one showed evidence of wear and distress.

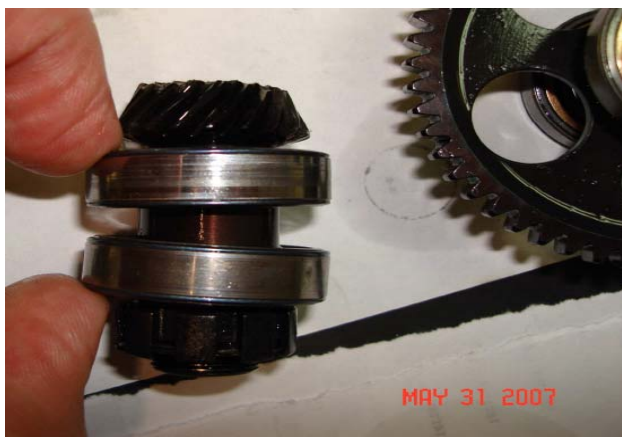
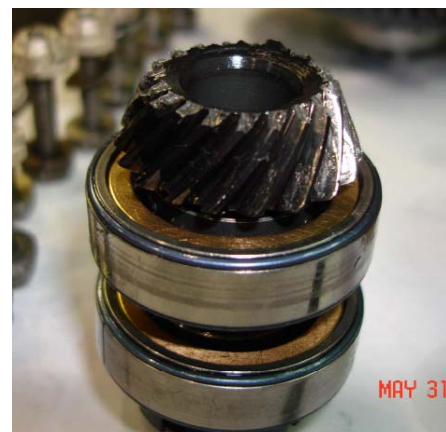
The ADG pinion and bevel gear teeth were also worn with damage evident at the toe end of the pinion gear teeth. The tooth contact pattern was inconsistent with the Overhaul Manual. Both the ADG bevel pinion assembly bearings showed evidence of wear and distress. All other bearings in the ADG were found to be in a normal condition.

ADG bevel pinion assembly, bearings and teeth.

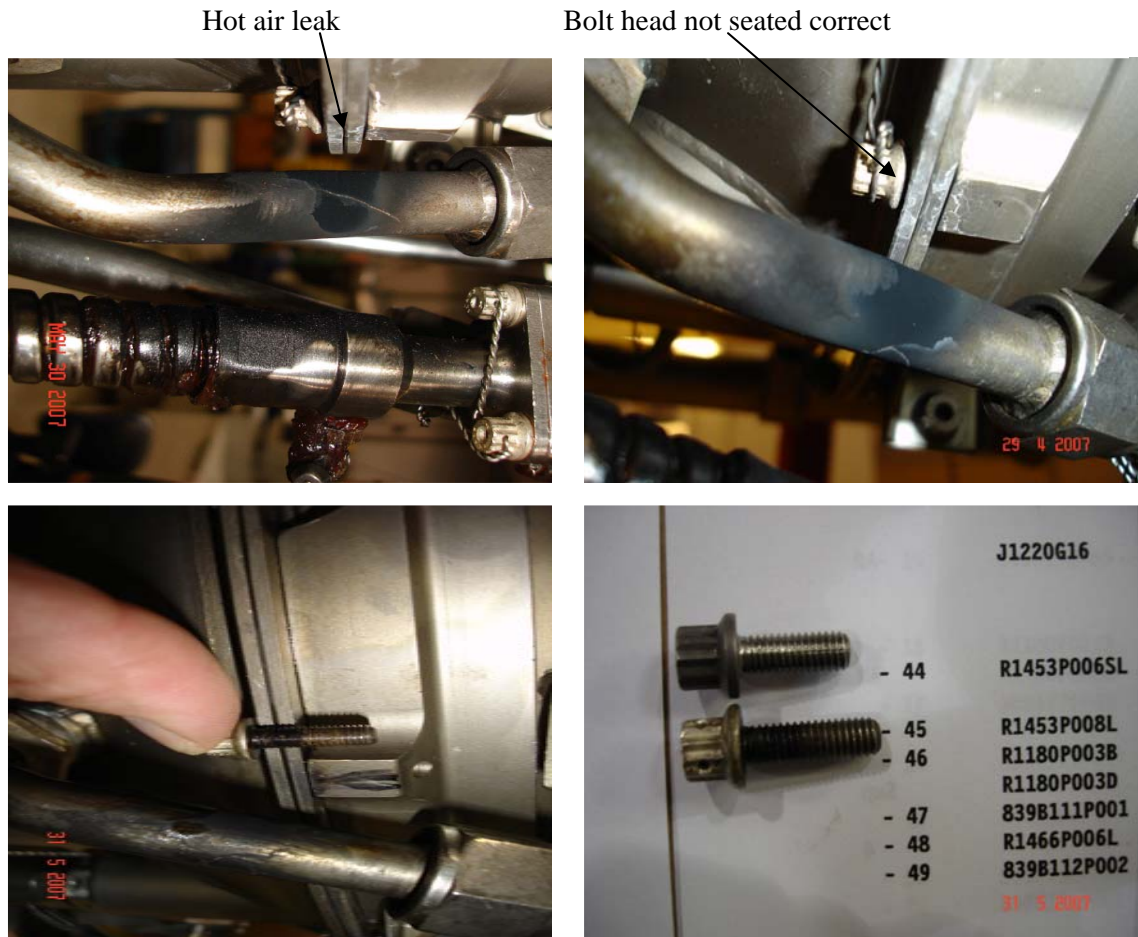
The casing mating flanges are required to use a combination of P06 bolts (13 mm long) and P08 bolts (16 mm long). The bolts through every other flange hole also screw into blind holes in the blade guard behind the flanges. These bolts should be P06 to avoid the risk of 'bottoming-out' of the bolt in the blind hole. The P08 bolts are used in combination with nuts on 'open' flange holes and when there was also a bracket mounted to the casing flanges.

All the casing flange bolts on the accident engine were found to be P08 bolts, which increased the likelihood of insufficient clamping force on the casing flanges due to 'bottom-out' of the blade guard blind hole locations.

The wrong bolts installed, which caused the hot air leak at the 6 o'clock position from the engine flanges of the second stage turbine casing, did not influence the sequence of events.
