## REPORT

| <b>HCL 69/00</b> | <b>Accident</b> | | |
| Aircraft Type: | Socata TB 10 | Aircraft Registration: | D-EACQ |
| Place: | South of Skovmose on Als | Date and time: | 29.11.2000, 1713 UTC |

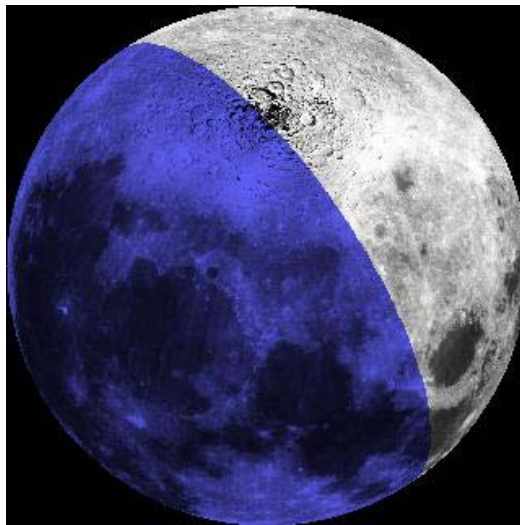
At the time of the accident, the Moon was very low above the horizon in the direction SW. The Moon was very thin and could probably only have been limited visible near its position above the horizon.

View of the Moon seen from the Earth (from the accident site at the time of the accident).

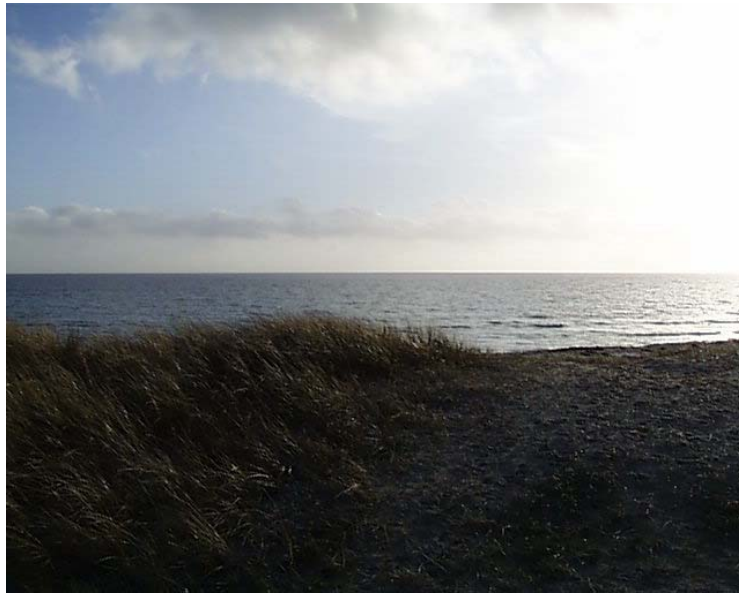
The accident site was approximately 300 meters south of 'Skovmose' at the position N54° 52,121' E010° 01,542'. The depth of the water was approximately 5 meters. The distance from beginning of runway 14 to

the accident site was approximately 10 nm and the direction was approximately 126° (GEO).

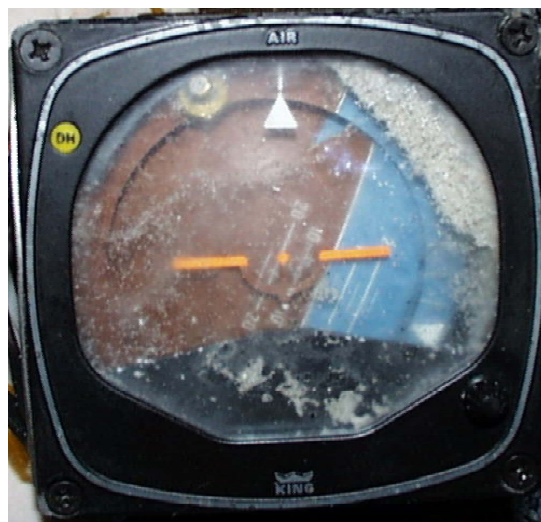
The artificial horizon was found at the accident site. (See below). The artificial horizon was locked at a 120° bank to the left. The pitch could be moved between 10° up and 20° down.

pulling back in the wheel, but as the aircraft was inverted, the result was an increase of airspeed. The artificial horizon found at the accident site indicated also a 120° bank to the left, and that the aircraft was inverted at the time of the accident.

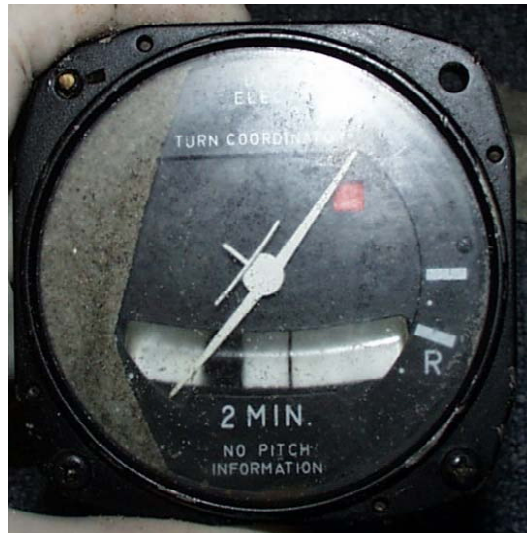
The turn indicator was found at the accident site. (See below). The indicator showed a left turn. The instrument was locked in that position. The indication was maximum left turn at mechanical limit.

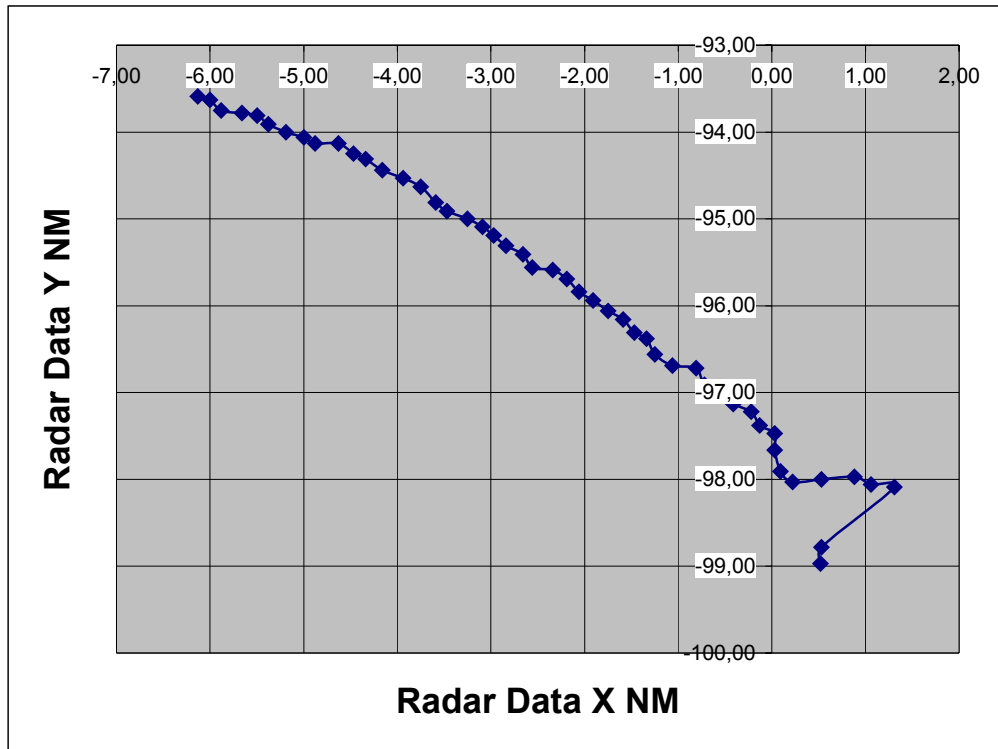
Appendix B: Radar data. 1 unit = 1 nm.

Between 17:07:07 hrs and 17:08:05 hrs the average was TT  $113,3^{\circ} \pm 18,6^{\circ}$   
between 17:08:05 hrs and 17:09:07 hrs the average was TT  $118,3^{\circ} \pm 24,2^{\circ}$   
between 17:09:07 hrs and 17:10:04 hrs the average was TT  $127,0^{\circ} \pm 17,1^{\circ}$   
between 17:10:04 hrs and 17:11:07 hrs the average was TT  $124,1^{\circ} \pm 21,8^{\circ}$   
between 17:11:07 hrs and 17:12:04 hrs the average was TT  $127,9^{\circ} \pm 29,0^{\circ}$   
between 17:12:04 hrs and 17:13:07 hrs the average was TT  $129,4^{\circ} \pm 47,8^{\circ}$  and  
between 17:13:07 hrs and 17:13:23 hrs the average was TT  $169,4^{\circ} \pm 65,9^{\circ}$ .

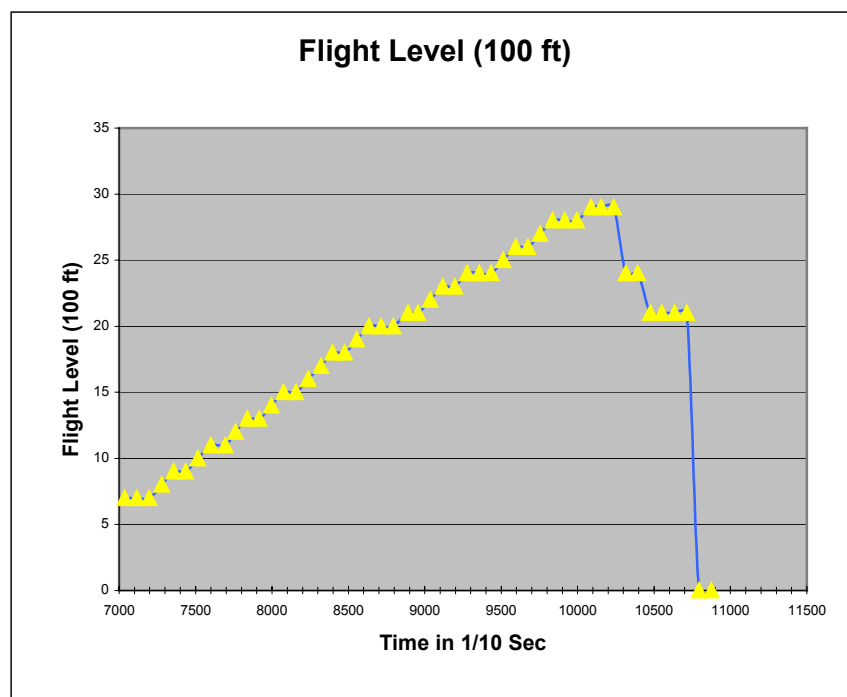
Appendix C: Mode A Altitude. Y is the altitude in 100 feet. X time in 1/10 second.

Between 17:13:07 hrs and 17:13:23 hrs, the average rate of descent was more than 5250 feet/minute.

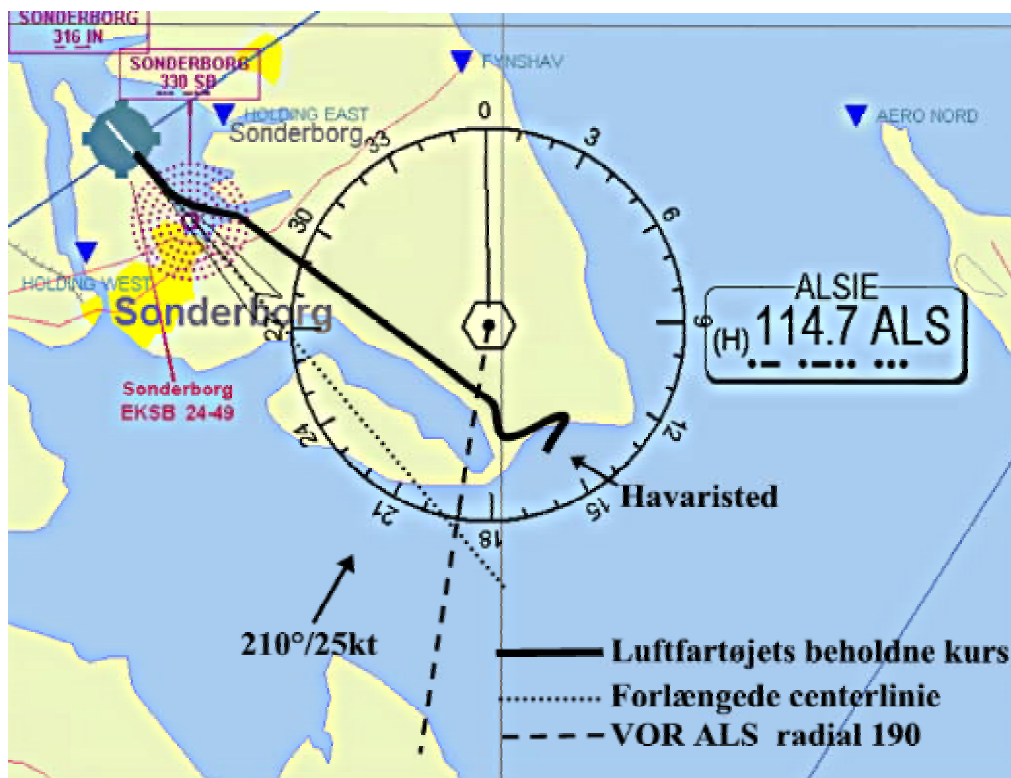
Appendix D: The aircraft track.

The aircraft track is displayed in appendix D.
