REDEGØRELSE

HCLJ510-2011-74	Lufttrafikhændelse	
Dato og tid	13-12-2011 kl. 1549 UTC	
Hændelsessted:	5,5 nm sydvest for VOR AAL (116,700 MHz)	
Lufttrafiktjenesteluftrum:	København CTA, luftrumsklasse C	
	A	B
Registrering:		
Luftfartøjstyper:	CRJ9	CRJ9
Flyvehøjder (→ ↗ ↘):	↘	→
Flyveregler:	IFR	IFR
Civilt eller militært luftfartøj:	Civilt	Civilt
Flyvevejrforhold:		
Lysforhold:	Mørk nat	
ATS:	København ACC (126,055 MHz)	
Informationskilder:	Air Traffic Safety Report (ATSR), radardata, talekommunikation samt Havarikommisionens egne undersøgelser.	
Klassifikation af lufttrafikhændelsen:	B) Sikkerhed ikke tilsikret

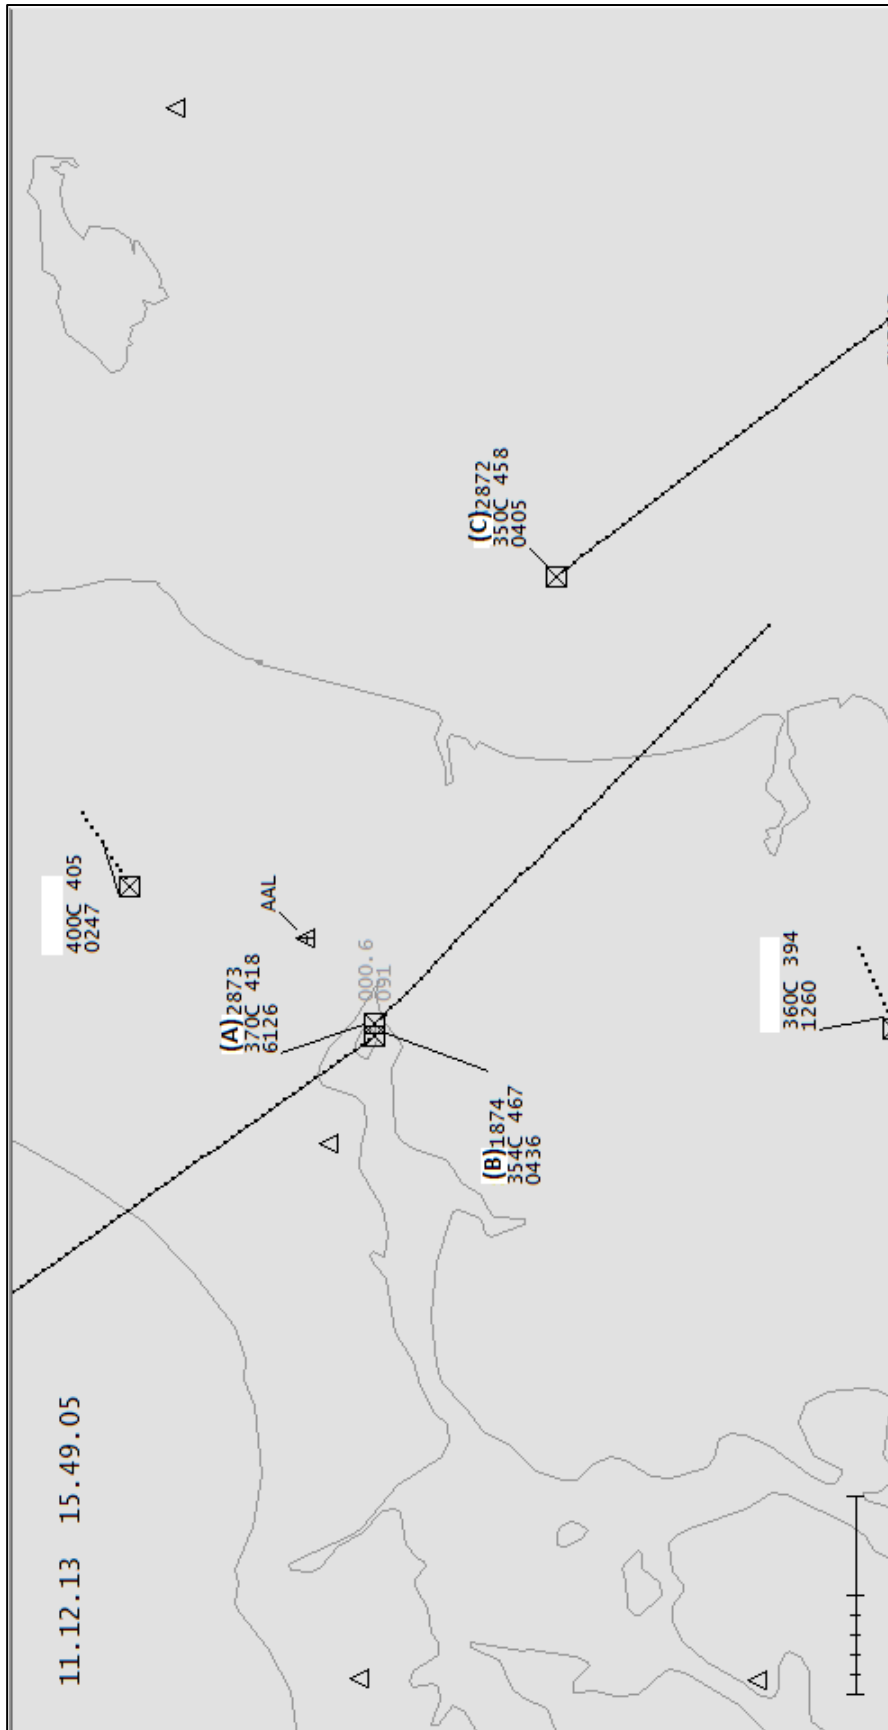
Bilag 1

15:49:05	<p>Den mindste horisontale og vertikale separation mellem luftfartøjerne A og B radarpræsenteredes (the closest point of approach).</p> <p>Se bilag 1.</p>	A & B 0,6	A & B 1600
