PRELIMINARY REPORT

Accident

DIAMOND DA40

N39SE

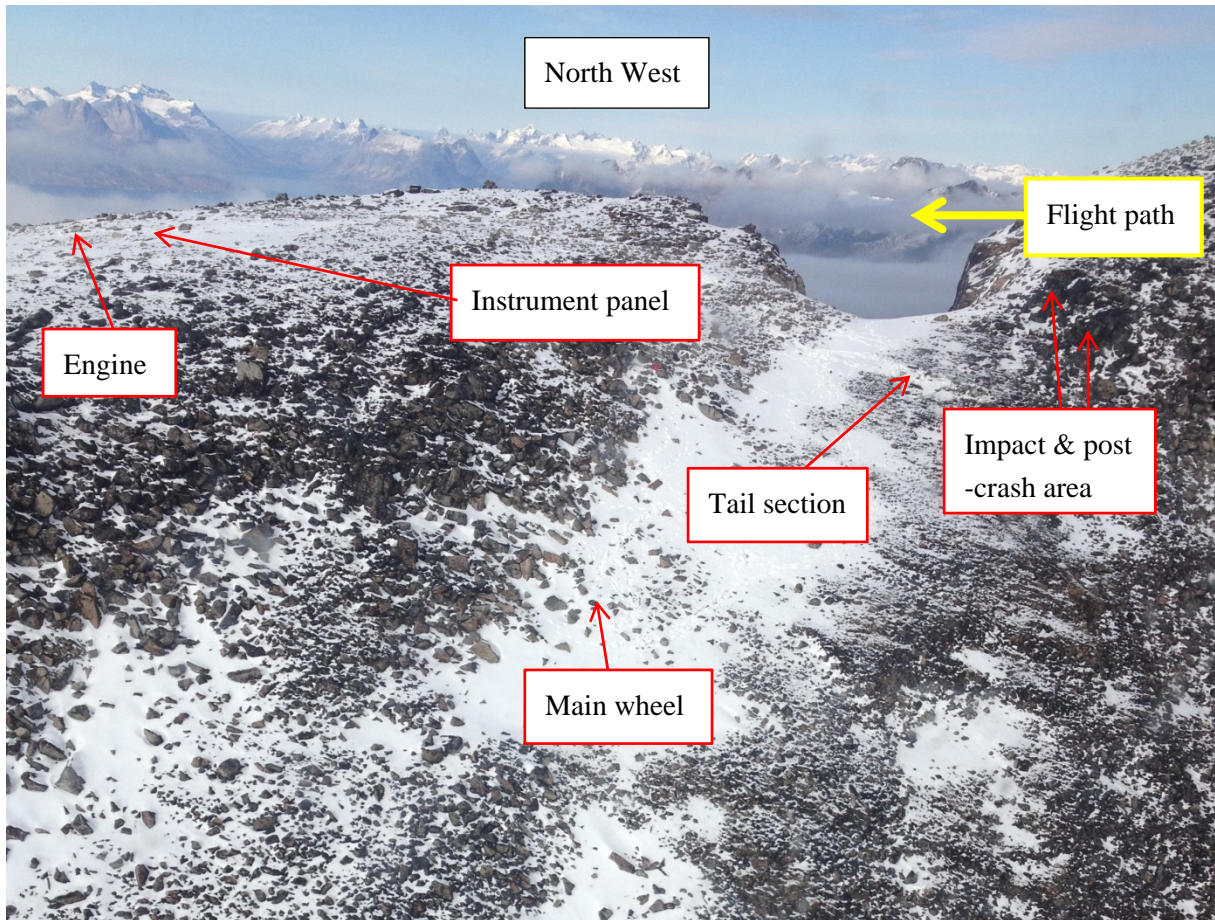
Wreckage and impact information

An extensive search of the aircraft was initiated, but due to adverse weather condition and other factors, the aircraft wreckage was not located until six days after the accident. Approximately three nm southeast of Kulusuk airport at GPS position 65 33 42,7N – 37 04 59,0W, the wreckage was located near a mountain top.

The aircraft was destroyed.

The aircraft was partially consumed by a post-crash fire.
