Havarikommissionen
Accident Investigation Board Denmark

BULLETIN

ELA 07 R-100 C

OY-1027

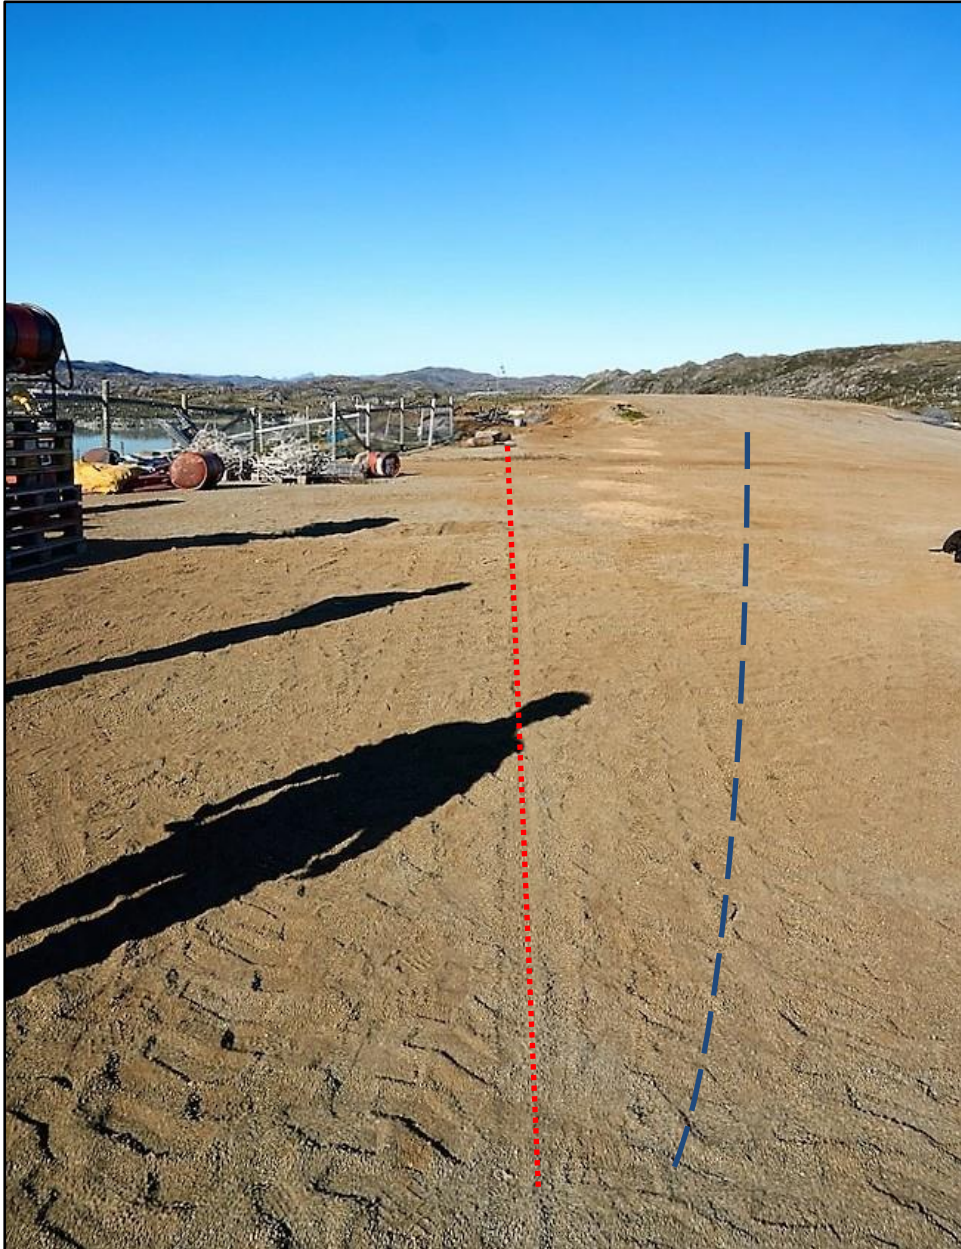
— — — — — Intended take-off roll
..... Actual take-off roll

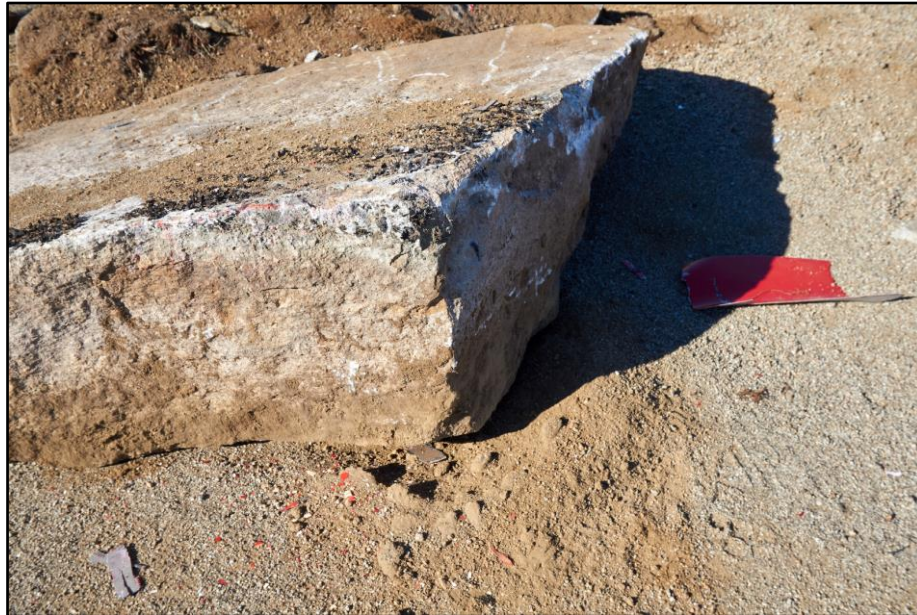
During the take-off roll, the gyroplane started veering to the left and hit a rock next to the runway edge.

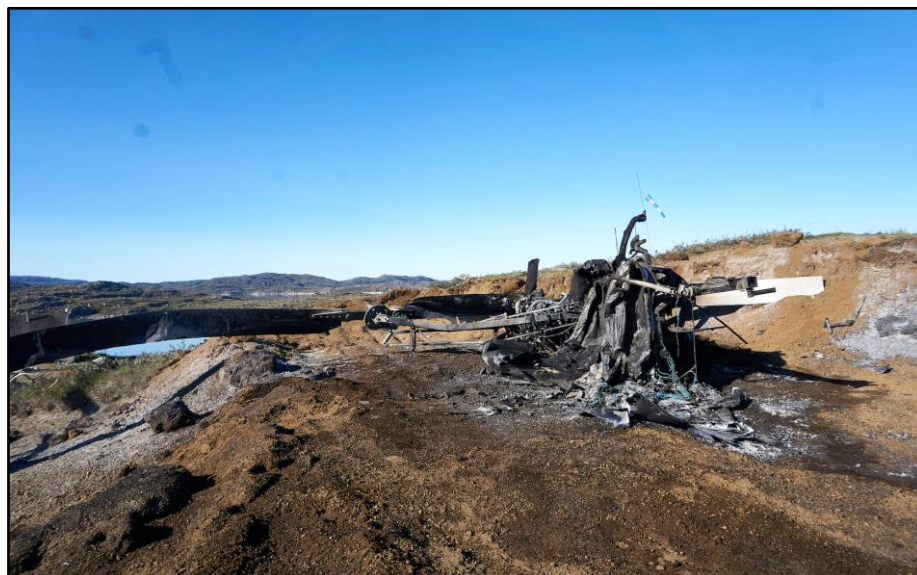
The gyroplane ended up in an almost upside down position.

Fuel started leaking and caught fire, and the gyroplane was destroyed by the fire.

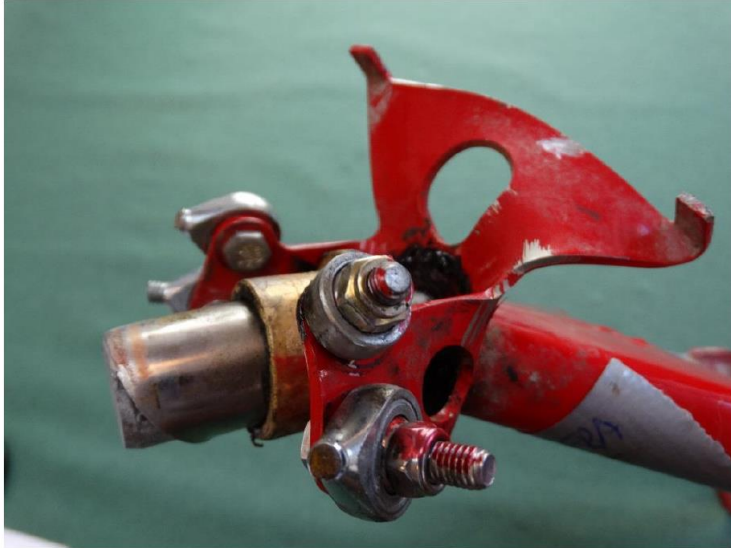
The main steering frame showed significant signs of deformation with the steering rod mounting plate and nose wheel steering column bent extensively c.f. figure 3.

Figure 3 Main steering frame with significant signs of deformation.

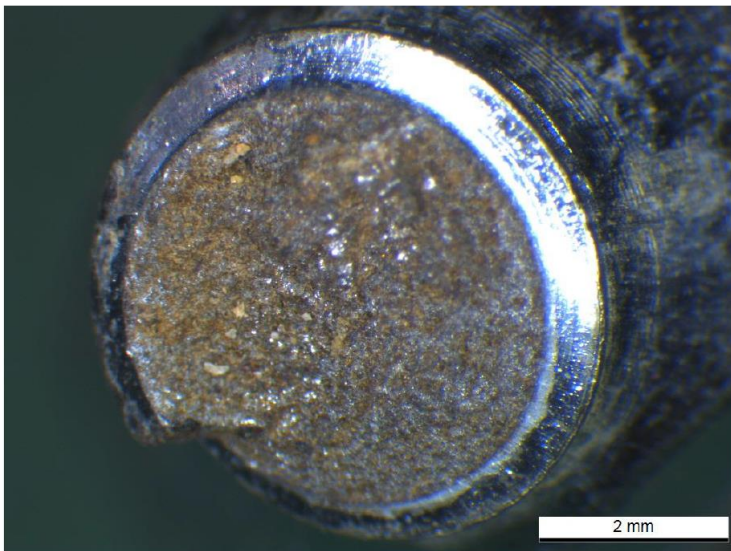
The forward left steering rod, as well as both left and right aft steering rods had visible fracture surfaces with signs of corrosion in their threaded regions, cf. figures 4 - 6. Following cleaning and removal of the corrosional products on all three fracture-surfaces, the topography displayed an intergranular structure with selected areas of cracking, suggesting that the failure mode could be ductile fracture cf. Figures 7 – 9.

Figure 4 Forward left hand steering rod fracture surface with signs of surface corrosion.

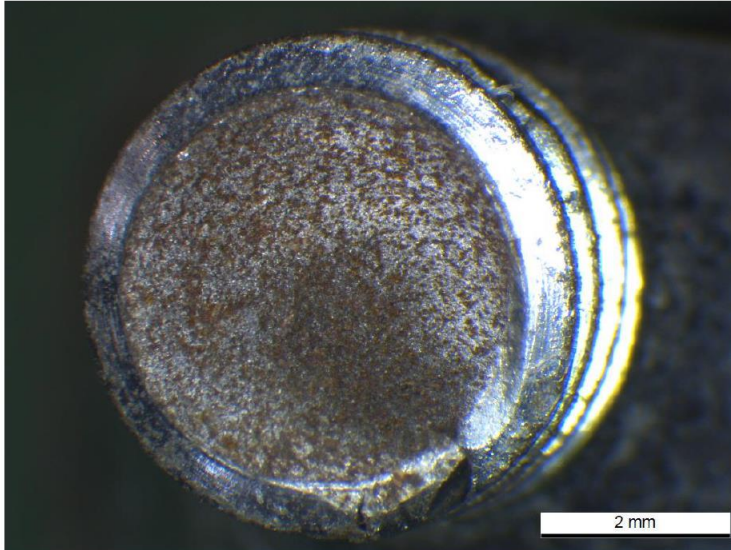
Figure 5 Aft left hand steering rod fracture surface with signs of surface corrosion.

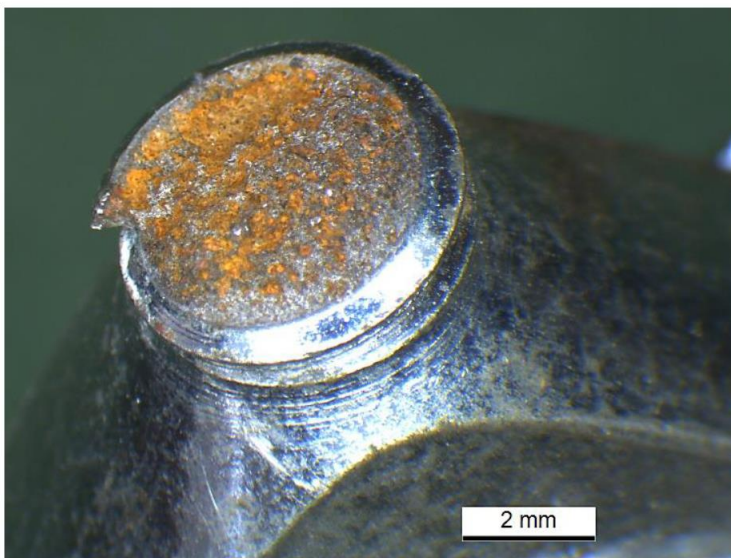
Figure 6 Aft right hand steering rod fracture surface with signs of surface corrosion.

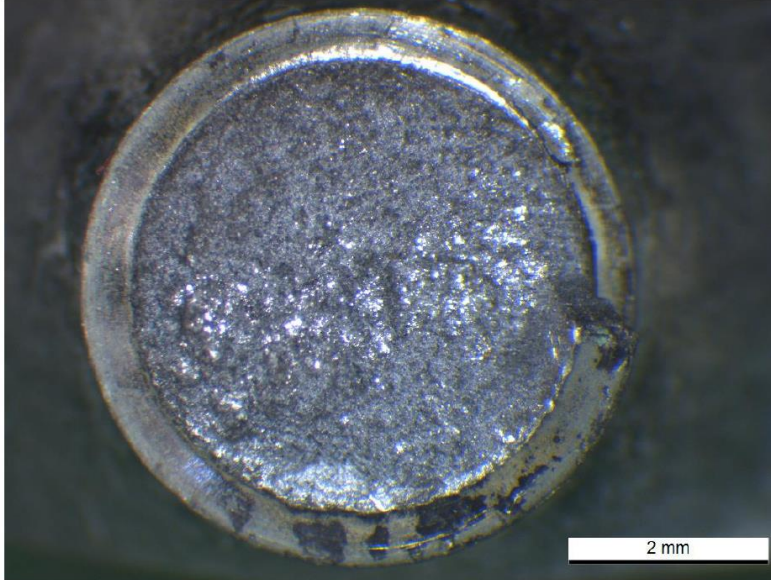
Figure 7 Forward left hand steering rod fracture surface in cleaned condition.

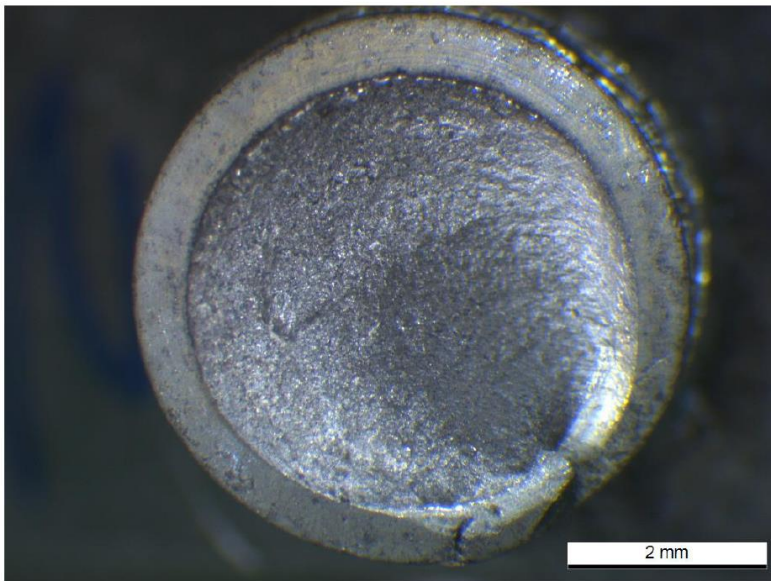
Figure 8 Aft left hand steering rod fracture surface in cleaned condition.

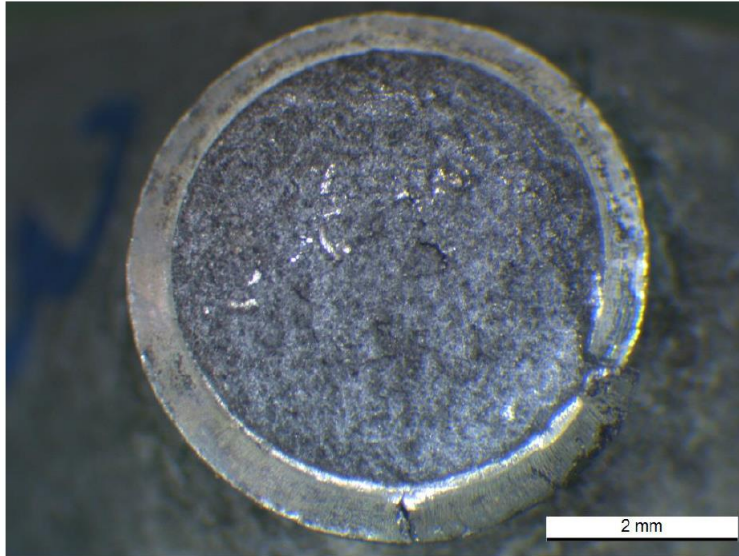
Figure 9 Aft right hand steering rod fracture surface in cleaned condition.

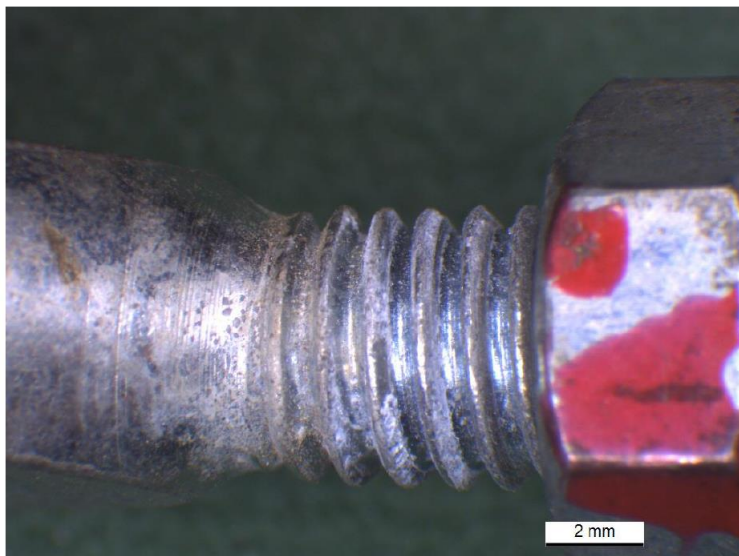
The forward right hand steering rod assembly had no visible fracture surfaces, but was forced off its fastening bearing which remained on the main steering frame as seen in Figure 3. The threaded rod ends were also examined and showed no signs of comparable damage to their counterparts cf. figures 10 and 11.

Figure 10 Forward right hand steering rod threaded rod end, free of fracture marks and corrosion.

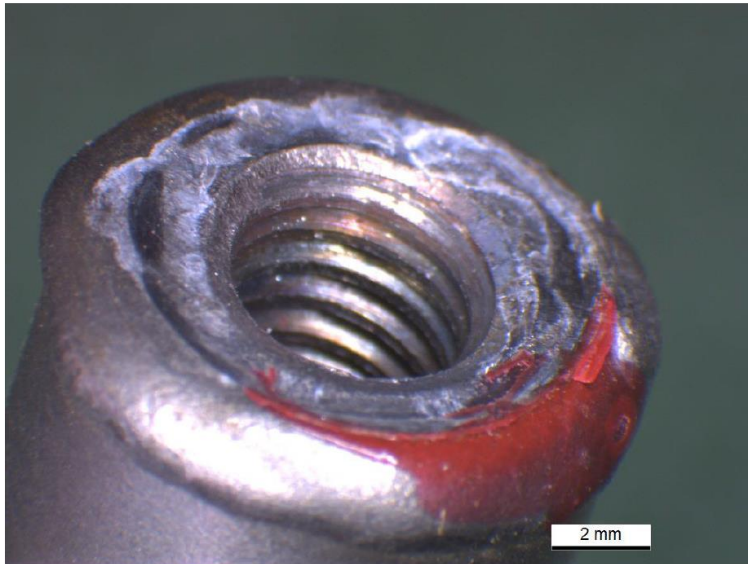
Figure 11 Forward right hand steering rod end, free of fracture marks and corrosion, surface markings are an attribute of assembly.

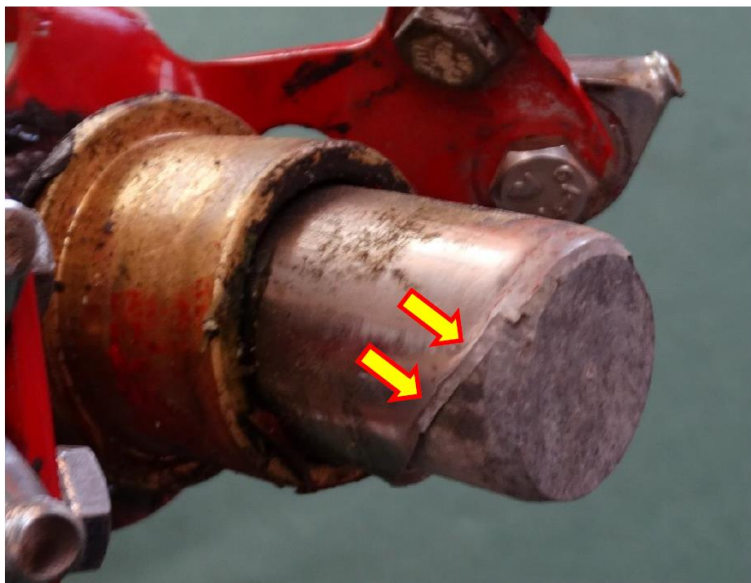
The nose wheel steering fork had no signs of corrosion, but had an elliptical semi-circumferential fracture surface, which may be seen in Figure 12 and at higher magnification in figures 13 and 14.

Figure 12 Nose wheel steering fork elliptical semi-circumferential fracture surface, yellow arrows denote left side fracture surface.

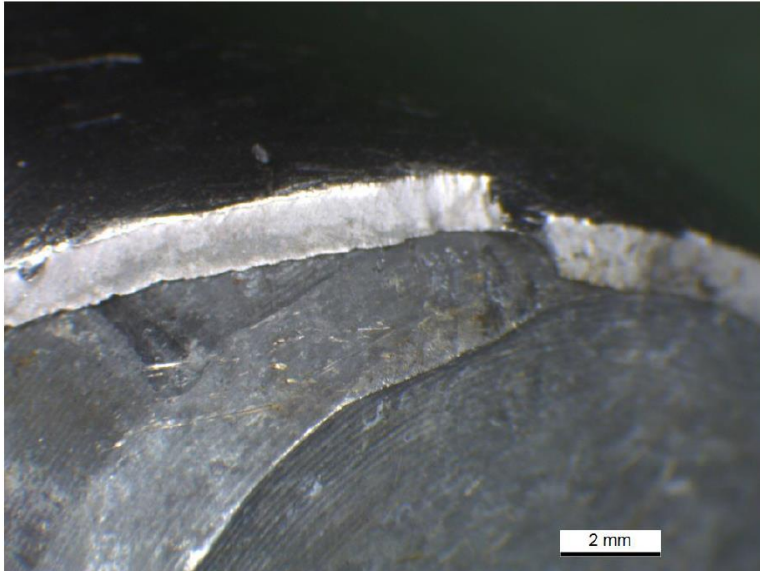
Figure 13 Nose wheel steering fork elliptical semi-circumferential left side fracture surface at higher magnification.

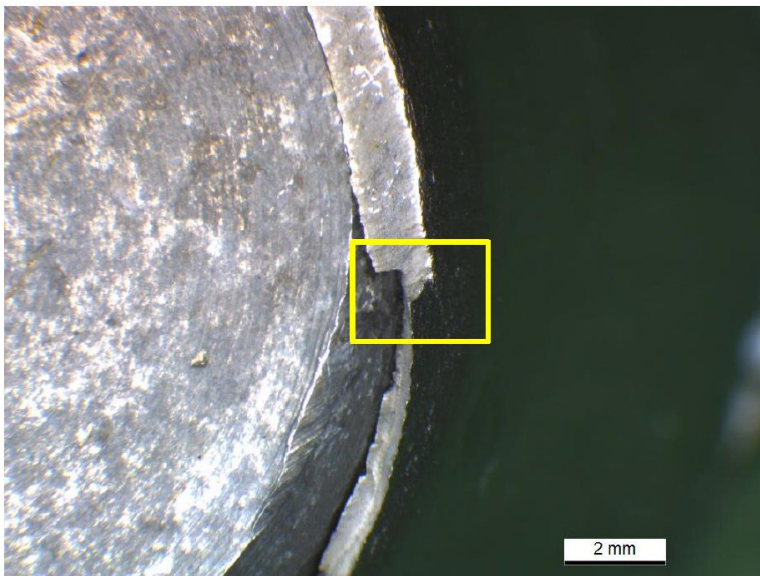
Figure 14 Nose wheel steering fork elliptical semi-circumferential right side fracture surface at higher magnification. Yellow box denotes the region seen in Figure 21.

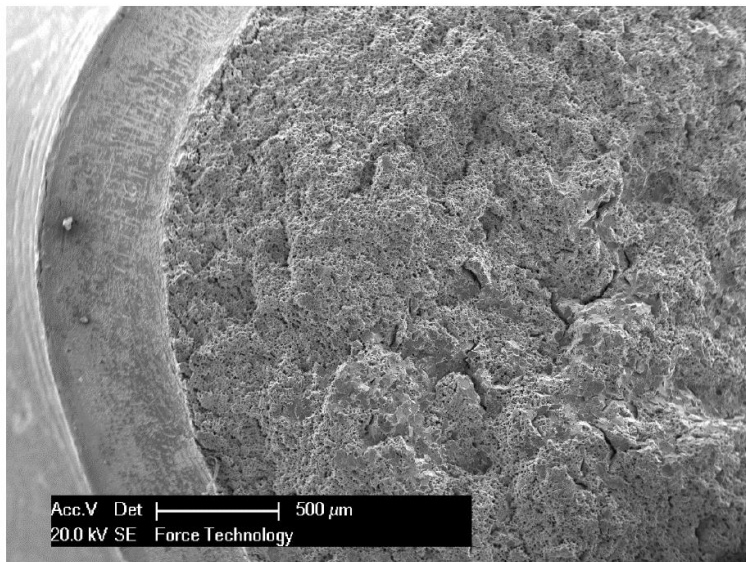
The forward left hand steering rod fracture surface could be categorised as being the result of ductile fracture as seen by the general shear dimple morphology in a torsional orientation cf. Figure 15. The centre of the bolt did however display partial signs of brittle fracture within the shear dimples, suggesting that the failure of the threaded rod section occurred almost instantaneously cf. Figure 16.

Figure 15 SEM micrograph of forward left hand steering rod fracture surface.

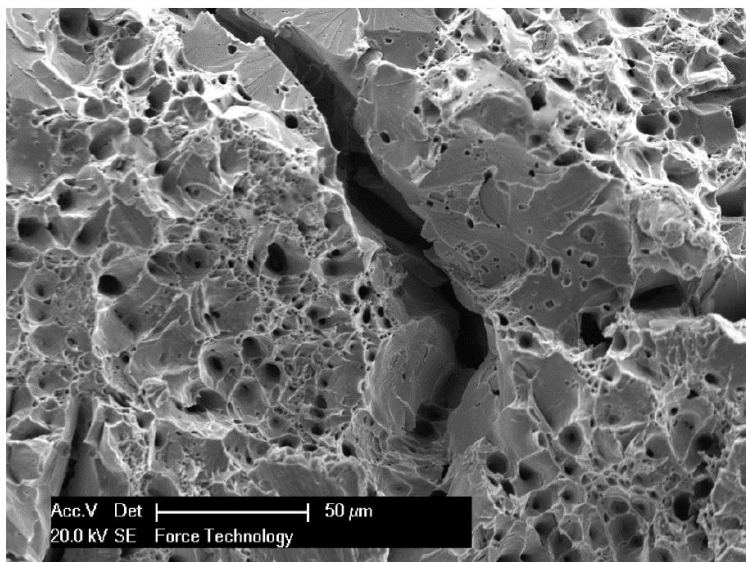
Figure 16 SEM micrograph of forward left hand steering rod fracture surface showing partial signs of brittle fracture surrounded by shear dimples.

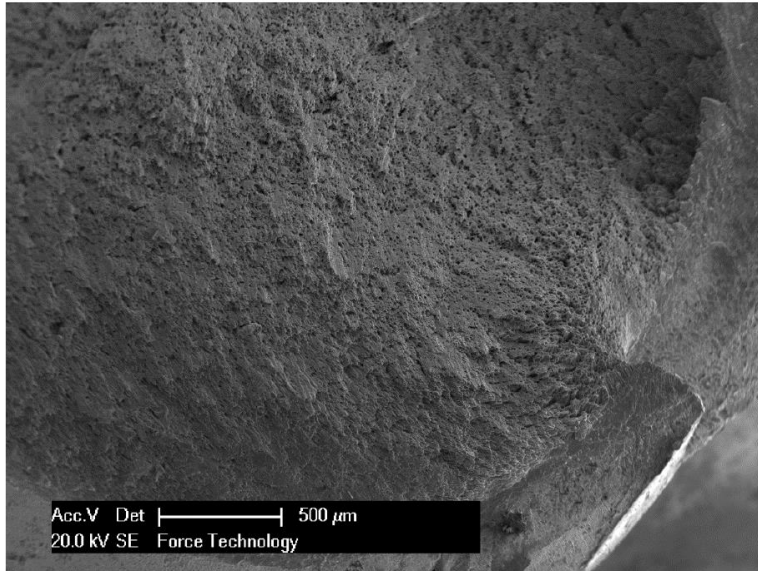
The aft left hand steering rod fracture surface also displayed signs of torsional deformation through ductile fracture as confirmed by the presence of shear dimples cf. Figures 17 - 18.

Figure 17 SEM micrograph of aft left hand steering rod fracture surface.

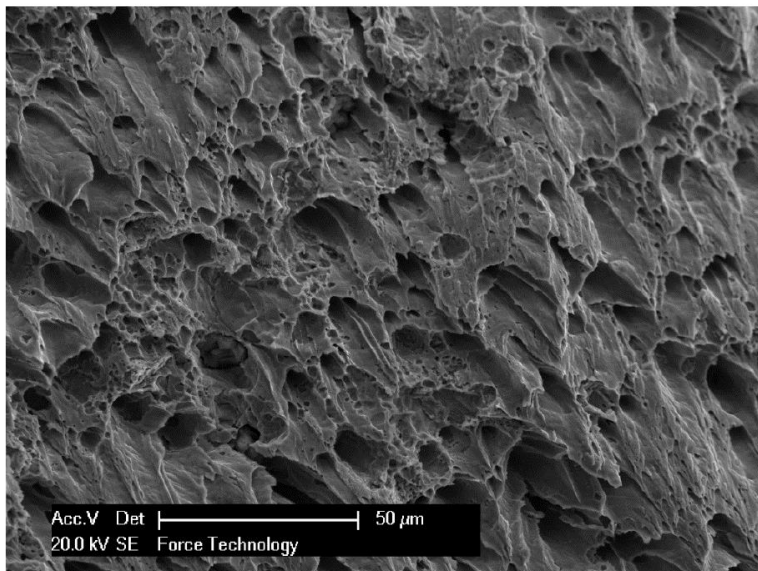
Figure 18 SEM micrograph of aft left hand steering rod fracture surface displaying ductile fracture confirmed by shear dimples.

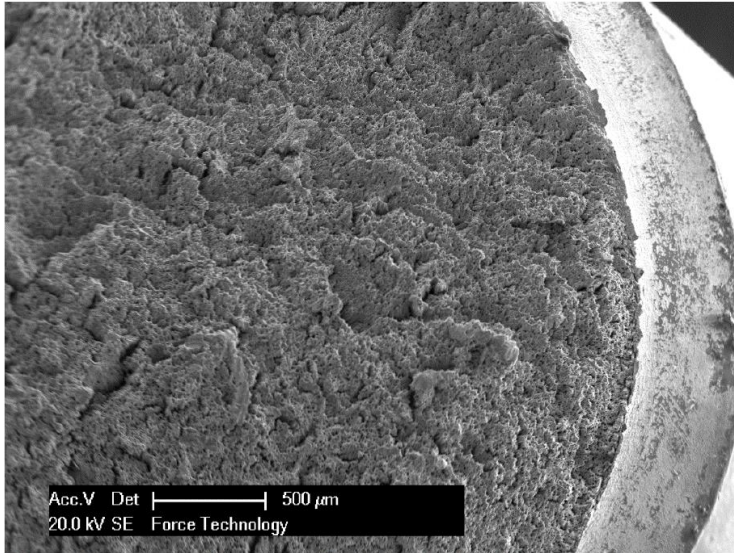
The aft right hand steering rod fracture surface, similarly to the before mentioned, exhibited ductile fracture confirmed by shear dimples cf. Figure 19. However, in contrast to the left forward and aft fracture surfaces, the orientation of the shear dimples is more tensile in orientation as opposed to a torsional deformation cf. Figure 20.

Figure 19 SEM micrograph of aft right hand steering rod fracture surface.

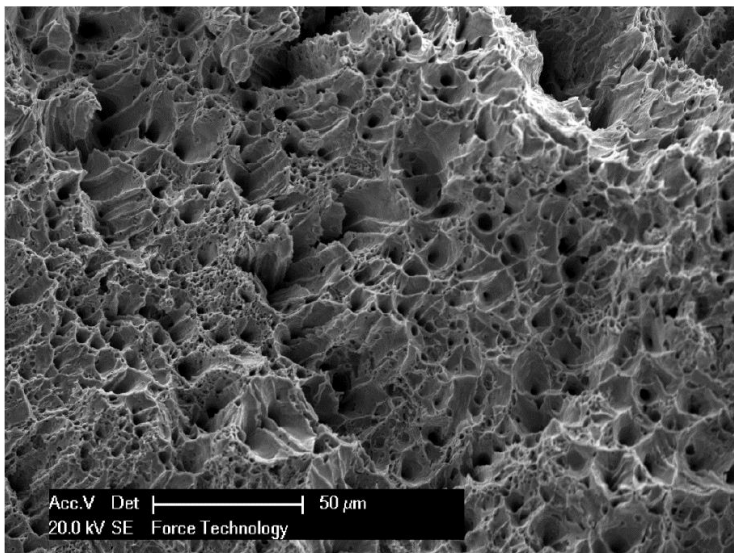
Figure 20 SEM micrograph of aft right hand steering rod fracture surface displaying ductile fracture confirmed by shear dimples.

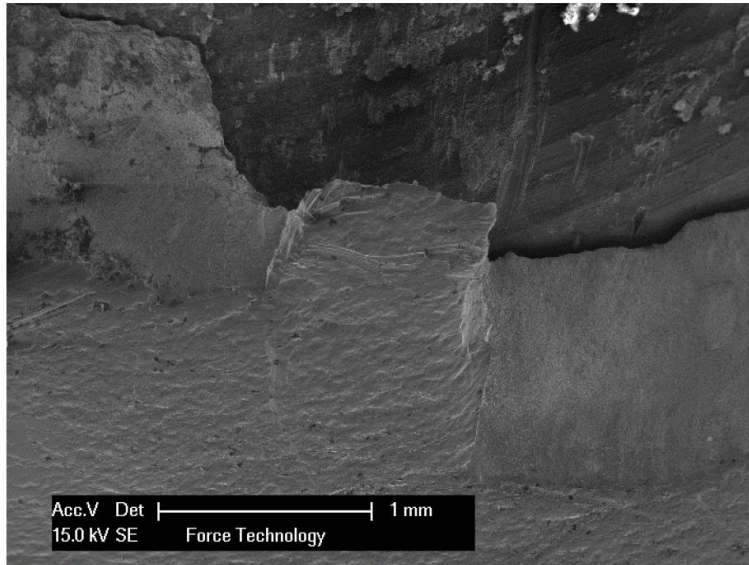
The nose wheel steering fork fracture surface was categorised as being the result of ductile fracture seen by a general shear dimple morphology in a tensile orientation at both the left and right sides of circumferential fracture surface c.f. Figure 21 - 23.

Figure 21 SEM micrograph of nose wheel steering fork fracture surface, location reference can be seen in Figure 14.

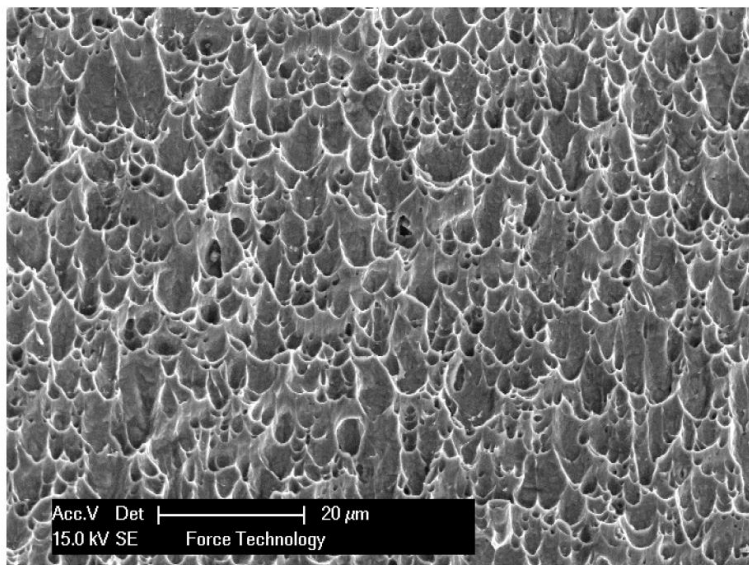
Figure 22 SEM micrograph of nose wheel steering fork right side fracture surface displaying ductile fracture confirmed by shear dimples.

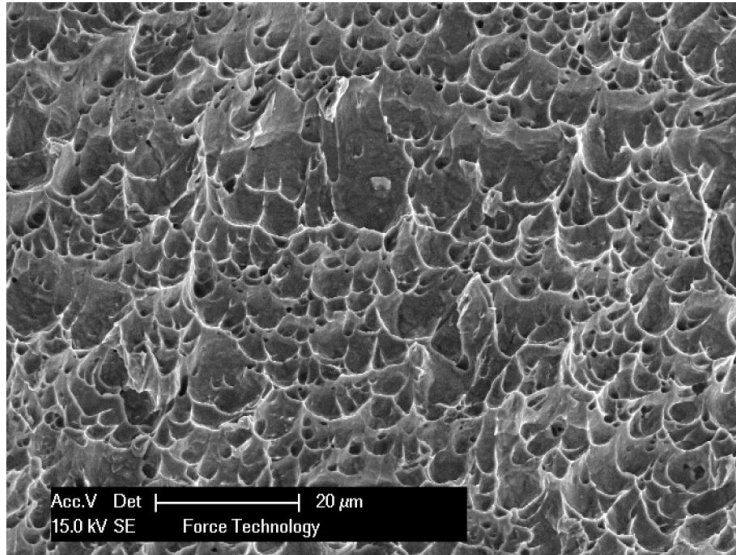
Figure 23 SEM micrograph of nose wheel steering fork left side fracture surface displaying ductile fracture confirmed by shear dimples.
