REDEGØRELSE

HCLJ510-000596	Havari		
Luftfartøj:	Robinson R44	Registrering:	OY-HHF
Motor:	Lycoming IO-540-AE1A5	Flyvning:	Skoleflyvning, VFR
Besætning:	1 – ingen tilskadekomst	Passagerer:	Ingen
Sted:	Københavns Lufthavn, Roskilde (EKRK)	Dato og tidspunkt:	23.10.2008 kl. 1618 UTC

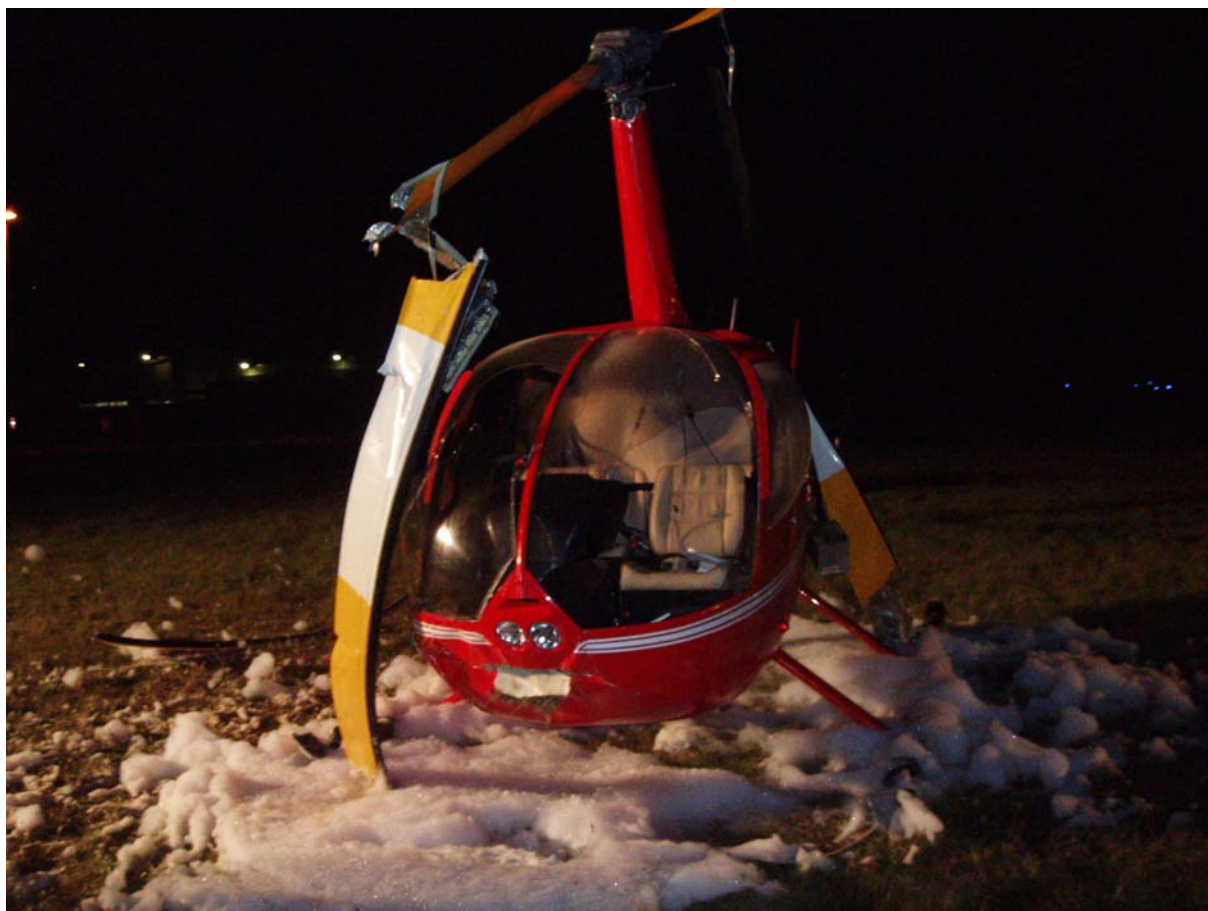
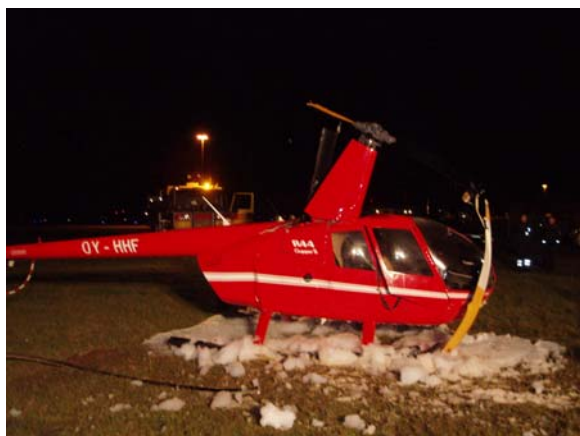
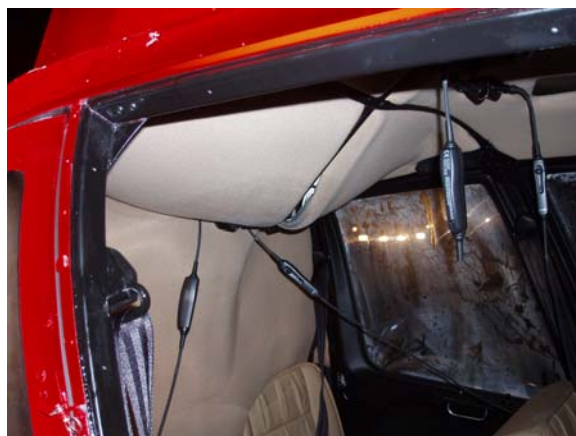
Skade på helikopteren

Helikopteren blev ødelagt ved havariet.

Helikopteren, der havde gyldigt luftdygtighedsbevis, blev undersøgt for tekniske fejl og mangler. HCLJ konstaterede på havaristedet ingen tekniske fejl eller skader, der ikke kunne relateres til havariet.

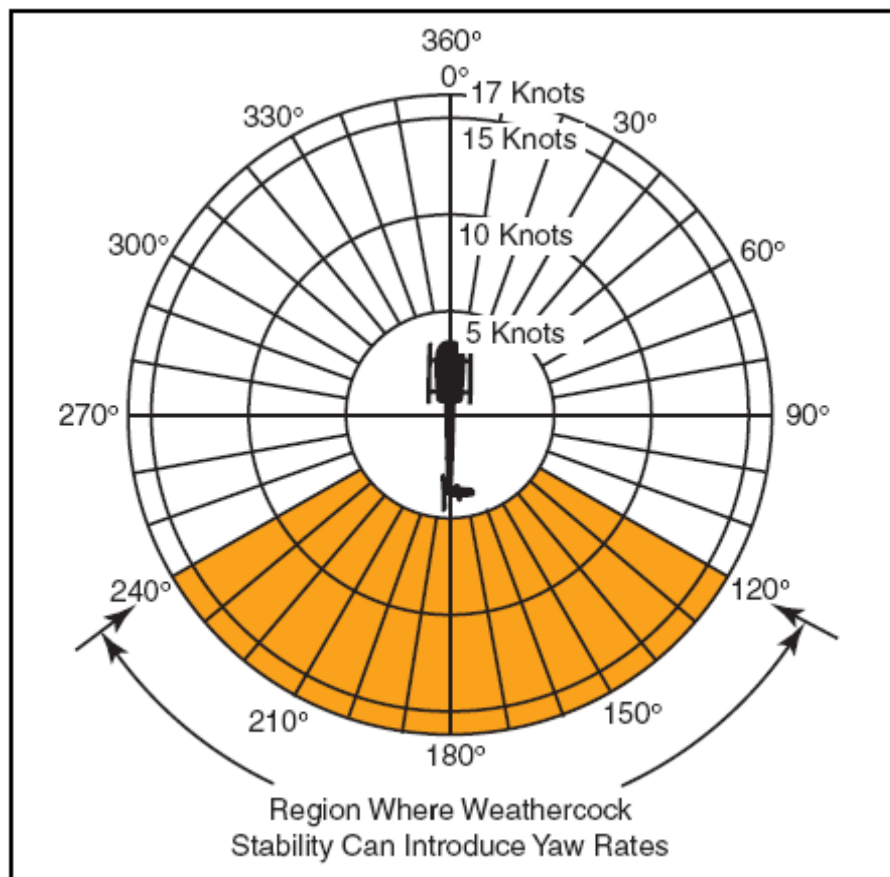
”(2) Weathercock stability (120” to 240”). (See figure below.)

(a) Tailwinds from 120’ to 240”, like left crosswinds, will cause a high pilot workload. The most significant characteristic of tailwinds is that they are a yaw rate accelerator. Winds within this region will attempt to weathervane the nose of the aircraft into the relative wind. This characteristic comes from the fuselage and vertical fin.

(b) The helicopter will make a slow uncommanded turn either to the right or left depending upon the exact wind direction unless a resisting pedal input is made. If a yaw rate has been established in either direction, it will be accelerated in the same direction when the relative winds enter the 120’ to 240’ area unless corrective pedal action is made.

(c) If the pilot allows a right yaw rate to develop and the tail of the helicopter moves into this region, the yaw rate can accelerate rapidly. It is imperative that the pilot maintain positive control of the yaw rate and devote full attention to flying the aircraft when operating in a downwind condition.

(d) The helicopter can be operated safely in the above relative wind regions if proper attention is given to maintaining control. If the pilot is inattentive for some reason and a right yaw rate is initiated in one of the above relative wind regions, the yaw rate may increase.

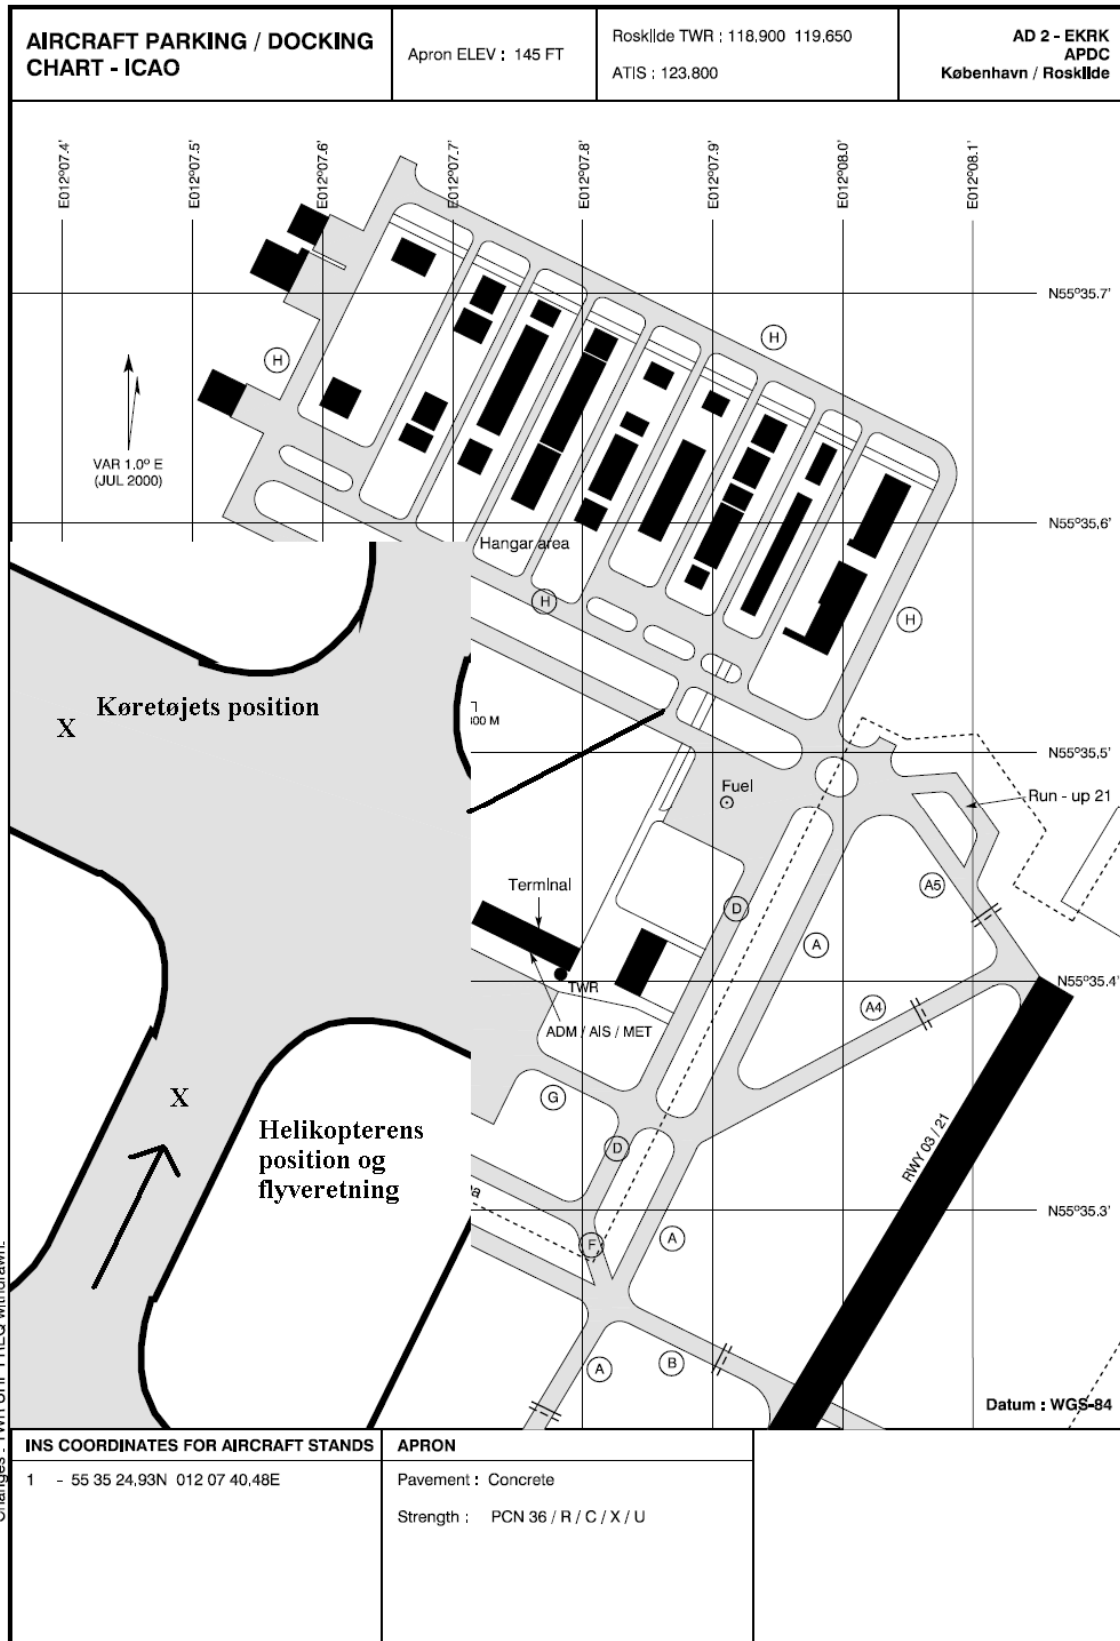
Bilag 1

Under air taxi i ca. tre meters højde på tværvejen mellem rullevej H og rullevej J observerede flyveeleven et køretøj, der med lygterne tændte holdt stille på rullevej H ca. 30 meter til venstre for helikopteren. Se bilag 1.

- Køretøjets tilstedeværelse på en rullevej, der ikke var godkendt som kørevej.
- Havariet indtraf i tussørke.
- Hover på tværvejen blev udført i medvind.

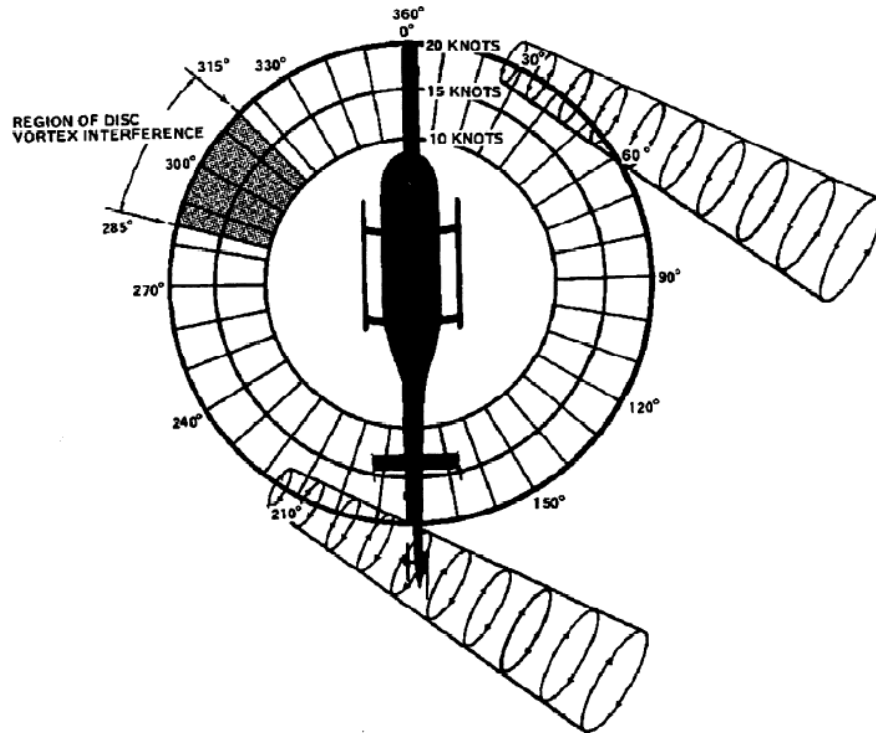
FIGURE 1. MAIN ROTOR DISC VORTEX INTERFERENCE

(a) Winds at velocities of about 10 to 30 knots from the left front will cause the main rotor vortex to be blown into the tail rotor by the relative wind. The effect of this main rotor disc vortex is to cause the tail rotor to operate in an extremely turbulent environment.

(b) During a right turn, the tail rotor will experience a reduction of thrust as it comes into the area of the main rotor disc vortex. The reduction in tail rotor thrust comes from the air flow changes experienced at the tail rotor as the main rotor disc vortex moves across the tail rotor disc. The effect

(d) As the main rotor vortex passes the tail rotor, the tail rotor angle of attack is reduced. The reduction in the angle of attack causes a reduction in thrust and a right yaw acceleration begins. This acceleration can be surprising, since the pilot was previously adding right pedal to maintain the right turn rate.

(e) This thrust reduction will occur suddenly and, if uncorrected, will develop into an uncontrollable rapid rotation about the mast. When operating within this region, the pilot must be aware that the reduction in tail rotor thrust can happen quite suddenly and the pilot must be prepared to react quickly and counter that reduction with additional left pedal input.

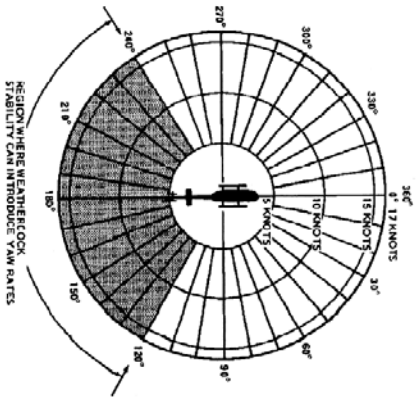
FIGURE 2. WEATHERCOCK STABILITY

(a) Tailwinds from 120° to 240°, like left crosswinds, will cause a high pilot workload. The most significant characteristic of tailwinds is that they are a yaw rate accelerator. Winds within this region will attempt to weathervane the nose of the aircraft into the relative wind. This characteristic comes from the fuselage and vertical fin.

(b) The helicopter will make a slow uncommanded turn either to the right or left depending upon the exact wind direction unless a resisting pedal input is made. If a yaw rate has been established in either direction, it will be accelerated in the same direction when the relative winds enter the 120° to 240° area unless corrective pedal action is made.

(c) If the pilot allows a right yaw rate to develop and the tail of the helicopter moves into this region, the yaw rate can accelerate rapidly. It is imperative that the pilot maintain positive control of the yaw rate and devote full attention to flying the aircraft when operating in a downwind condition.

(d) The helicopter can be operated safely in the above relative wind regions if proper attention is given to maintaining control. If the pilot is inattentive for some reason and a right yaw rate is initiated in one of the above relative wind regions, the yaw rate may increase.

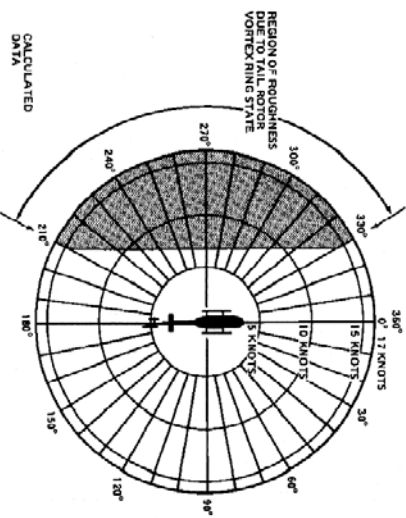
FIGURE 3. TAIL ROTOR VORTEX RING STATE

(a) Winds within this region will result in the development of the vortex ring state of the tail rotor. As the inflow passes through the tail rotor, it creates a tail rotor thrust to the left. A left crosswind will oppose this tail rotor thrust. This causes the vortex ring state to form, which causes a non-uniform, unsteady flow into the tail rotor. The vortex ring state causes tail rotor thrust variations which result in yaw deviations. The net effect of the unsteady flow is an oscillation of tail rotor thrust. This is why rapid and continuous pedal movements are necessary when hovering in left crosswind.

(b) In actuality, the pilot is attempting to compensate for the rapid changes in tail rotor thrust. Maintaining a precise heading in this region is difficult. LTE can occur when the pilot overcontrols the aircraft

(d) When the thrust being generated is less than the thrust required, the helicopter will yaw to the right. When hovering in left crosswinds, the pilot must concentrate on smooth pedal coordination and not allow an uncontrolled right yaw to develop.

(e) If a right yaw rate is allowed to build, the helicopter can rotate into the wind azimuth region where weathercock stability will then accelerate the right turn rate. Pilot workload during vortex ring state will be high. A right yaw rate should not be allowed to increase.
