**REDEGØRELSE**

| <i>HCLJ 510-2011-17</i> | | Registrering: | OY-NLA |
| Luftfartøj: | Cessna Citation 650 | Flyvning: | Taxaflyvning, IFR |
| Sted: | Københavns lufthavn, EKCH | | |

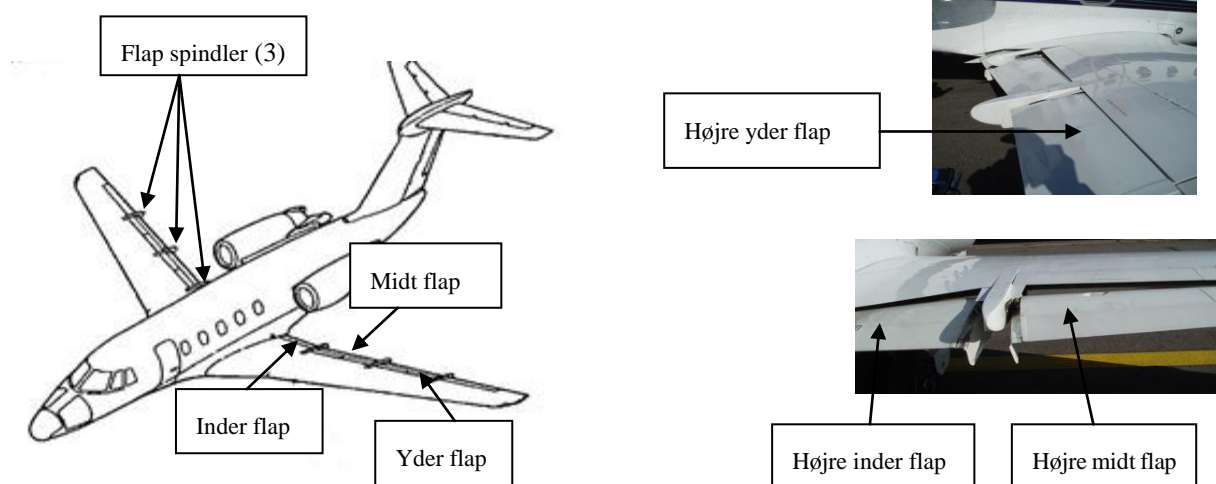
Denne flytype var udstyret med et flaps asymmetrisk system, som skulle stoppe flaps bevægelse, hvis der blev uoverensstemmelse med flap positionen mellem venstre og højre vingeflaps. Følerne (sensorerne) som registrerede uoverensstemmelse mellem venstre og højre flaps var placeret på de yderste flaps. Endvidere var luftfartøjet udstyret med et beskyttelsesystem, en elektrisk overbelastningssikring (current limiter) som skulle stoppe flaps bevægelse, hvis der blev for stor modstand i den mekaniske del af flapssystemet. Den ville samtidig tænde ”flaps inop ” lyset i cockpittet. Ingen af beskyttelsessystemerne havde stoppet flapbevægelsen umiddelbart og derved ikke forhindre at luftfartøjet kom i en kritisk flyvekontrol situation. Da begge yder flaps var oppe, havde det asymmetriske system ikke følt en difference på de øvrige flaps positioner og derfor ikke aktiveret beskyttelsessystemet og standset flaps. Fokus på den tekniske undersøgelse blev derfor koncentreret om, hvorfor den elektriske sikring til flapsmotoren havde aktiveret for sent.

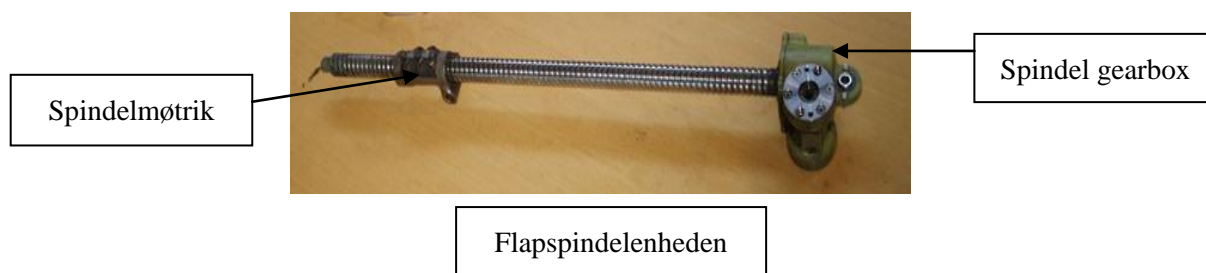
Ved undersøgelsen blev det konstateret, at højre inder flap og midter flap var mekaniske fastlåst ca. 20° fra flap op positionen. Højre yder flap var kørt til op position, det samme gjaldt venstre vinges inder - midt -og yder flaps.

Det blev afdækket at højre flapspindel (ballscrew), som var forbundet med en spindelmøtrik (ballscrew nut) til højre del af højre inder flap og venstre del af højre midt flap ikke kørte når flapsystemet blev aktiveret. Det kunne endvidere konstateres, at flapsystemet kørte let og den mekaniske modstand var indenfor fabrikantens specifikationer.

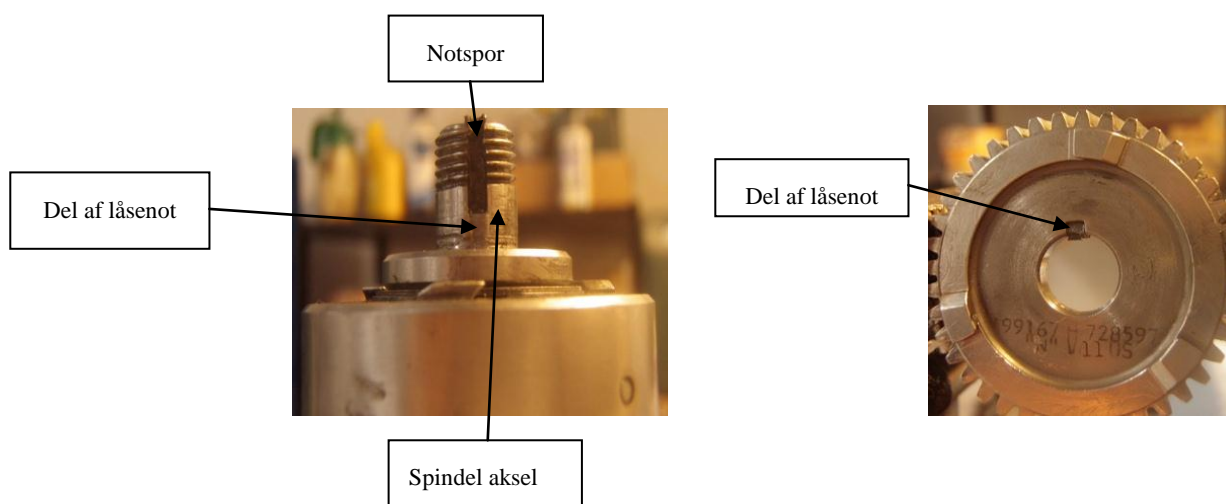
Ved adskillelsen af spindel gearboxen blev det konstateret, at gearboxen var velsmurt og fedtet var af god kvalitet. Det kunne afdækkes at tandhjulet som overførte flapsystemets bevægelse til flap spindelen kunne drejets, uden at spindelen fulgte med.

Tandhjulet blev demonteret fra spindel akselen og det kunne afdækkes at låsenoten som låste tandhjulet med spindel akselen var knækket.

Brudfladen på låsenoten viste tegn på overbelastningsbrud. Da flapsene kunne køre frit uden nævneværdig modstand, blev flapspindlen og flapspindelmøtrikken undersøgt for general slidtage. Det kunne konstateres visuelt, at frigangen (freeplay) var anseelig både aksialt og radially. I flapspindelmøtrikken var der et antal stålkugler som overførte rotationskræfterne fra spindelrotationen i flapspindelmøtrikken til bevægelse af flapsene.

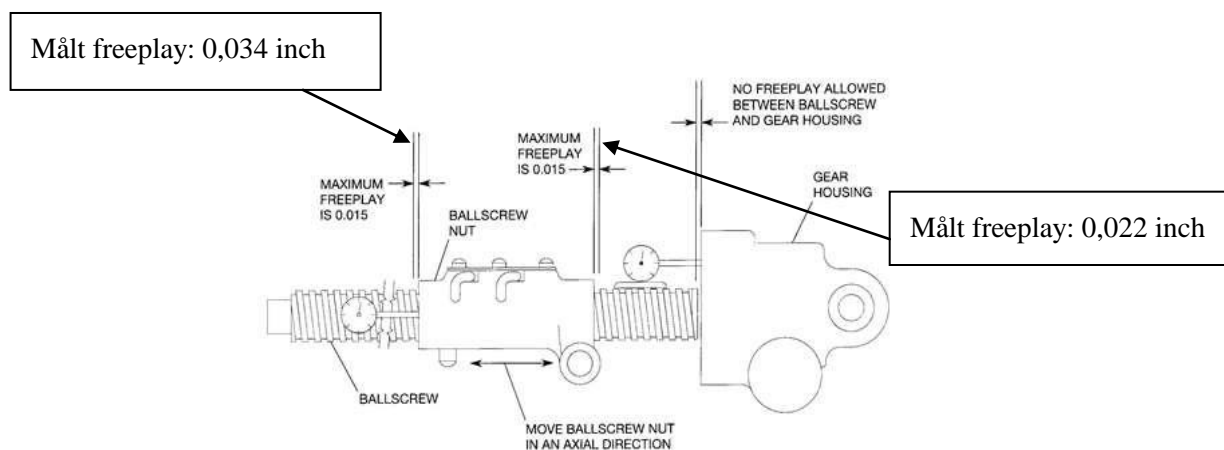
I. H. T. fabrikantens forskrifter var maksimum tilladte aksial freeplay mellem flapspindel og flapspindelmøtrikken 0,015 inch (0,385 mm). Udmålingen af freeplay afdækkede et aksialt freeplay, henholdsvis væk fra gearboxen på 0,022 inch (0,57 mm) og i modsat retning 0,034 inch (0,870 mm). Et radiale freeplay var tilladt, hvis det aksiale freeplay var indenfor fabrikantens begrænsninger (0,385mm). Der blev ikke konstateret freeplay mellem flapspindlen og gearboxen.

Undersøgelsen af flapsystemet afdækkede at flapspindelen og flapspindelmøtrikkens freeplay var væsentlige over de i fabrikantens foreskrevne begrænsninger. Det er Havarikommissionens vurdering at flapspindelmøtrikken havde sat sig fast i flapspindlen ved begge hændelser. Ved den første hændelse havde current limiteren fungeret korrekt og deaktiverede hele flaps bevægelsen på grund af for stor modstand i flapsystemet. Ved den anden hændelse satte flapsmøtrikken sig fast igen, men forårsagede samtidigt at låsenoten mellem tandhjulet og spindelen i gearboxen blev revet over. Den kortvarige modstand i flapsystemet hvor flapsmøtrikken havde sat sig fast, til at låsenoten blev brudt var ikke nok til at aktivere current limiteren. Current limiteren havde først aktiveret, da højre inder flap kørte skævt op med den inderste flapspindel, så flapsen gik fast i vingestrukturen og flapspererne (flap track)
