ACCIDENT INVESTIGATION REPORT

AIRCRAFT ACCIDENT REPORT 02/2008

Bell 212, A6-ALV

Rashid Drilling Rig, MAERSK RESILIENT

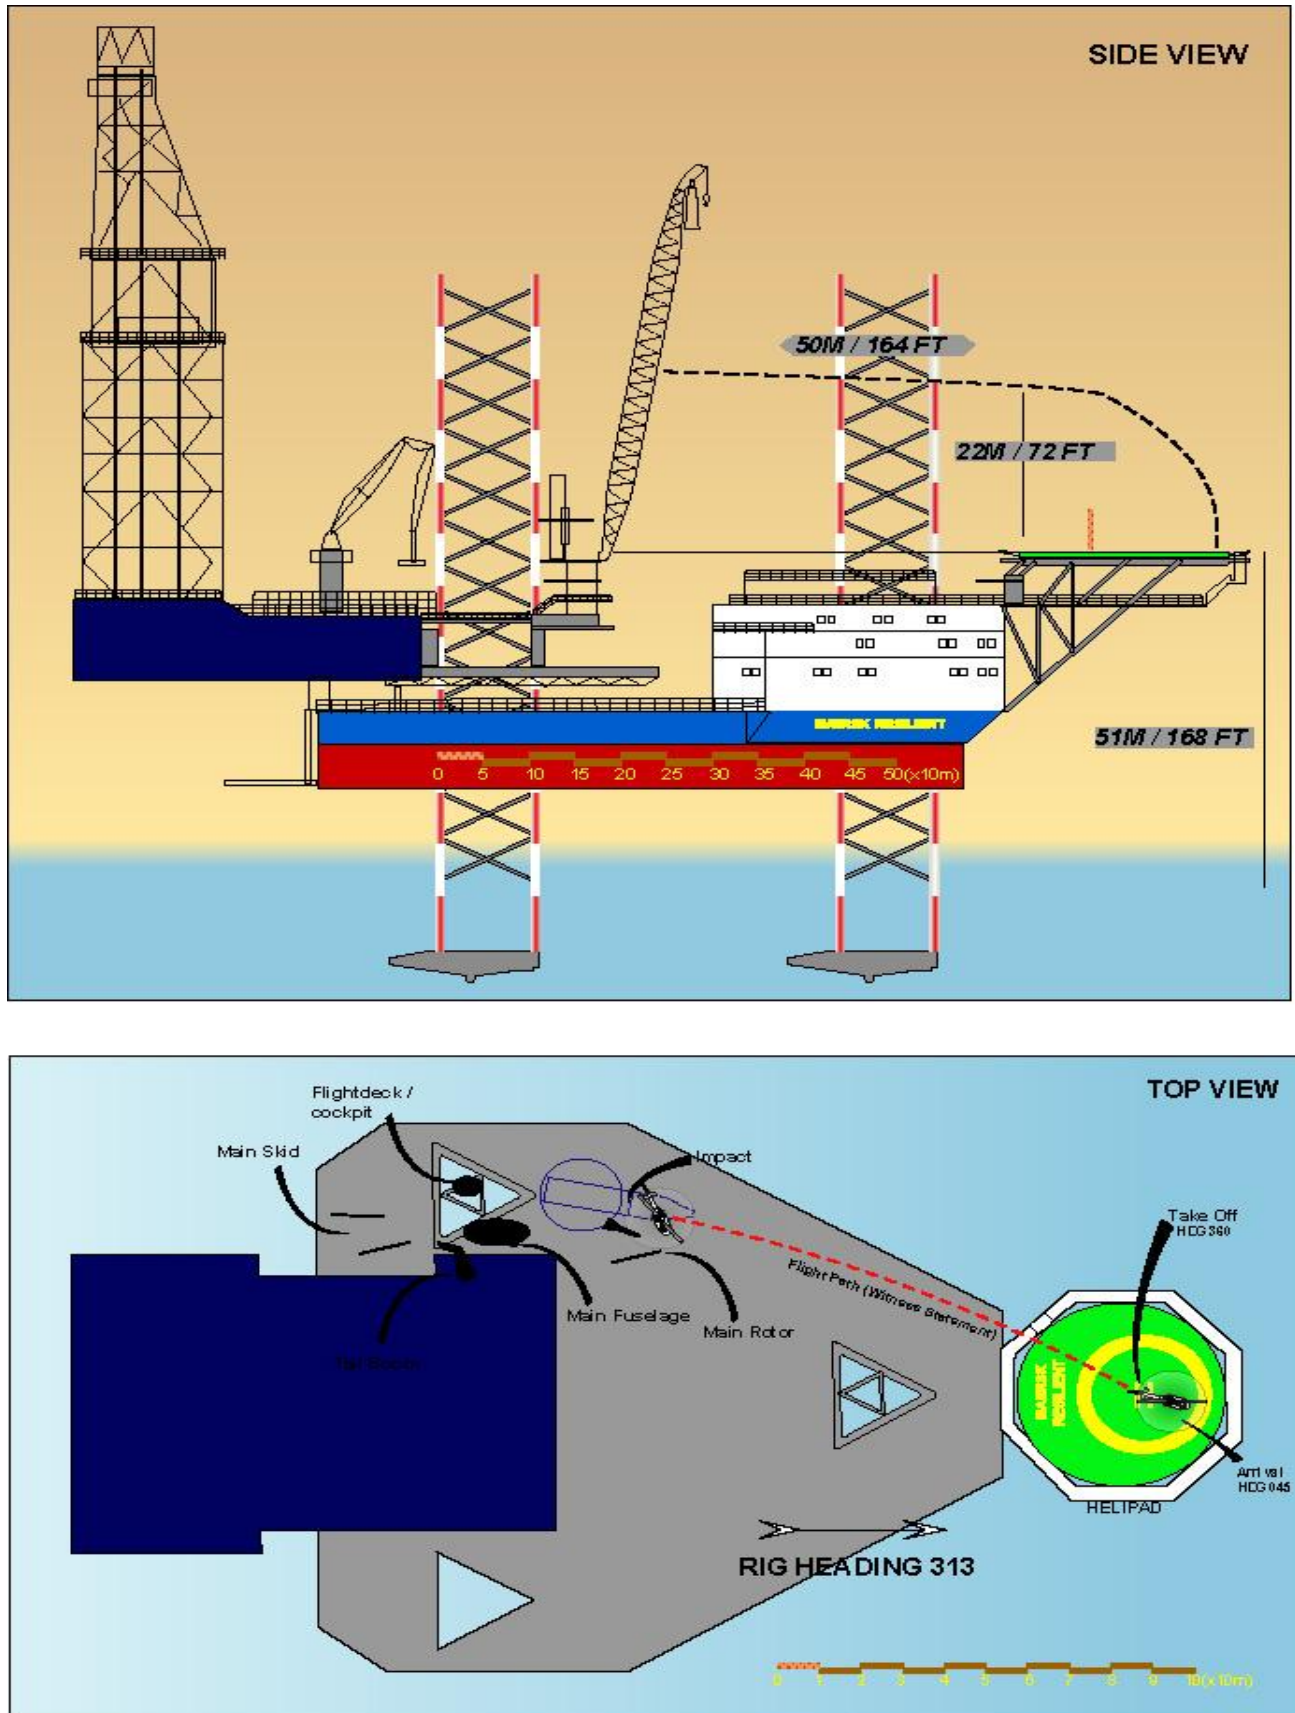
Figure 1 (approximate flight path and approximate location of main wreckage)

Whilst the Helicopter flew towards the Rig it received clearance from the Rig Radio Room to approach and land on the landing area. From eyewitnesses' statements, the Helicopter crew, after given signals from the HLO, landed on the Maersk Resilient's landing area (see figure 1), at an approximate heading of approximately 045 degrees, without any reported anomalies. The pilot gave "thumbs-up" signal to the HLO for him and his assistants to approach the Helicopter. The freight was unloaded, the Helicopter's doors were closed and then the HLO gave "thumbs-up", as per the company's procedures, indicating that the Helicopter was cleared to depart. The Helicopter then lifted off approximately two meters vertically, and stayed in hover for two to three seconds, then turned counter clockwise approximately 180 degrees having the landing area behind it. The Helicopter subsequently climbed at take off power to a height of approximately twenty two meters while travelling backwards, in reverse, for approximately fifty meters. Whilst moving backwards, the main rotor blades collided with the vertical crane of the Drilling Rig, broke up and fell down into two major fuselage pieces, with one of the pieces falling onto the exhaust pipes from the port engine room of the Rig. The other major fuselage piece containing the cockpit area separated from the main wreckage and became submerged after falling through the centre of the rear jackup leg (see Figure 1).

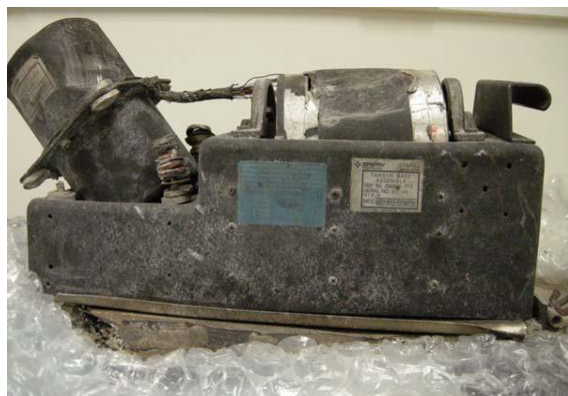
Figure 2- Tarsyn – 333 Three Axis Reference P/N 2593996-333, S/N: 6093099

The two Tarsyns – 333 Three Axis Reference could not be identified to each position (Pilot or Copilot).

All instruments were disassembled and inspected for signs relating to the instruments' operation. Corrosion and rust were found on many internal parts. All gyro rotors inside the instruments were inspected for signs of rotor rotation and at least some evidence suggesting rotation was found on each. The rotor P/N 4019190-13, S/N 6093099 which was fitted to the Tarsyn – 333 Three Axis Reference P/N 2593996-333, S/N: 6093099 (the left upper corner of figure 5) contained non-rotational marks that were not found on the other rotors.

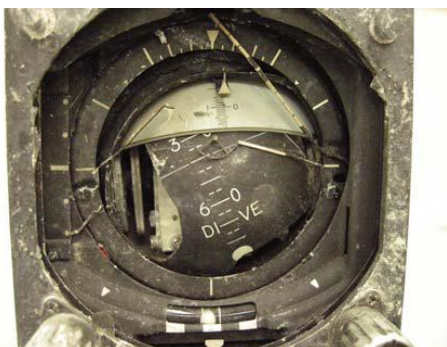
Figure 6- Pilot ADI (P/N: 2593996-333, S/N 0050220)

The pilot and co-pilot ADI's were further inspected for signatures of their positions at impact. The roll carriages for both ADI's were jammed in their position by deformed surrounding structure. Approximate attitude positions at impact were developed using these roll positions and other witness marks found on each unit. For the pilot ADI, these indications are consistent with approximately 3 degrees right roll attitude and between 0 and 10 degrees aircraft nose down pitch attitude. For the co-pilot ADI, the marks are consistent with a roll attitude of approximately 5 to 10 degrees left roll and a pitch attitude between 0 degrees and 15 degrees aircraft nose up. For the standby ADI, the marks are consistent with a roll attitude of approximately 3 degrees right roll. A pitch attitude for the standby ADI could not be determined.
