Air Accident Investigation Sector - Final Incident Report -

AAIS Case File 14/2011

Tire Burst during Landing

Boeing 777-300

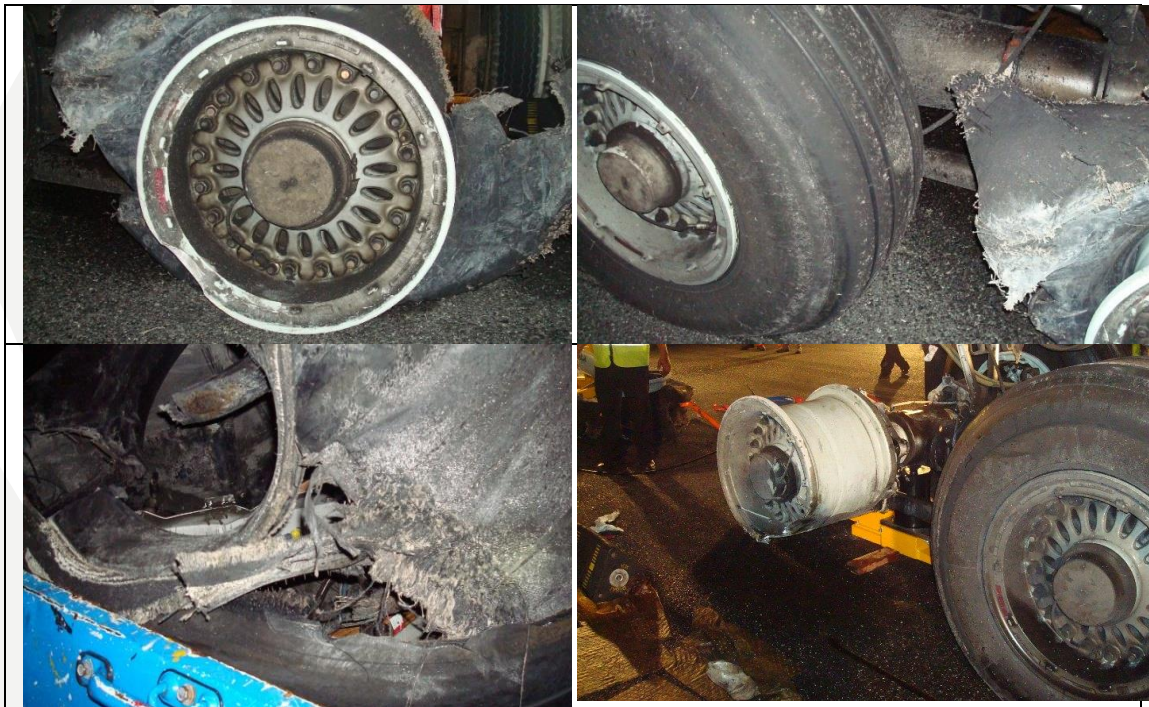
Another crew confirmed that there was debris at the beginning of runway 36. The ATCO (Tower) was informed at which time the ground maintenance crew was approaching the B777. The ground engineer informed the crew that the Left Hand Main Landing Gear tires 1 and 2 had separated from the wheel hubs and that there was other damage to the MLG.

Figure 1. Photos indicating the condition of the landing gears' hubs and tires at Male airport prior to removal from the aircraft.

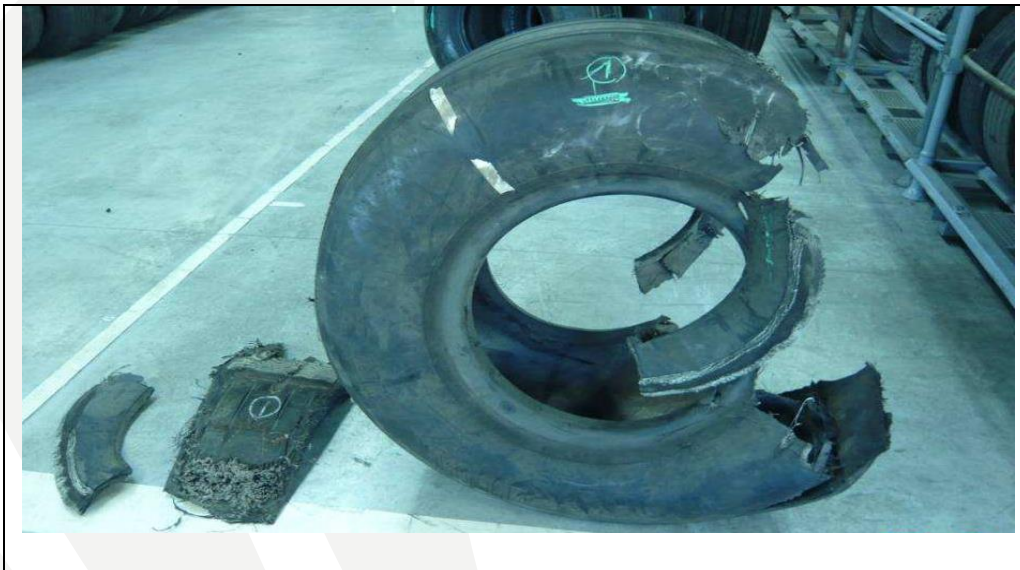
Photo 1. Tire position 1

A large part of the tire (approximately a quarter of the circumference) was missing (see photo 1). On the larger tire piece (see photo 2), the wrenching/tearing of all the crown plies (textile & metallic) were visible.

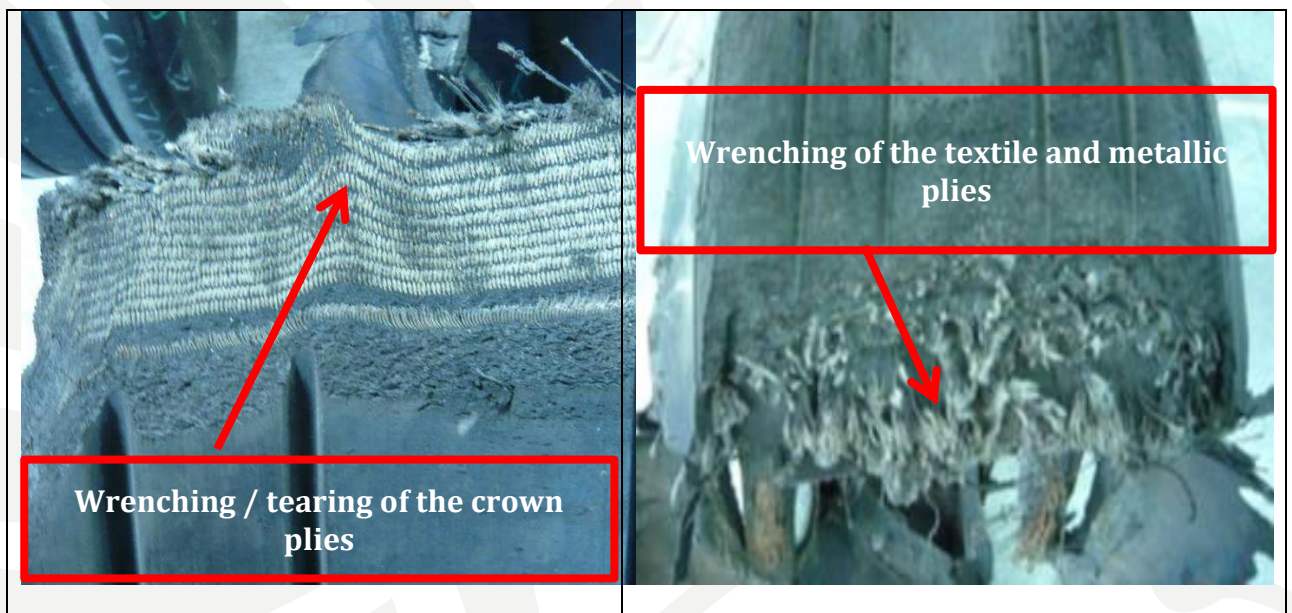
Photo 2. The two sides of the same torn portion Tire position 1

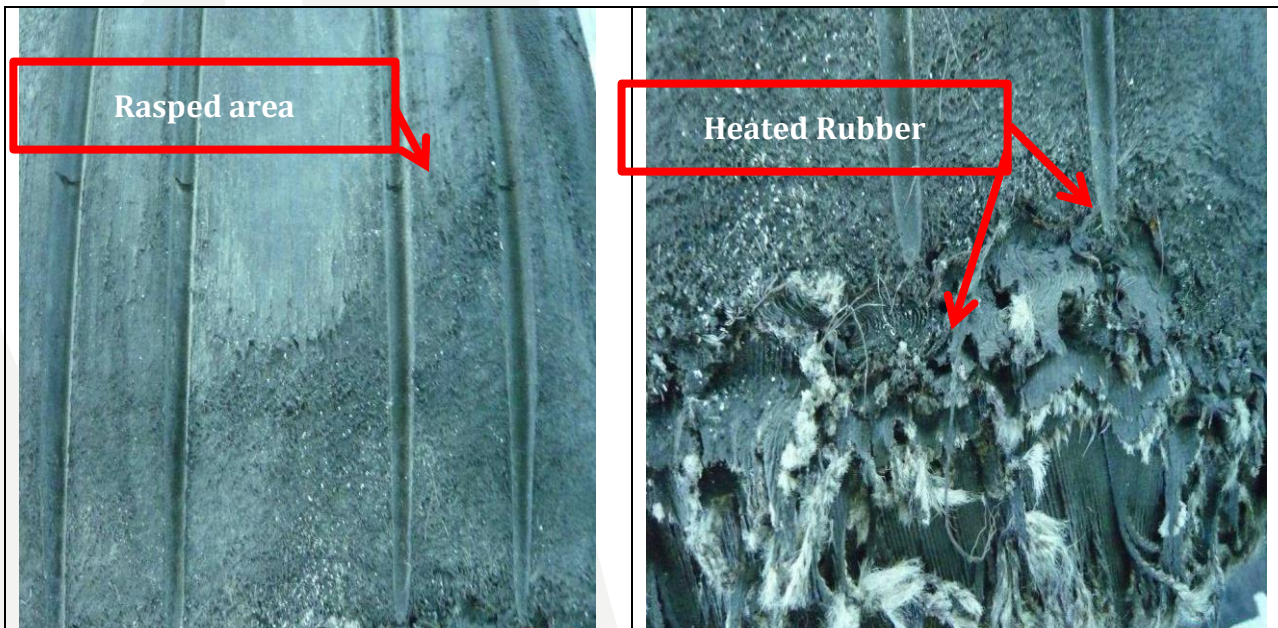
On both sides of this damaged area, the rubber exhibited locally a signature of high temperatures with marks of rasped areas on the tread (photo 3).

Photo 3. High Temperature signature on Tire position 1

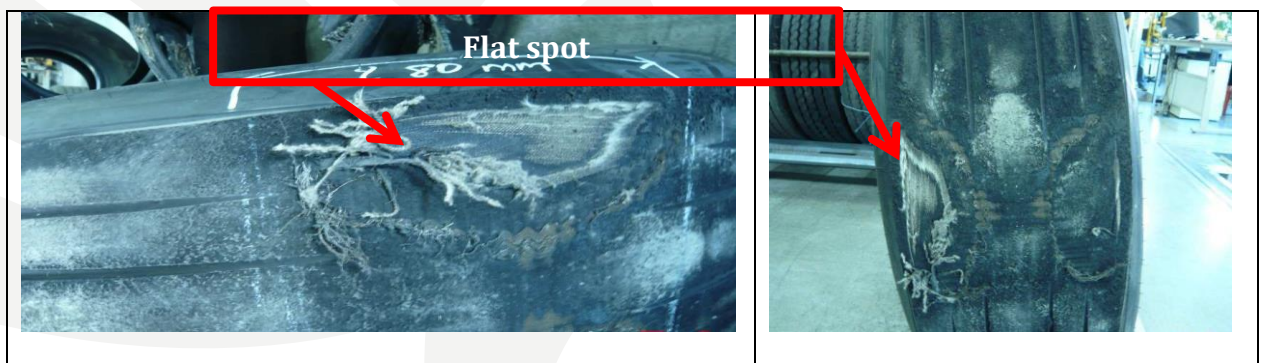
A second area of flat spotting, 280 mm long, is visible on the tread of the tire with tearing down to the crown plies (see photo 4).

Photo 4. Flat Spot on Tire position 1

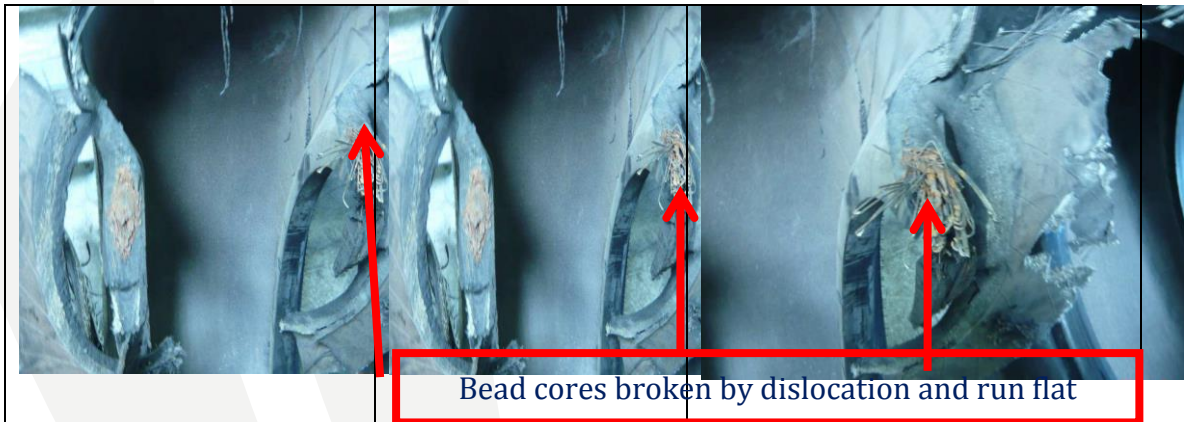
The dislocation of the tire was major with the beads ruptured and worn through on a quarter of the circumference (see photo 5).

Photo 5 Bead Cores broken tire position 1

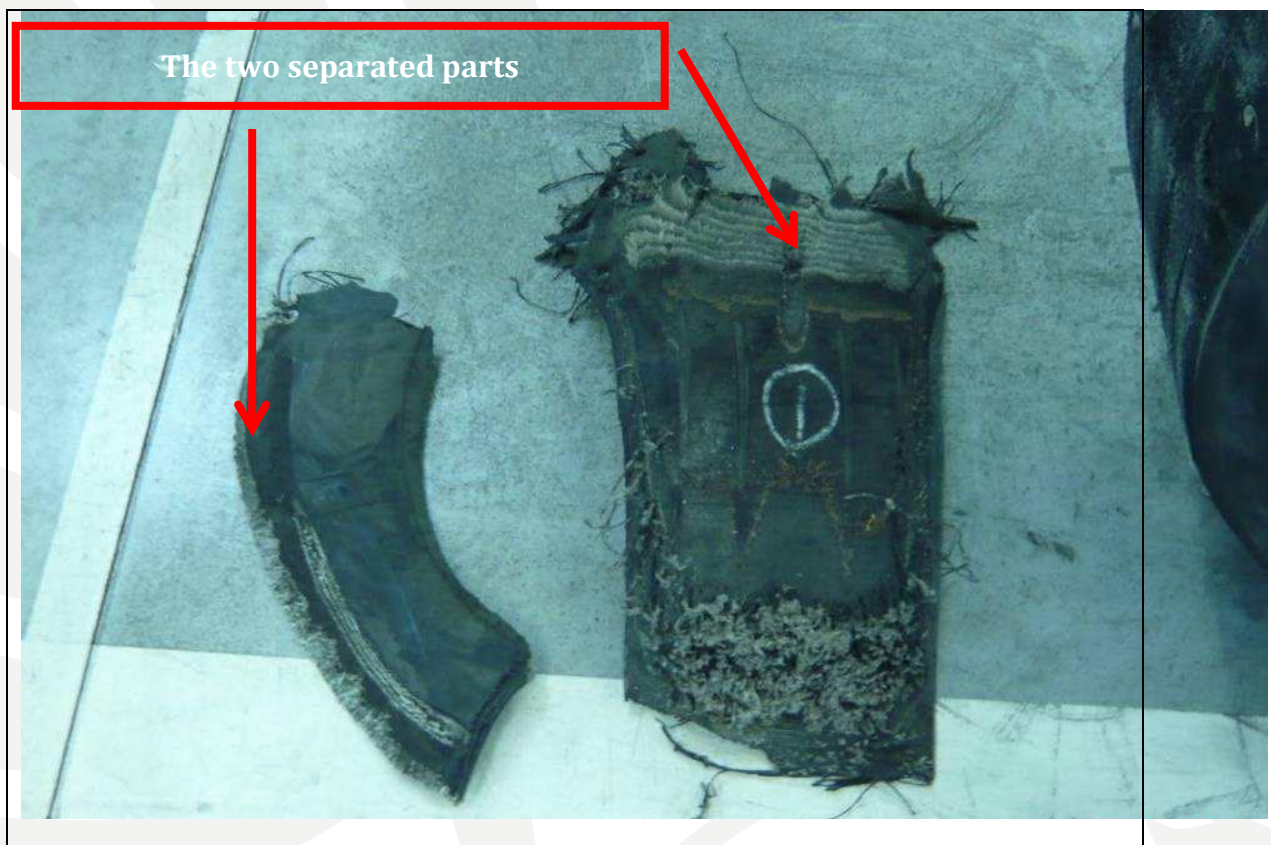
The two other pieces (photo 6) separated from the tire during the dislocation.

Photo 6. The two small parts of the three recovered of the tire position 1.

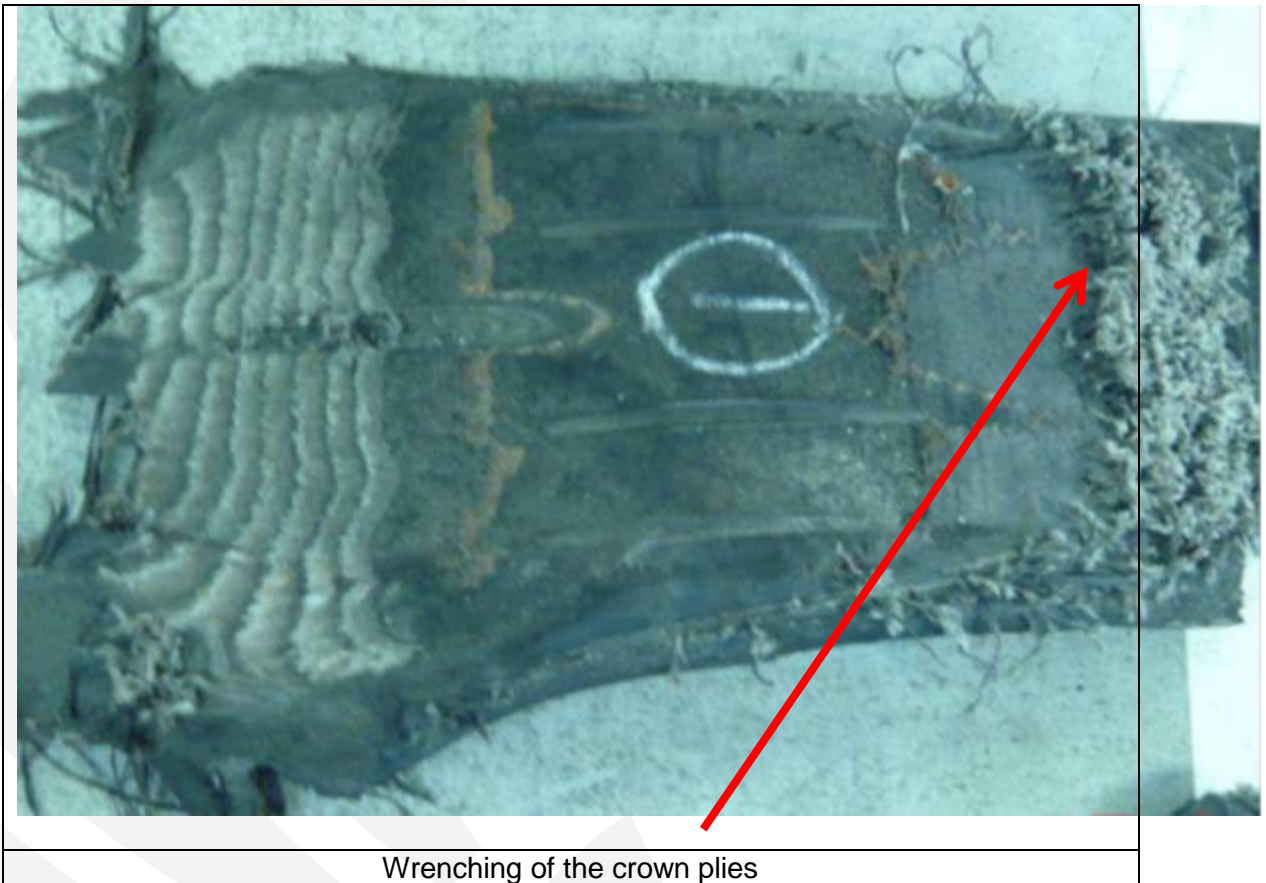
One of these tires recovered parts also shows some tearing of the crown plies (photo 7).

Wrenching of the crown plies

Photo 7. Detail of one part of the two dislocated parts Tire position 1.

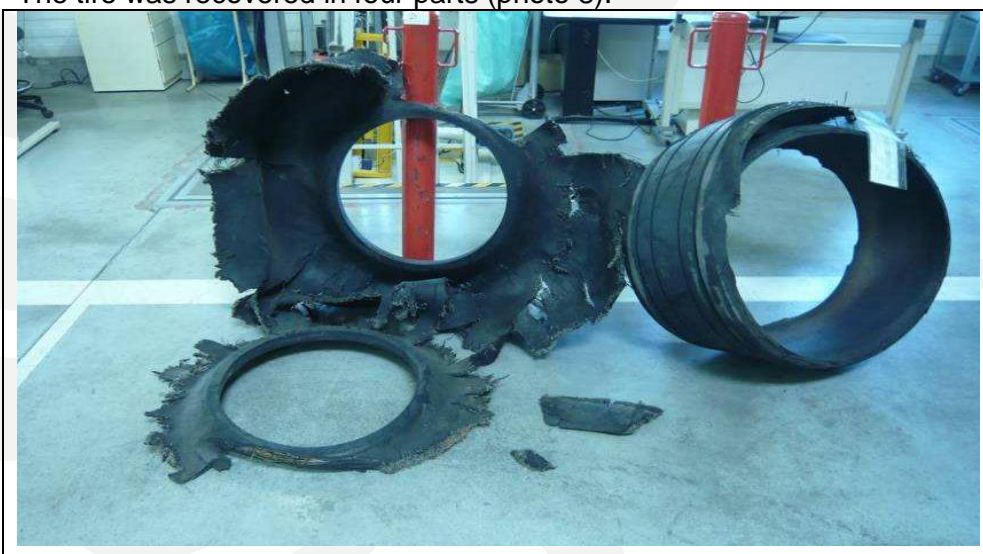
SN: 0357S047 (position n°2):
The tire was recovered in four parts (photo 8).

Photo 8. Tire position 2 broken in four parts.

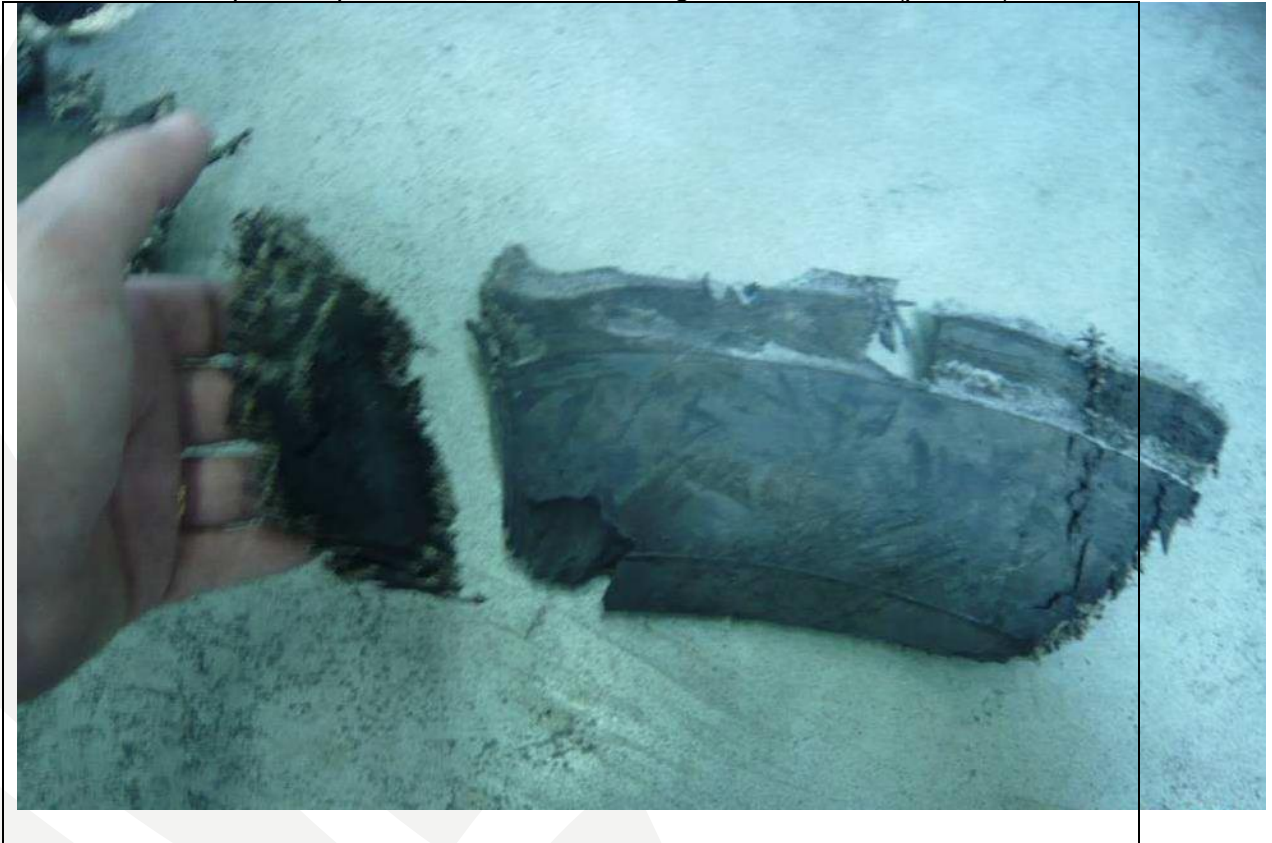
The two smaller parts separated from the tire during the dislocation (photo 9).

Photo 9. The two smaller parts of Tire position 2.

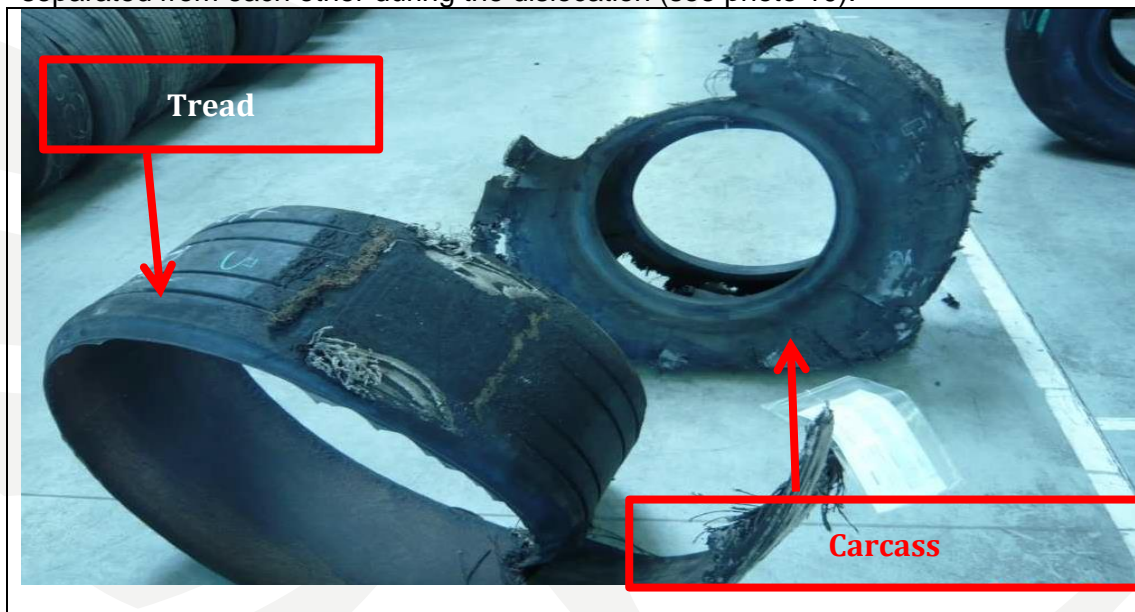
The two larger parts are the tread package and the tire carcass which were separated from each other during the dislocation (see photo 10).

Photo 10. The two large parts of Tire position 2.

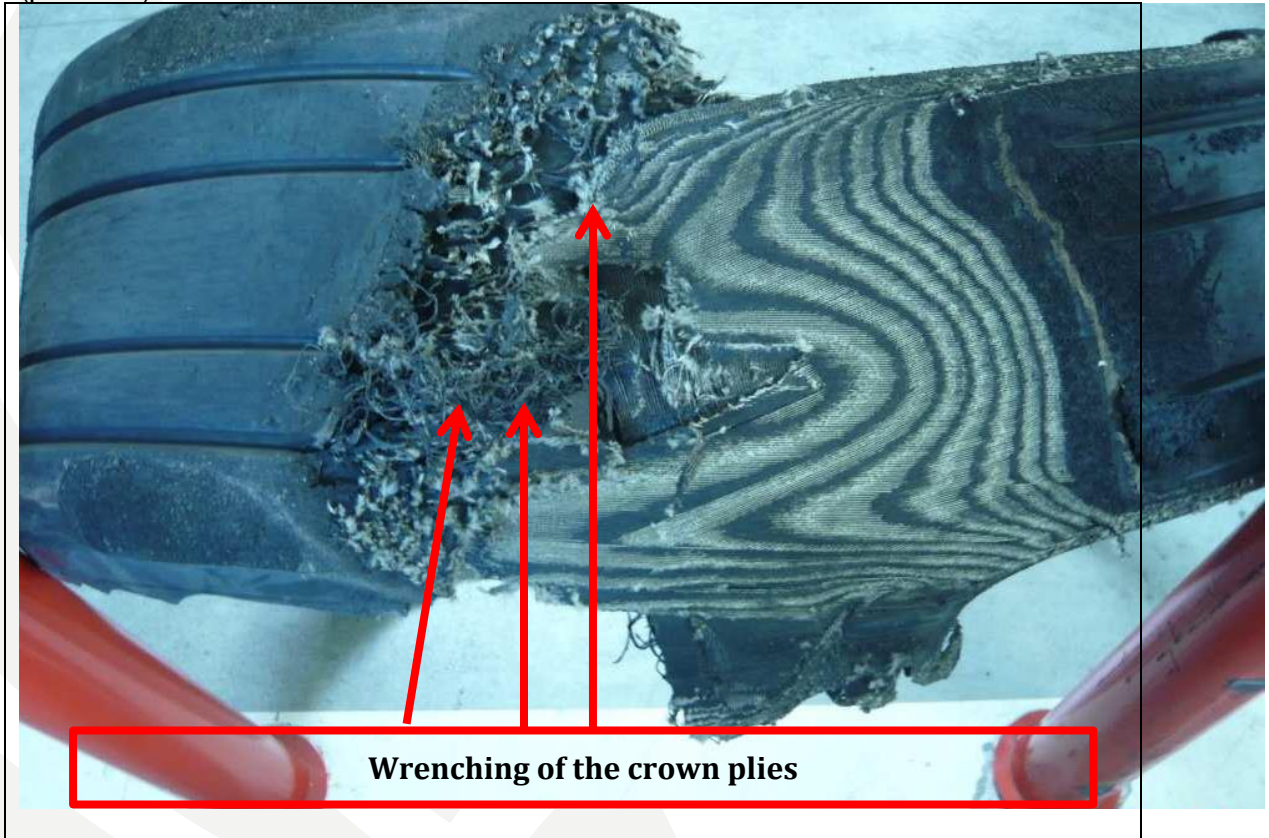
The tread has a radial rupture with tearing down to the crown plies (textile & metallic) (photo 11).

Photo 11. Tear down of the crown plies, Tire position 2.

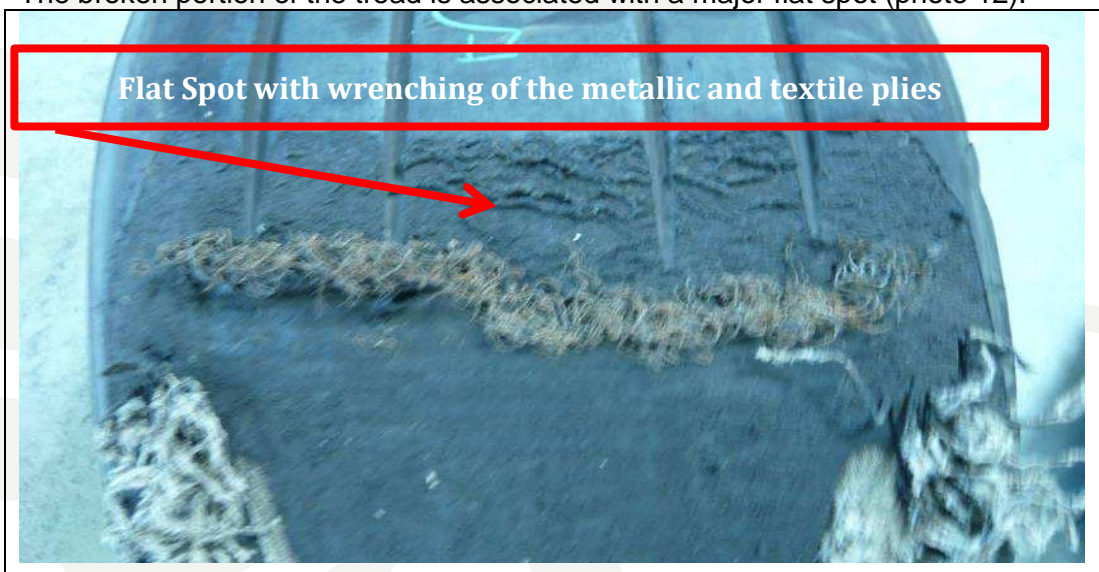
The broken portion of the tread is associated with a major flat spot (photo 12).

Photo 12. Flat spot, Tire position 2.

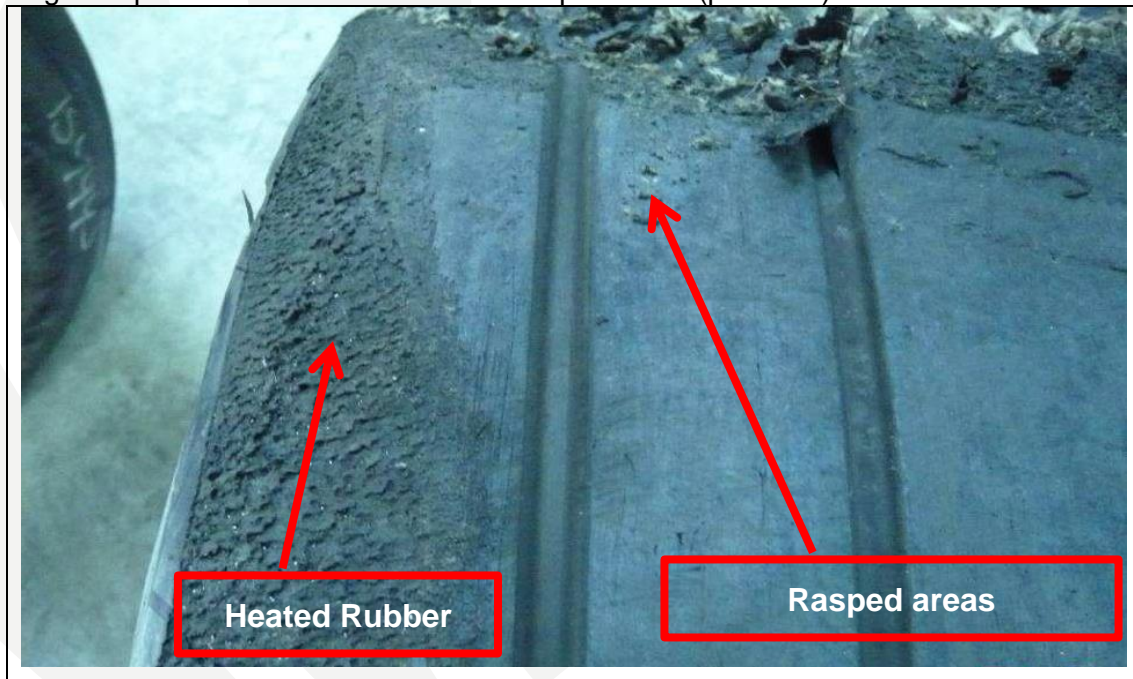
Another large flat spot area, 405mm long, with wrenching of the crown plies was also visible on the tread. In both flat spot areas, the rubber exhibits locally a signature of high temperatures with clear marks of rasped areas (photo 13).

Photo 13. Flat Spot heated areas Tire position 2.

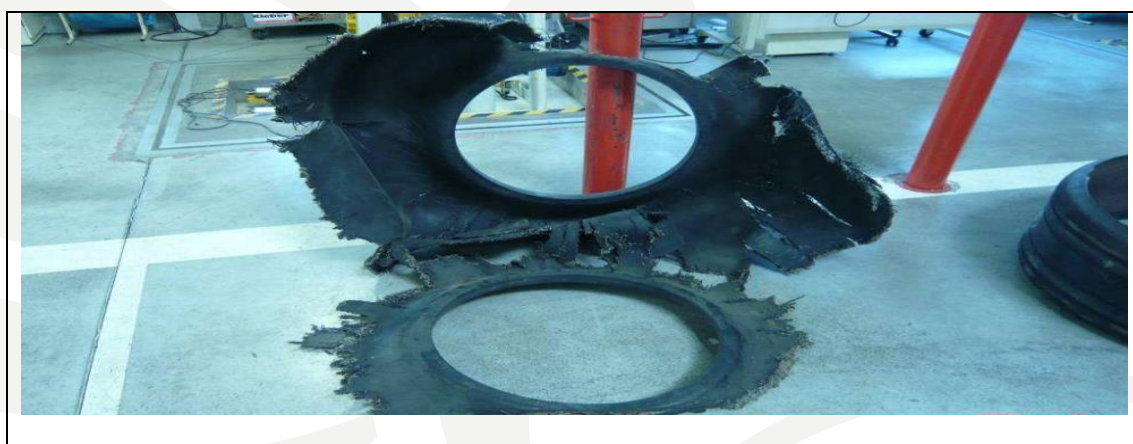
A total dislocation of the carcass of the tire is observed with broken bead cores (photo14).

Photo 14. Total dislocation, Tire position 2.

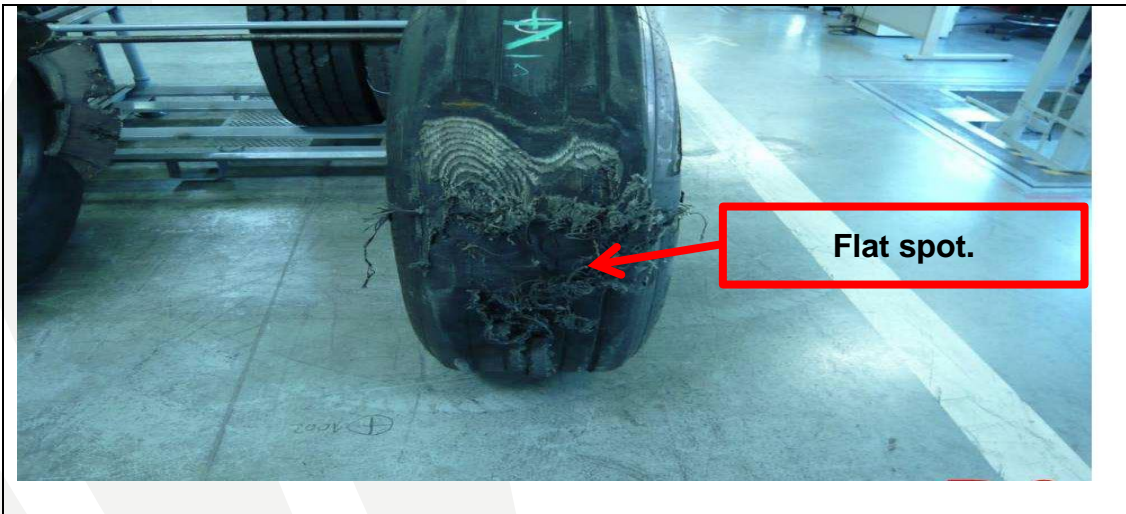
The tire is ruptured in the center of the tread at a 700 mm long flat spot area. This rupture reaches the crown plies.

Photo 15. 700 mm long flat spot, Tire position 5.

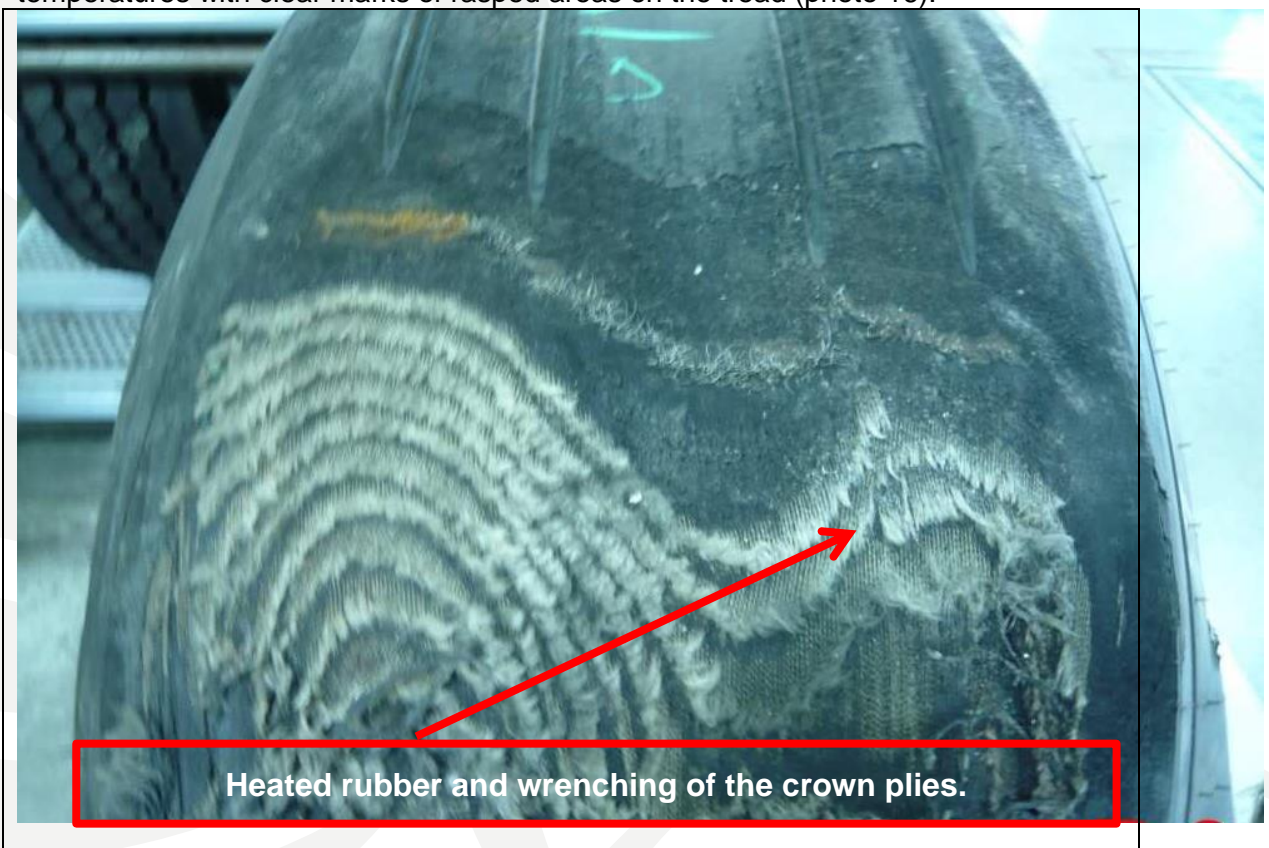
On both sides of this area, the rubber exhibits locally a signature of high temperatures with clear marks of rasped areas on the tread (photo 16).

Photo 16. Flat Spot heated rubber, Tire Position 5.

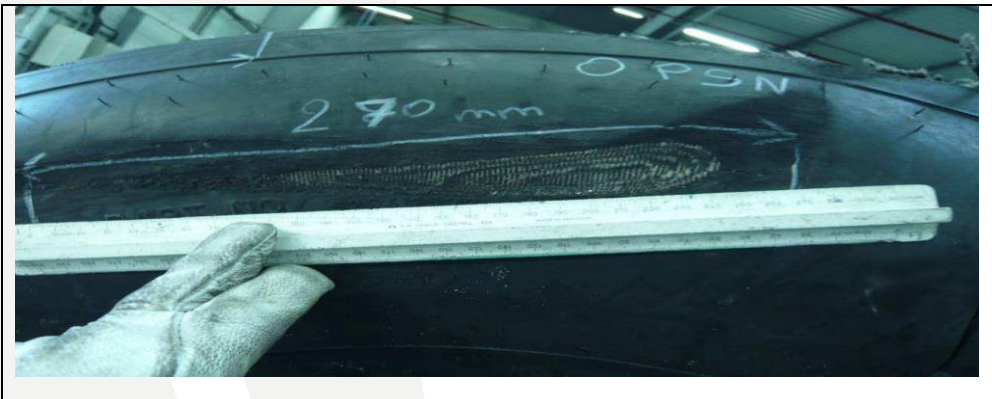
On the two sidewalls near the rupture there are two depressions probably caused by the run flat opposite serial number side: 270 mm long with a width of 30 mm (photo 17).

Photo 17. Opposite serial Number friction cut, Tire Position 5.

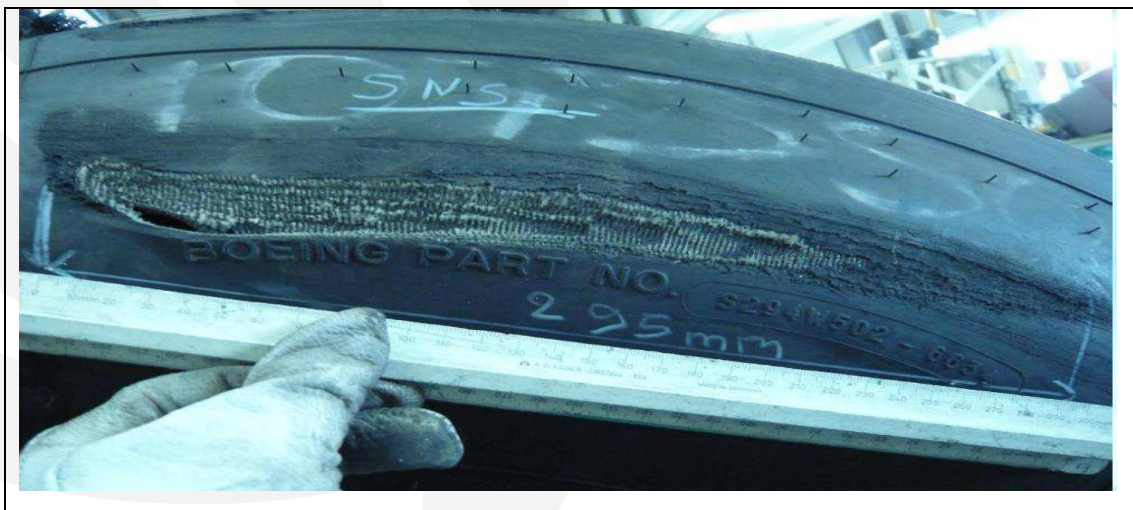
- Serial number side: 295 mm long with a width of 30 mm (photo 18).

Photo 18 Sidewall on the serial number side friction cut, Tire Position 5.

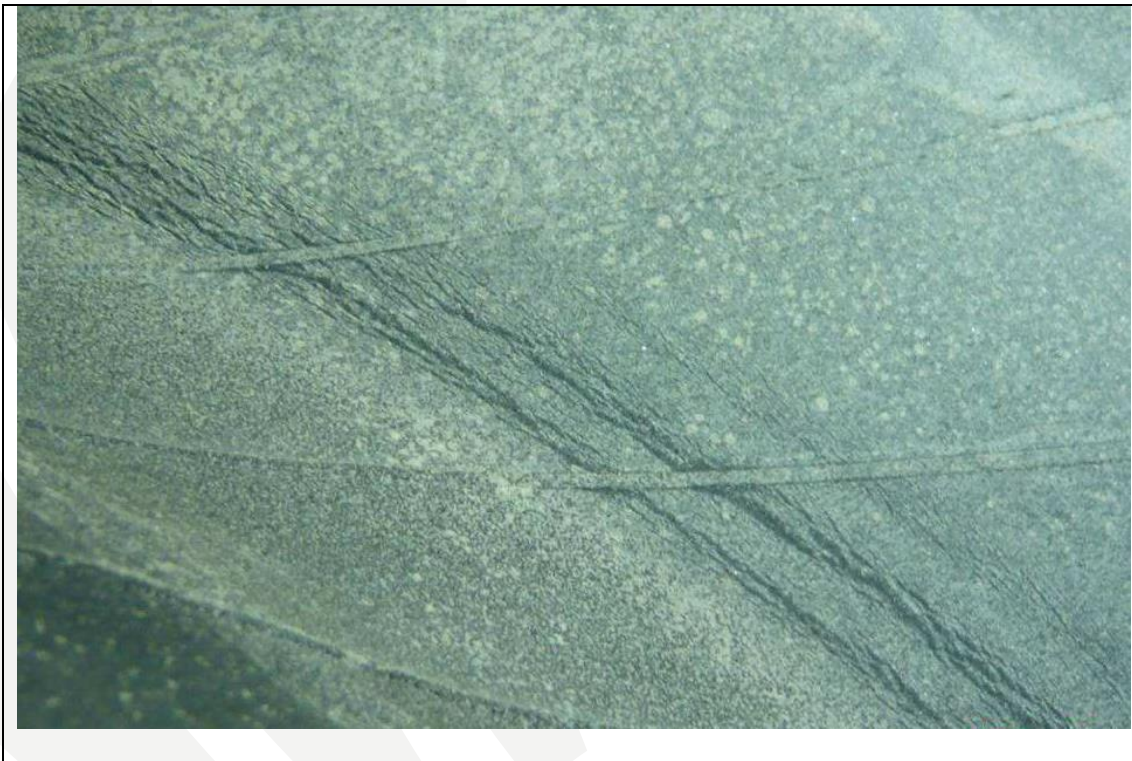
Wrinkles were also visible on the inner liner (photo 19).

Photo 19 Wrinkles, Tire Position 5.

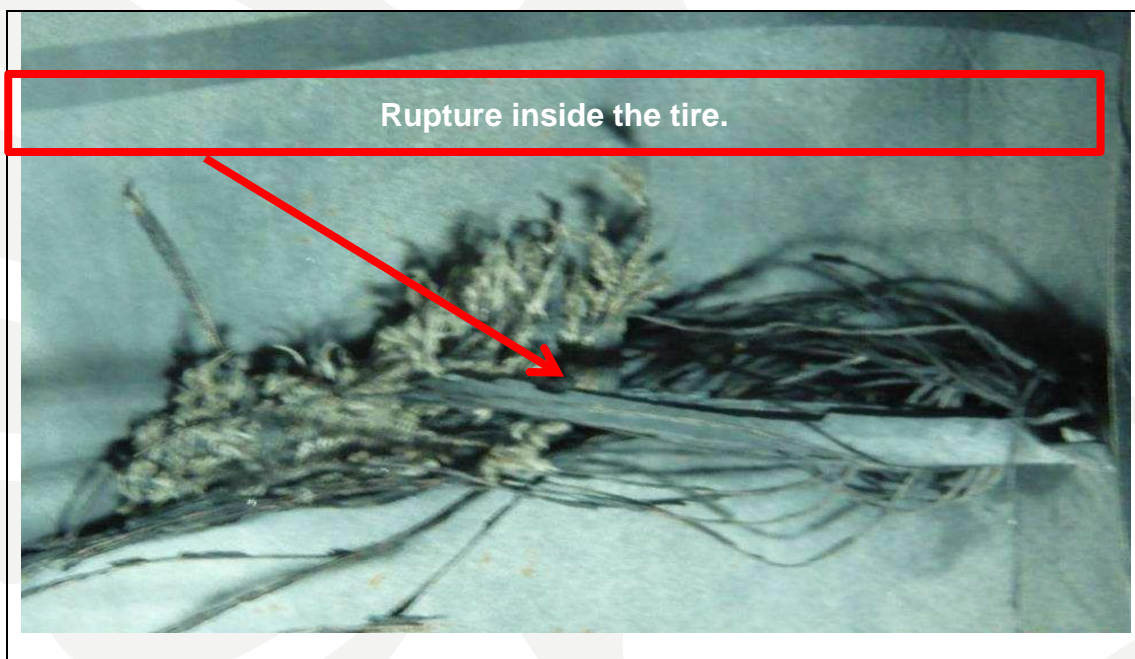
The rupture has reached the inside of the tire (photo 20).

Photo 20. Rupture, Tire Position 5.

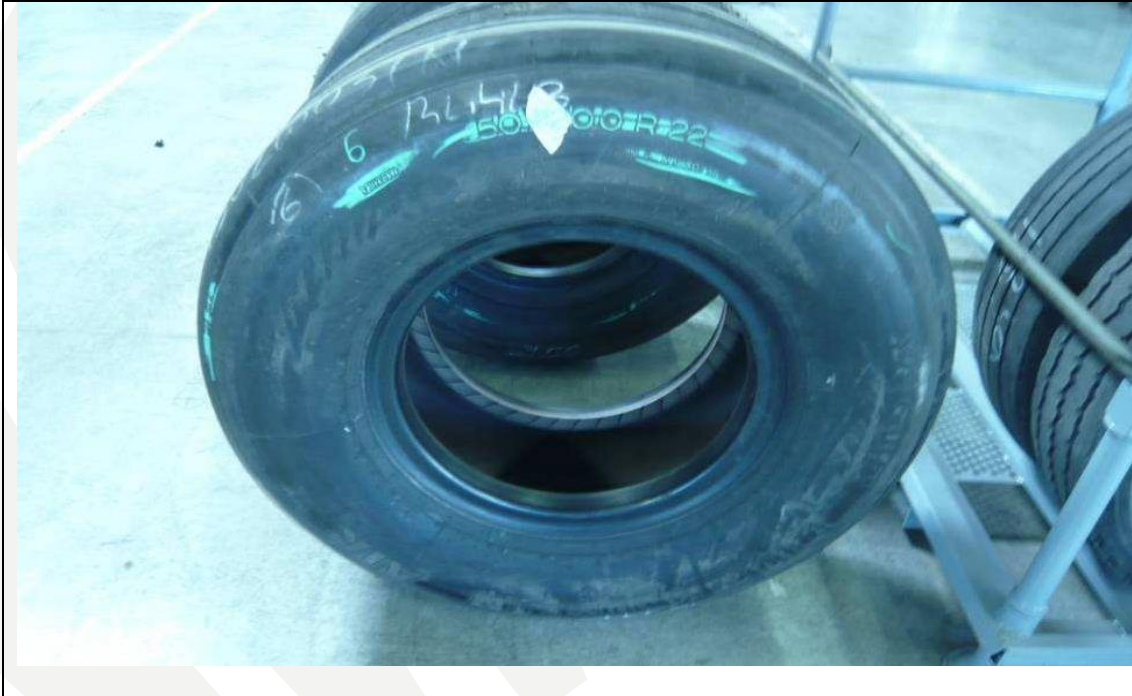
Photo 21. Tire Position 5.

SN: 9302W037 (position n°6): The tire is partially worn (photo 21).

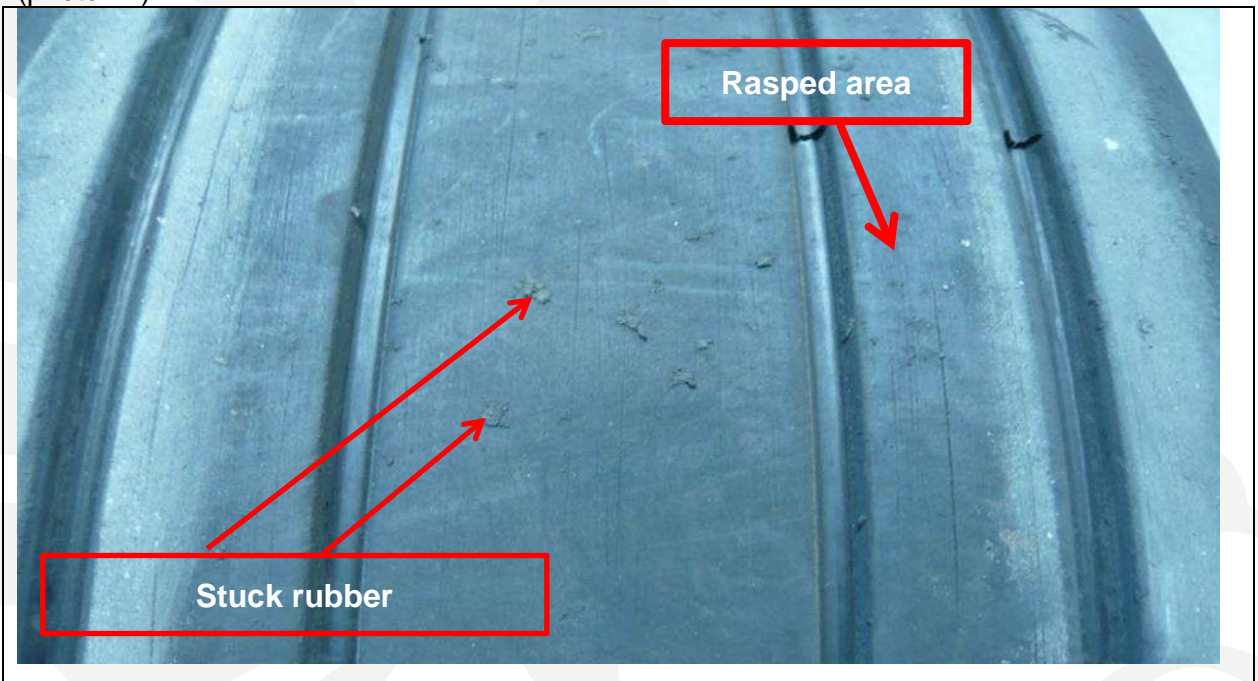
Some rasped areas are visible and some pieces of rubber are stuck to the tread (photo 22).

Photo 22. Detail Tire Position 5.

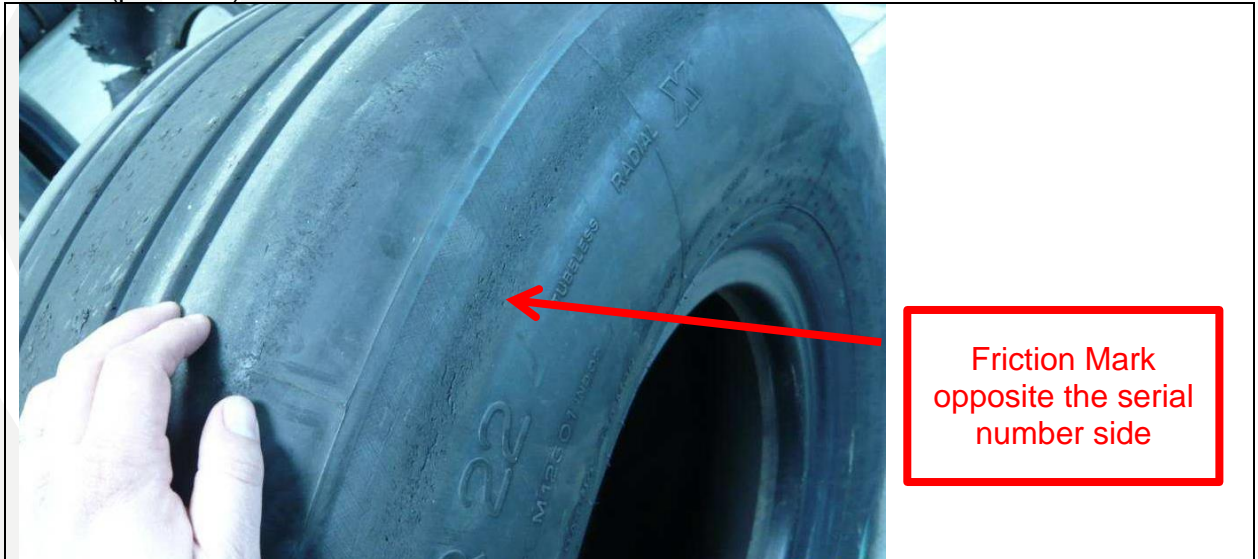
At the top of the opposite serial number side, a zone of circumferential friction is visible (photo 23).

Photo 23. Opposite serial number sidewall friction mark, Tire Position 6.

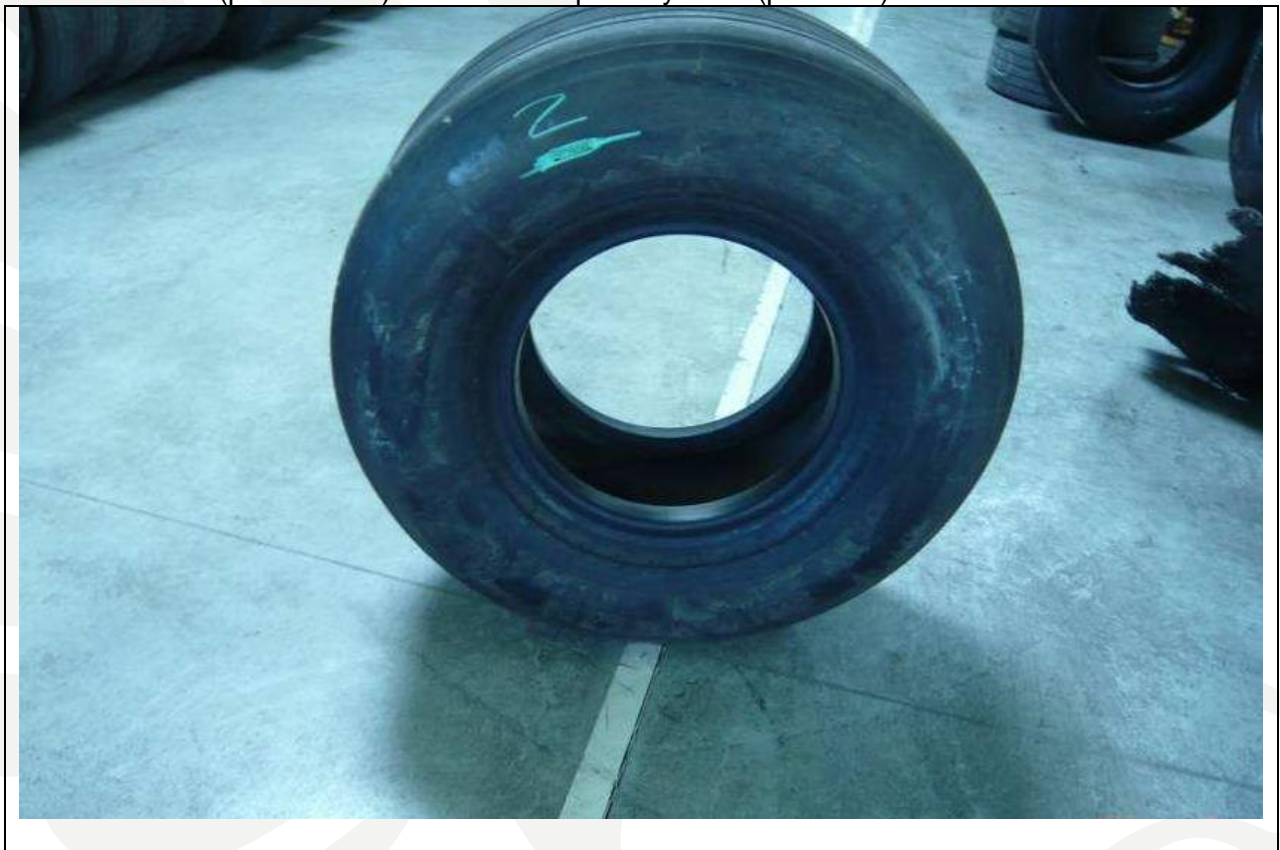
Photo 24. Tire Position 9.

SN: 1179S040 (position n°9): The tire was partially worn (photo 24).

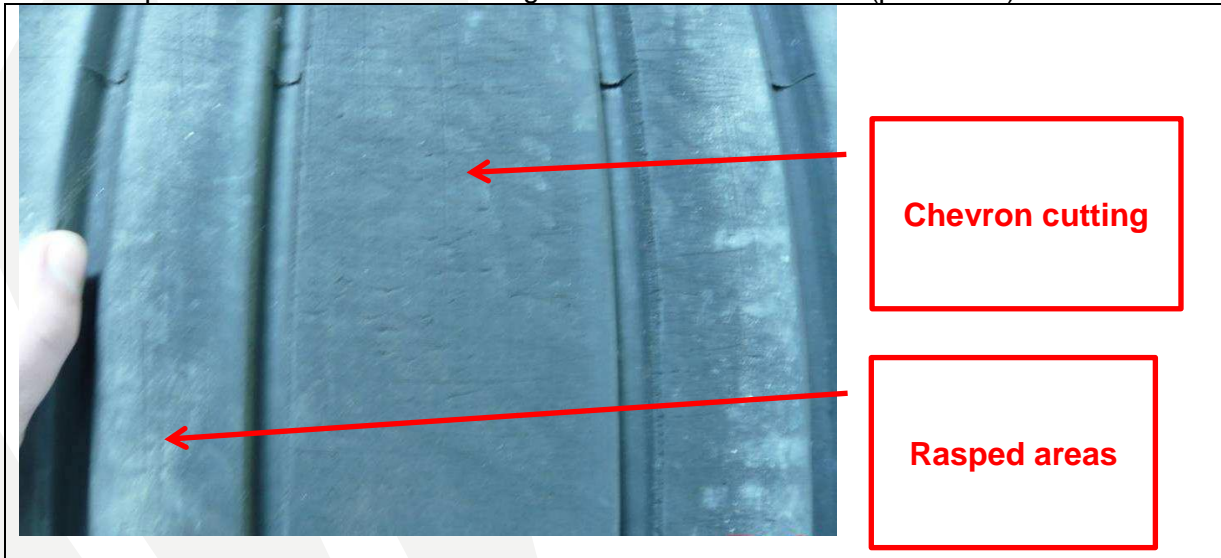
Some rasped areas and chevron cutting are visible on the thread (photos 25).

Photo 25. Rasped areas and Chevron cutting detail tire position 9.

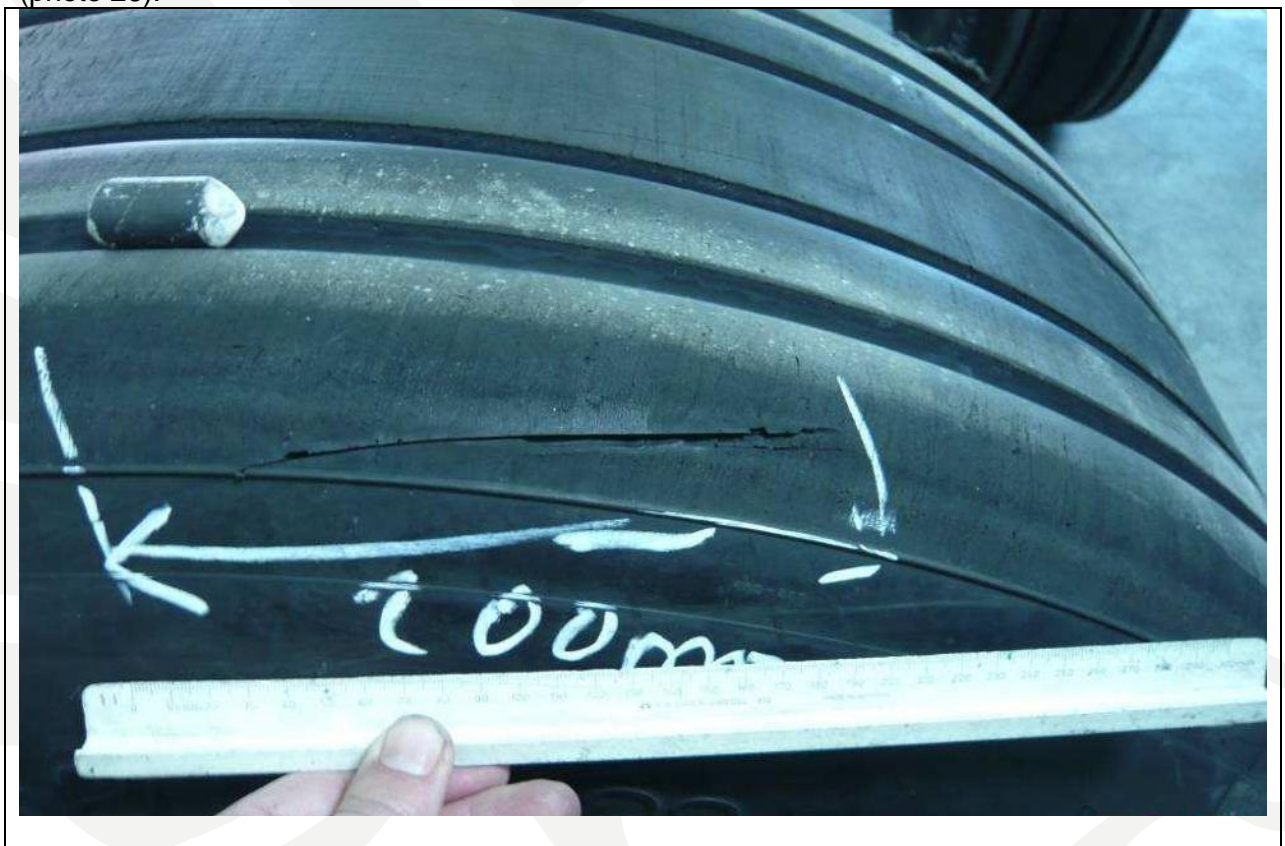
A 200 mm long cut is situated on the shoulder on the opposite serial number side (photo 26).

Photo 26. Shoulder cut on the opposite serial number side, tire position 9.

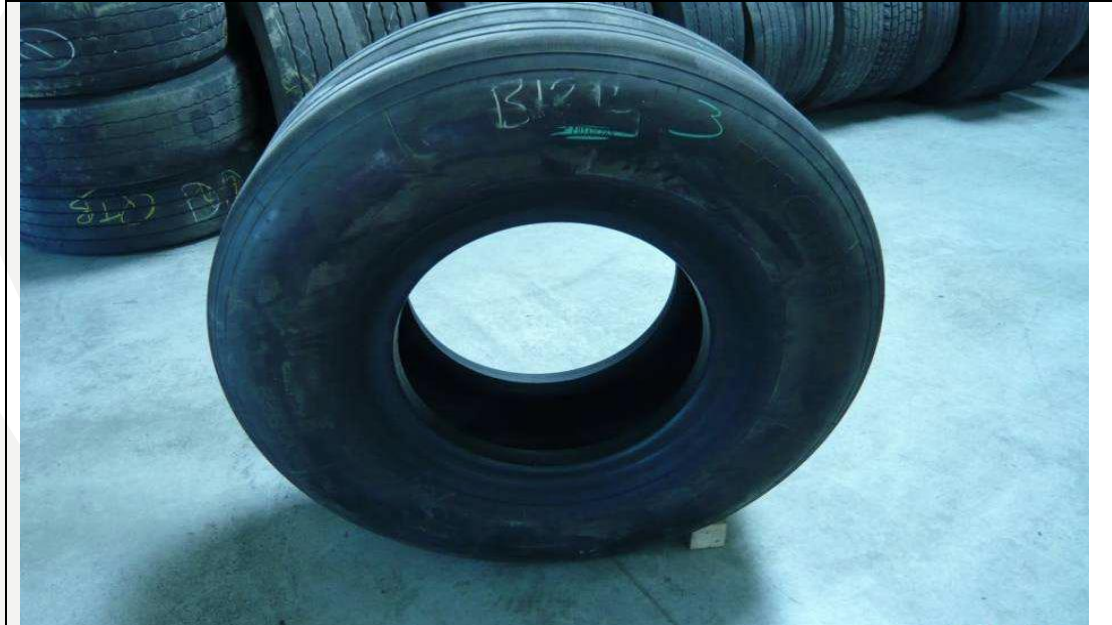
Photo 27. Tire position 10.

SN: 0340C263 (position n°10): The tire was partially worn (photo 27).
