Air Accident Investigation Sector - Final Incident Report -

AAIS Case File 14/2011

Tire Burst during Landing

Boeing 777-300

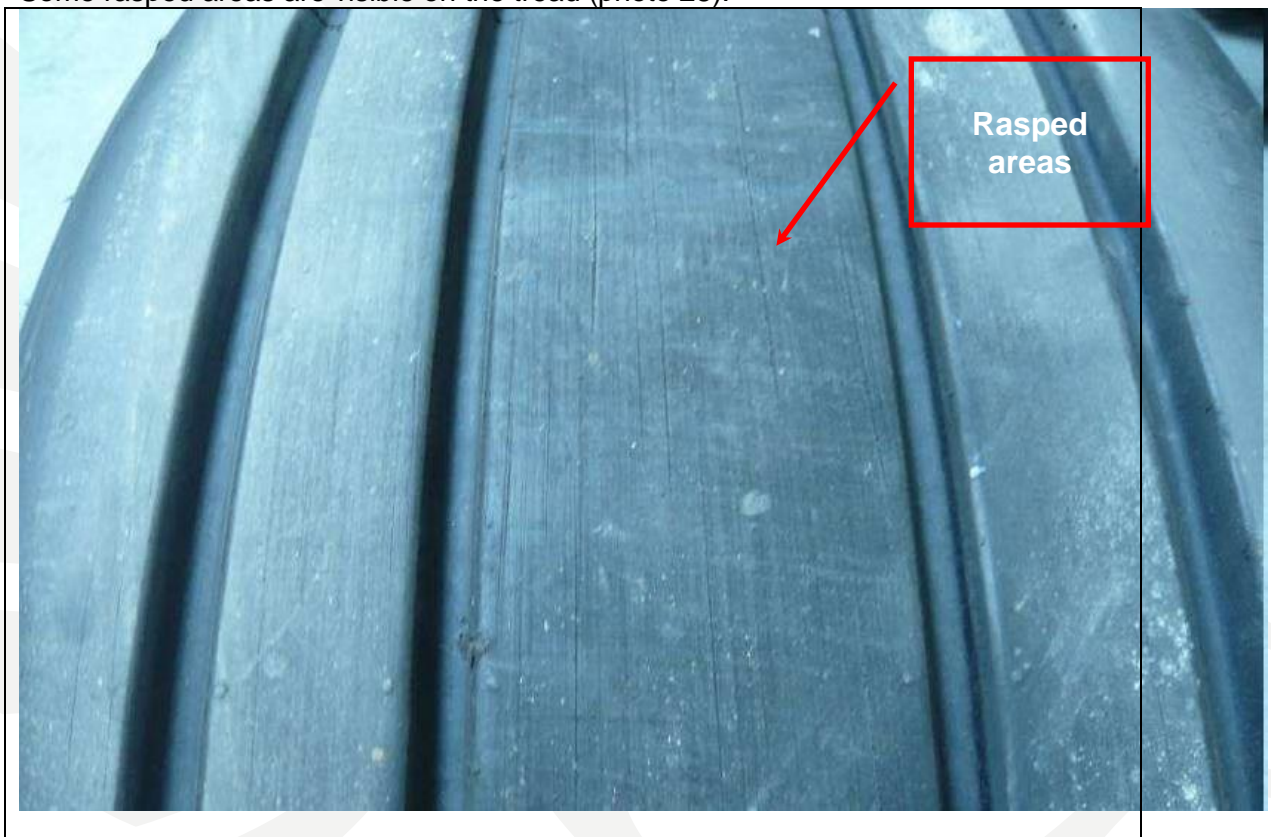
Some rasped areas are visible on the tread (photo 28).

Photo 28. Rasped areas on Tire Position 10.

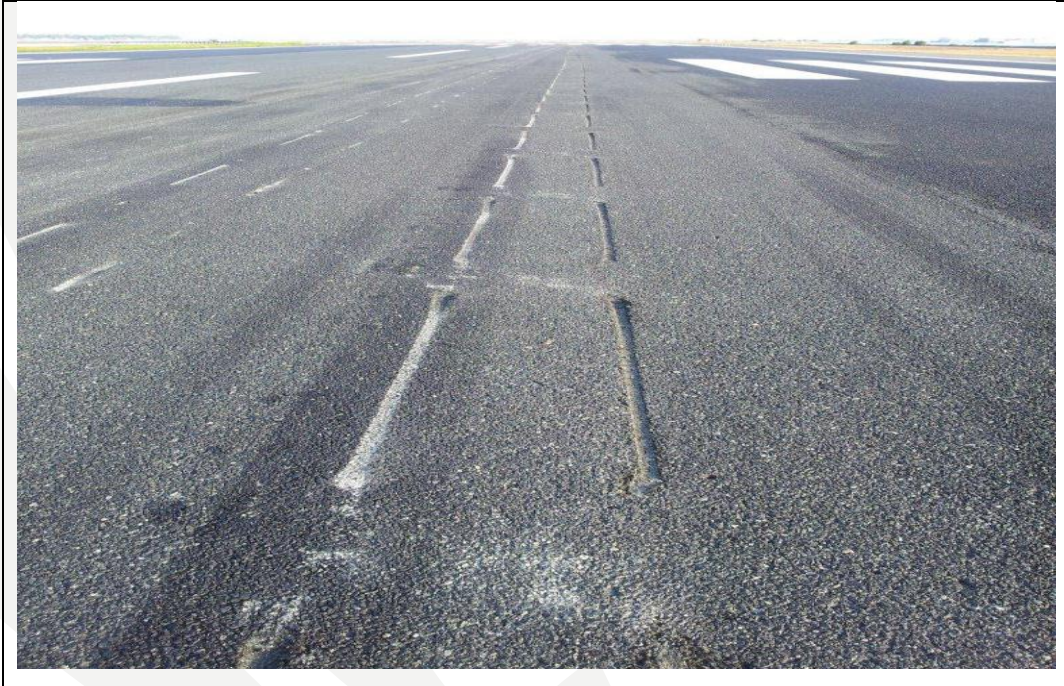
Parts of the runway surface showed damage with multiple grooves as a result of contact with the wheel hubs (see photos 29 & 30).

Photo 29. Damage on the runway surface.

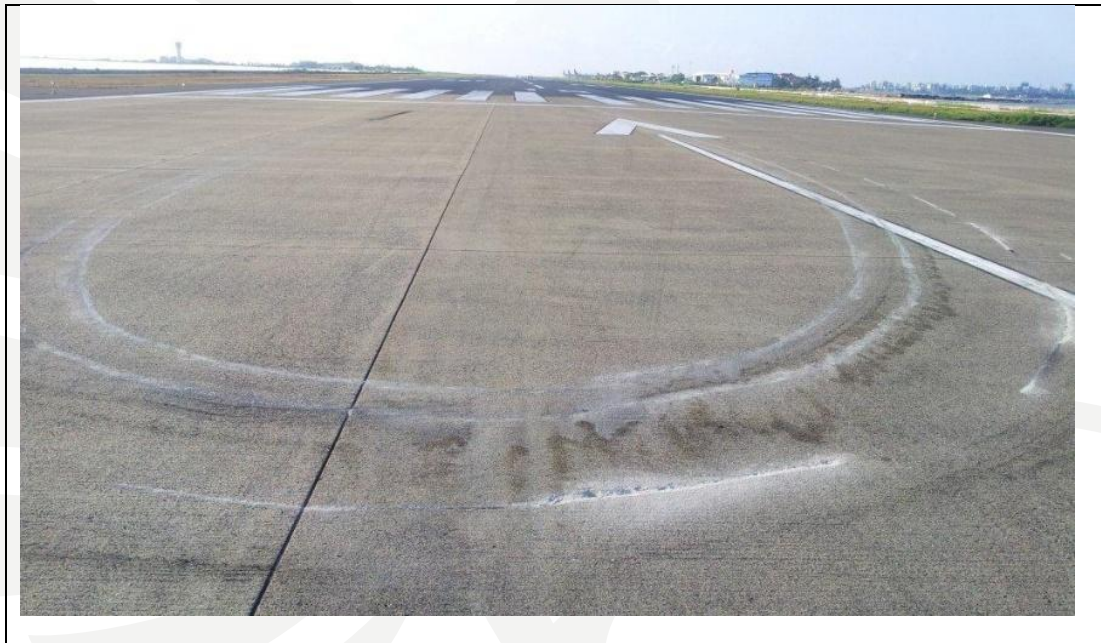
Photo 30. Runway 18 threshold area showing the damage on the runway surface.

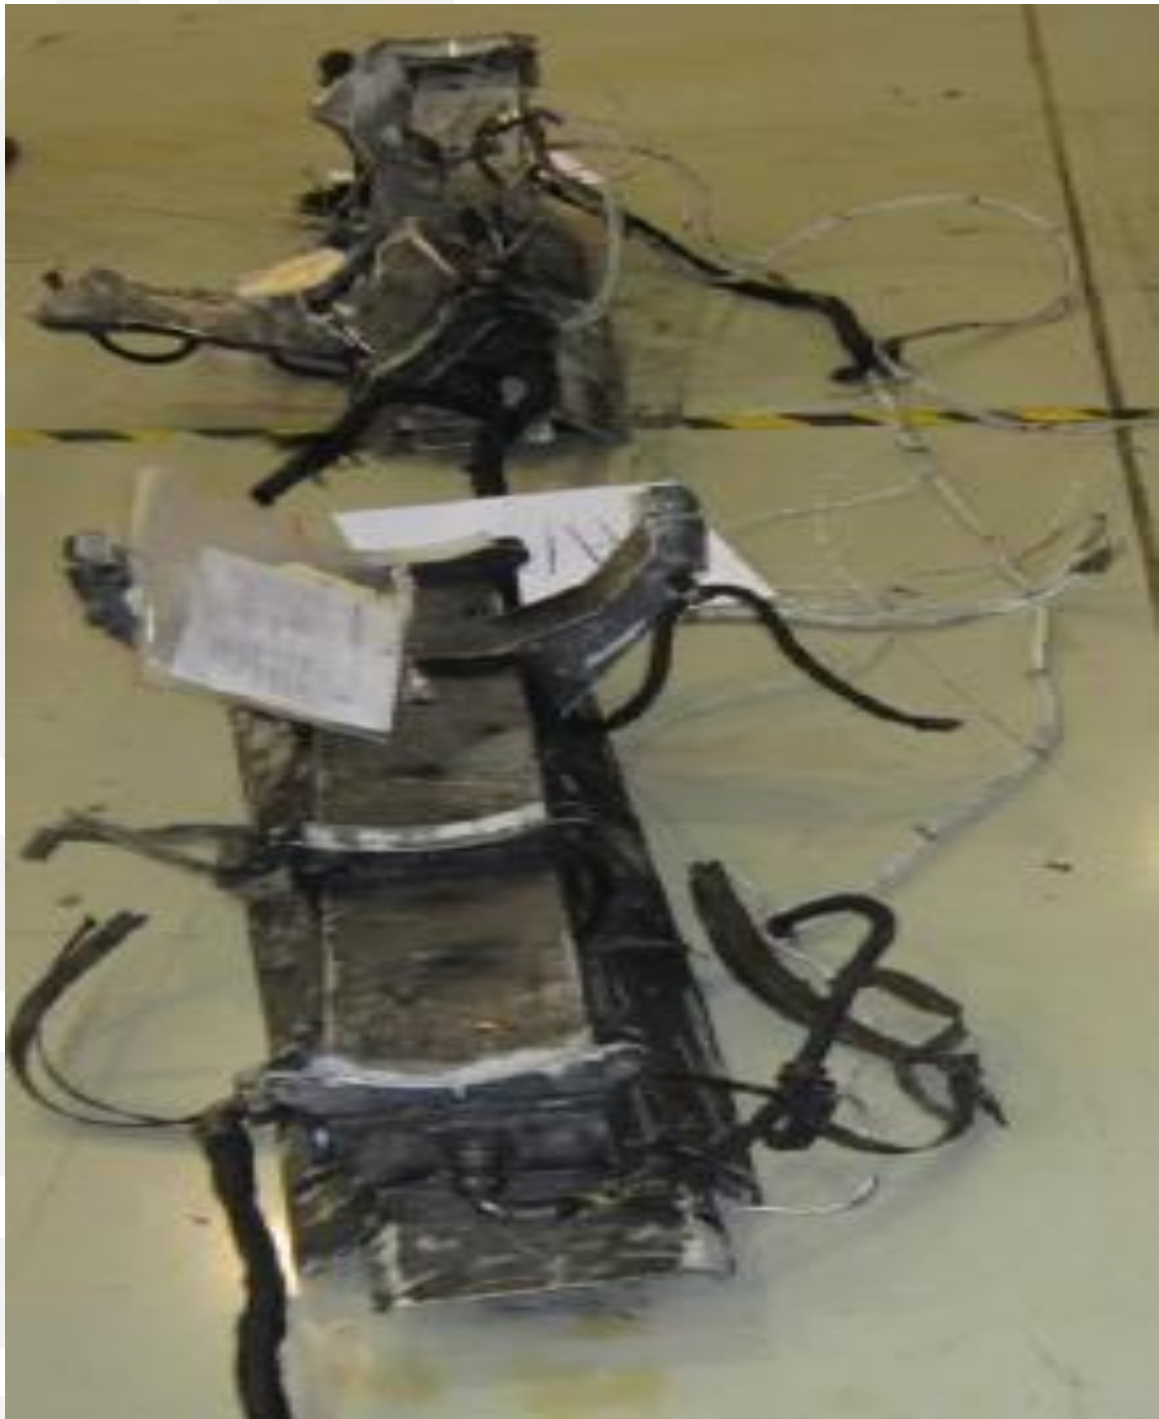
The manufacturer undertook an examination of all 6 band clamps from the 2 departed J-Boxes. See figure 3 for a photo of the recovered junction boxes. All of the failures were ductile failures, not attributable to fatigue. The failures were consistent with a failure mechanism of excessive standing water on the runway being splashed against the side of the junction boxes and likely overloading the band clamps (particularly the forward- and aft-most clamps).

Photo 31. Recovered junction boxes from A6EMR.⁵

3.1.8. All of the junction box failures were ductile failures, not attributable to fatigue.

3.1.9. The junction box failures were consistent with excessive standing water on the runway being splashed against the side of the junction boxes and likely overloading the band clamps (particularly the forward- and aft-most clamps).
