AAI Case Reference: 13/2011

SERIOUS INCIDENT FACTUAL REPORT

RUNWAY EXCURSION

REGISTRATION : A6-MPL

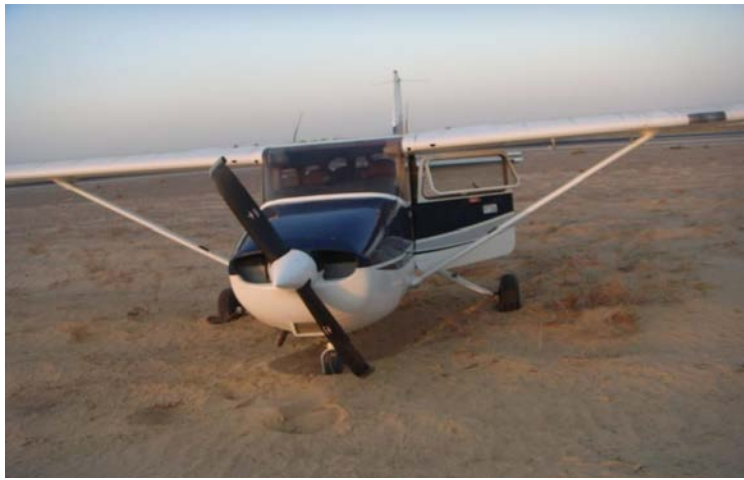
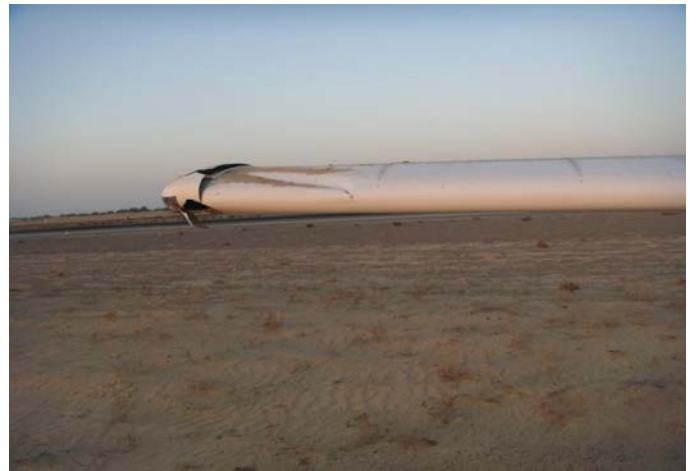
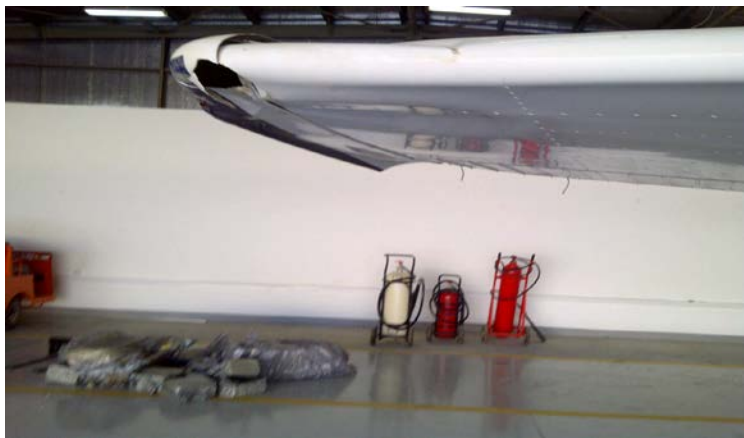
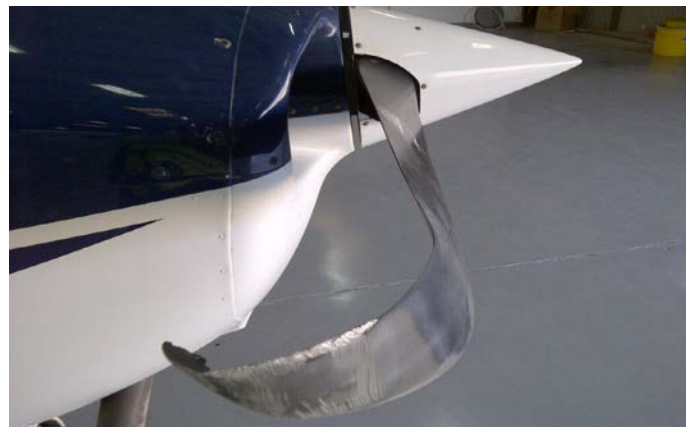
Appendix 1: Aircraft Damages – RH Wing and Propeller

1. Engine Propeller
2. Right Hand Wingtip
3. Right hand wing outermost rib together with leading edge skin attaching to the rib.
4. Right hand strobe light lens
5. Right hand NAV lamp lens.

As a result of the propeller damage, and as per the Aircraft Engineer, the Engine required inspection.

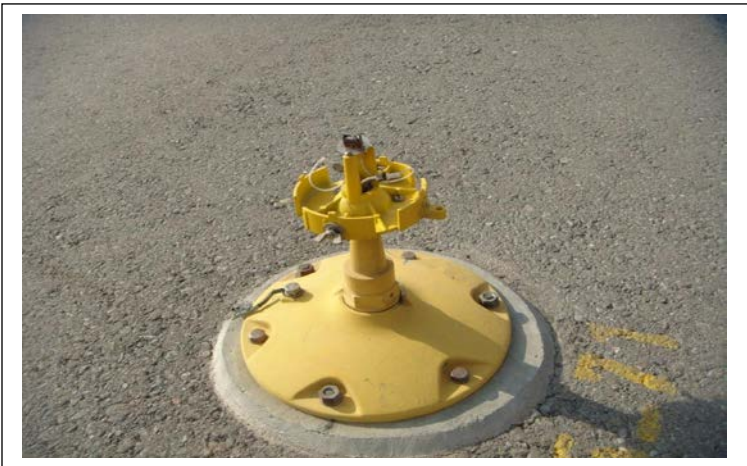
Appendix 2: Equipment Damages- Damaged Airfield Ground Lighting

Except for one Airfield Ground Light (AGL), on the edge of the runway there was no other damage such as buildings, vehicles, navigation facilities, aerodrome structures and installations reported.
