# AIRCRAFT ACCIDENT REPORT

NORTHWEST AIRLINES, INC.,  
BOEING 747-151, N606US  
OVER THE NORTH PACIFIC OCEAN  
105 NAUTICAL MILES WEST OF 150° EAST  
LONGITUDE AT 36° NORTH LATITUDE  
APRIL 12, 1972

NATIONAL TRANSPORTATION SAFETY BOARD  
Washington, D. C. 20591  
REPORT NUMBER: NTSB AAR-72-27

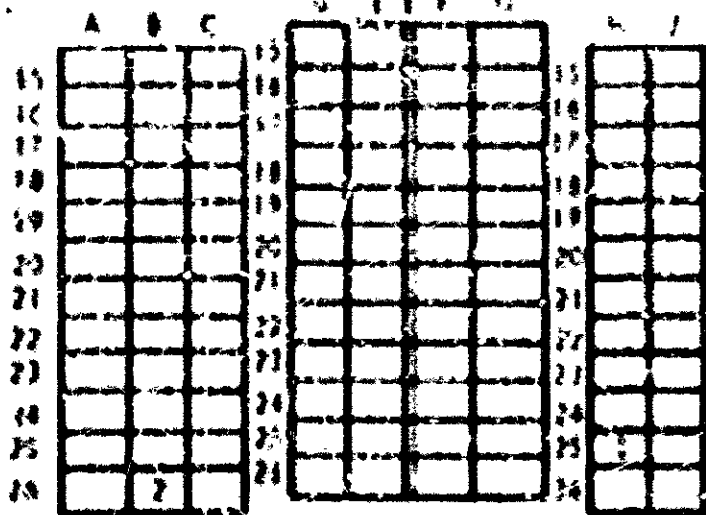
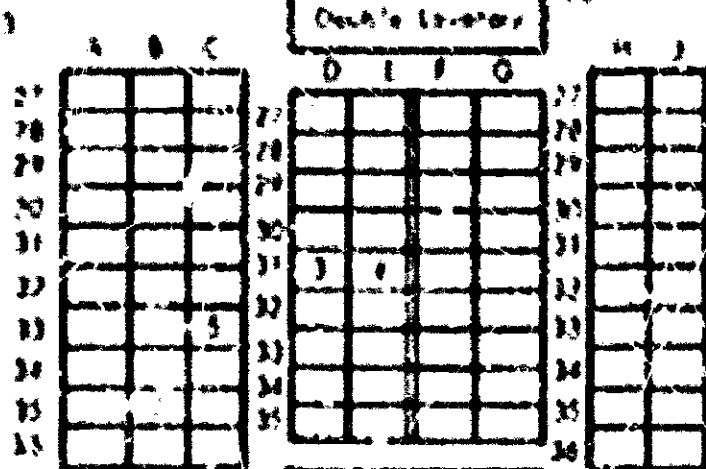
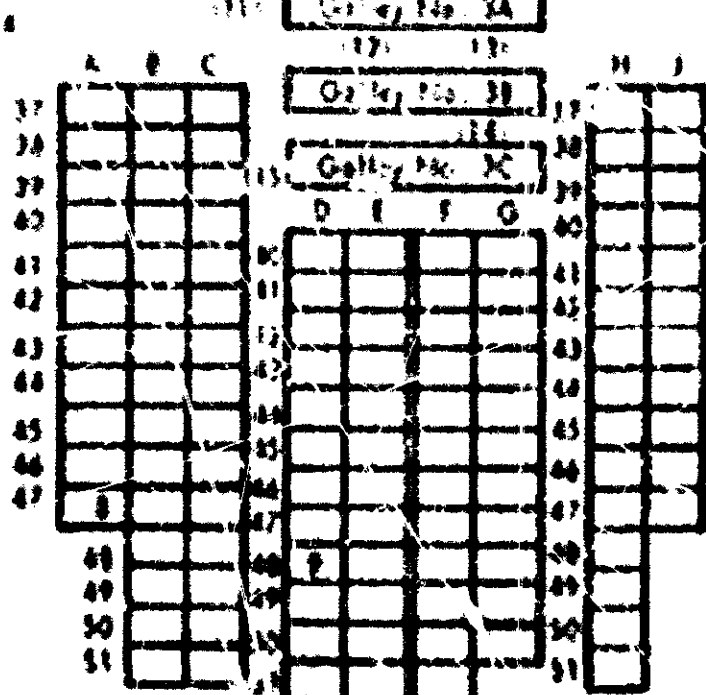
ATTACHMENT 2

Despite the purser's advisory announcement, none of the injured passengers had their seatbelts fastened, although the majority of them were in their seats. The five stewardesses were standing. All those injured were located in rear cabin areas.

<sup>2/</sup> Attachment 2 depicts the position and degree of injury of the personnel injured at the time of the turbulence encounter.
