## **AIRCRAFT ACCIDENT REPORT**

**UNIVERSAL AIRWAYS, INC.  
BEECH 70, EXCALIBUR CONVERSION, N777AE  
GULFPORT, MISSISSIPPI  
MARCH 1, 1979**

**NTSB-AAR-79-16**

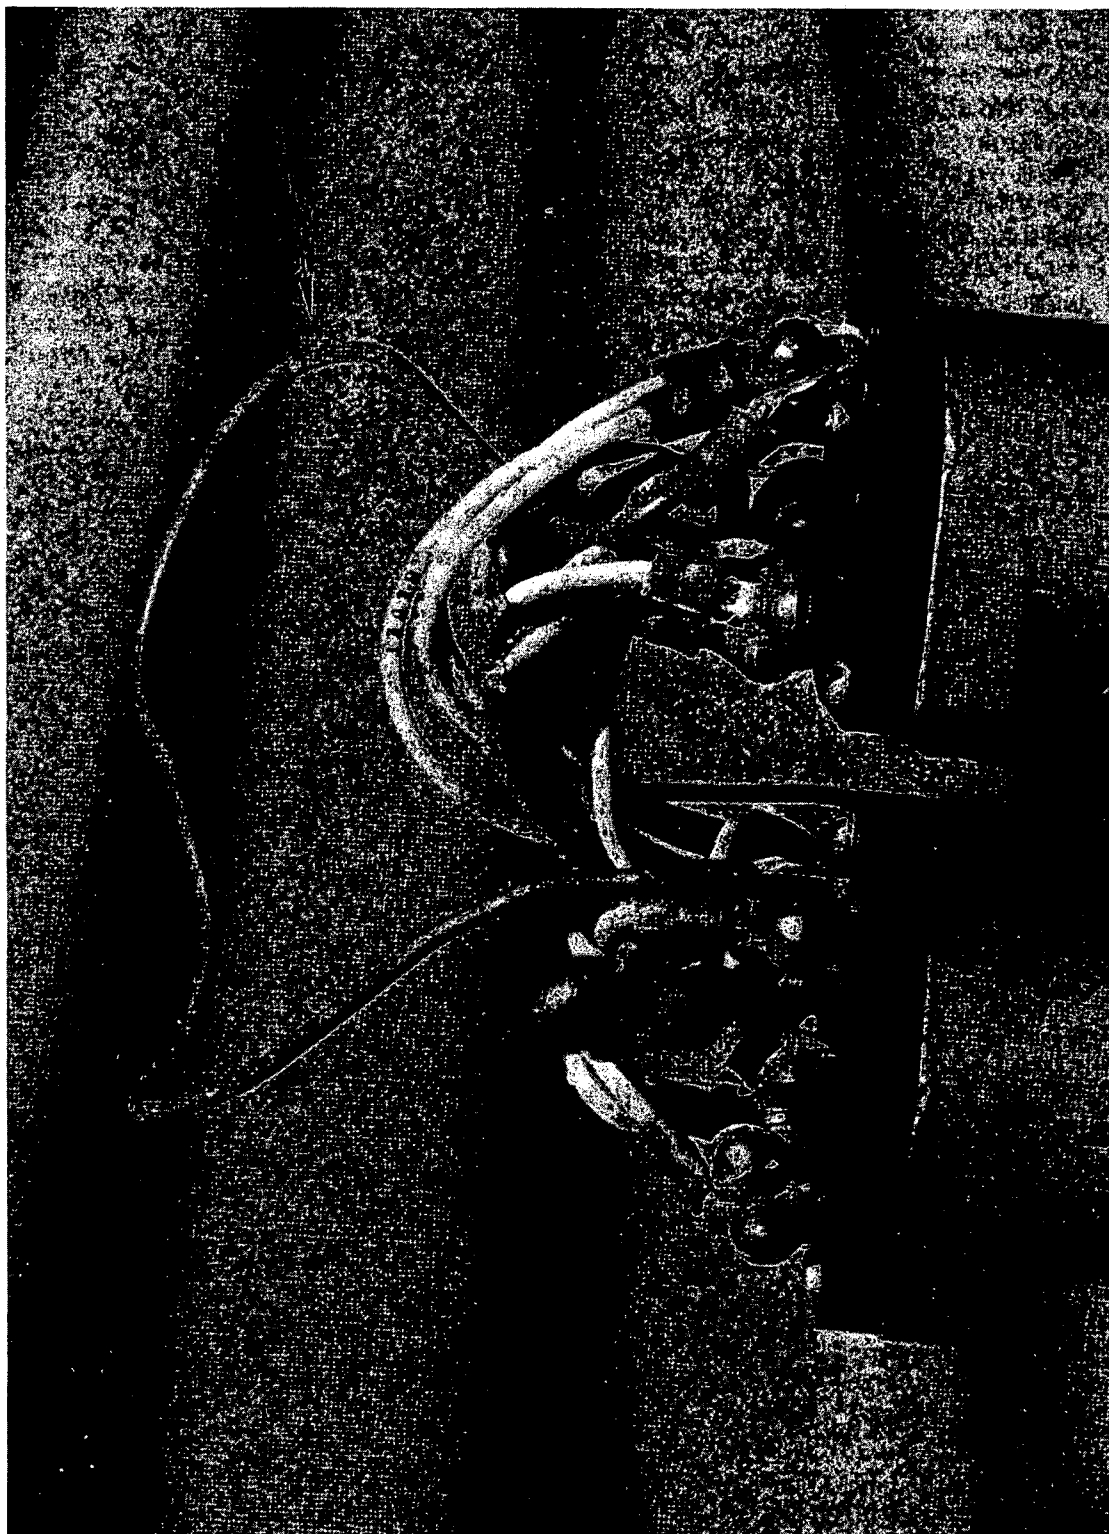
Figure 1. Wire connected to "BAT" terminal.

On the morning of January 4, the mechanic pulled the starter switches from under the control panel — he did not disconnect them. Before he removed the left starter, he noticed that a screw was missing from a terminal on the left starter and that two or three wires were loose. He connected the wires and the starter became activated. He replaced both starter switches in the control panel and signed off the aircraft logsheet as "Repaired starter circuit." The new starter switch was found in the wreckage of N777AE on March 1. The mechanic stated that when he repaired the left starter, he saw wires of different colors; he did not specifically remember seeing the red bypass wire. The Universal Airways employee who made the December repair could not recall ever seeing the red bypass wire.

The Safety Board was unable to determine when the red bypass wire was installed or who installed it. However, if it had been installed before Universal Airways acquired N777AE, we believe that it should have been discovered when the right starter switch was replaced in December 1978. Furthermore, after the left starter switch was repaired in Gulfport on January 4, 1979, the work should have been verified when the aircraft returned to Houston on January 5. Again, the wire should have been detected. Since the mechanic who worked on the aircraft on January 4 recalled only that there were different colored wires on the battery terminals, no conclusion can be drawn regarding whether the bypass wire was installed before or after the work in Gulfport. Finally, maintenance personnel should have been aware of the starter interrupt system so that a nose baggage door propeller strike would alert them that the safety system was inoperative. However, the fact that the safety system was bypassed reflects poorly on the management and quality control of the Universal Airways' maintenance program, since the initial cut in the door should have indicated the presence of the bypass wire.

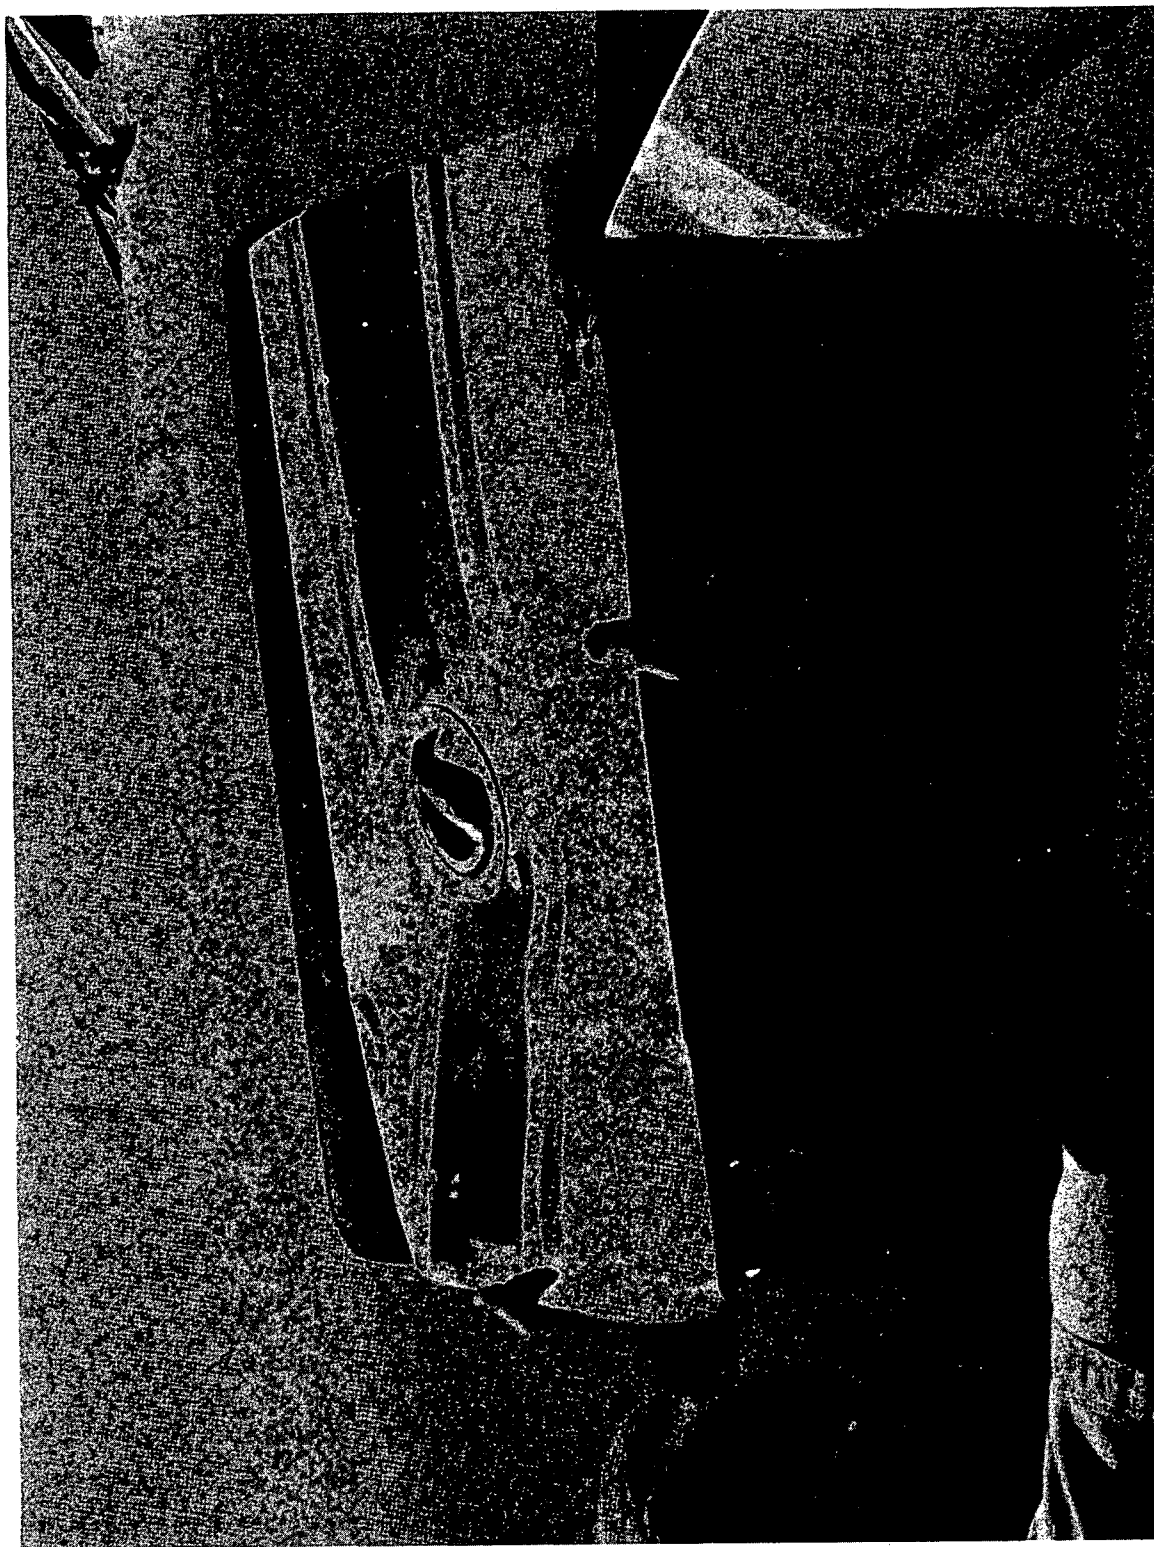
Figure 2. Door from accident aircraft.

The logsheet for January 5, contained the following writeup: "5. Mechanics GPT (Gulfport) turned left engine with nose bag door open and prop cut gash in it." No Universal employee recalled the propeller cut in the door before January 5. Even after the cut in the door was found, no Universal employee determine how it was done, who was responsible for it, or what its relationship might be to the bypass wire. The Gulfport mechanic stated he did not damage the door.

The aircraft was certificated in accordance with regulations and approved procedures. All flight control systems were determined to have functioned properly. The inspection and operation of the engines indicated that there were no preimpact malfunctions which would have reduced the efficiency of the engines or the thrust available at the time of the accident. The propeller examinations did not indicate any preimpact damage. Although both engines were capable of developing the required thrust, four of the six propeller blades had been bent at the tips, which indicated that the engines were not developing significant power at impact, since propellers which strike the ground while power is being developed will curl at the tips. Based on the evidence, the Safety Board concludes that the engines were capable of providing the required thrust and that the engine and propeller were not damaged significantly when the left propeller blades struck the nose baggage door.

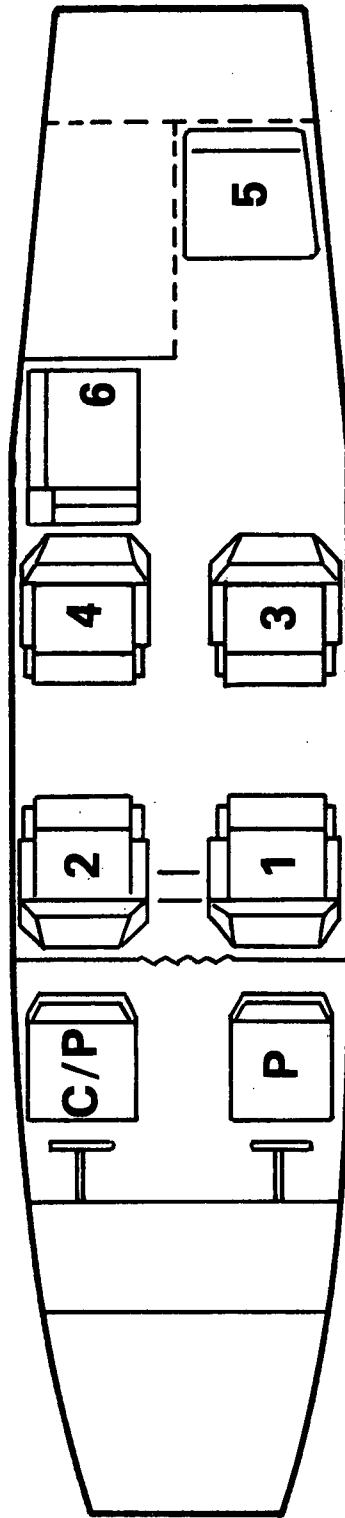
Seat 6, a plywood, side-facing seat, collapsed and failed completely. The insert hardware on the seatbelt faced toward the rear of the aircraft and the buckle hardware toward the front. The belt adjusted only on the buckle side and was found in the full length adjustment.

Figure 3. Seat arrangement for N777AE.

The rear baggage area was separated from the passenger area by a bulkhead aft of seat 6 and a net of nylon straps next to seat 5. The net failed, and most of the baggage was found at the seat 6 position.
