# **NATIONAL TRANSPORTATION SAFETY BOARD**

## **AIRCRAFT INCIDENT REPORT**

**AEROMEXICO  
DC-10-30, XA-DUH  
OVER LUXEMBOURG, EUROPE  
NOVEMBER 11, 1979**

**NTSB-AAR-80-10**

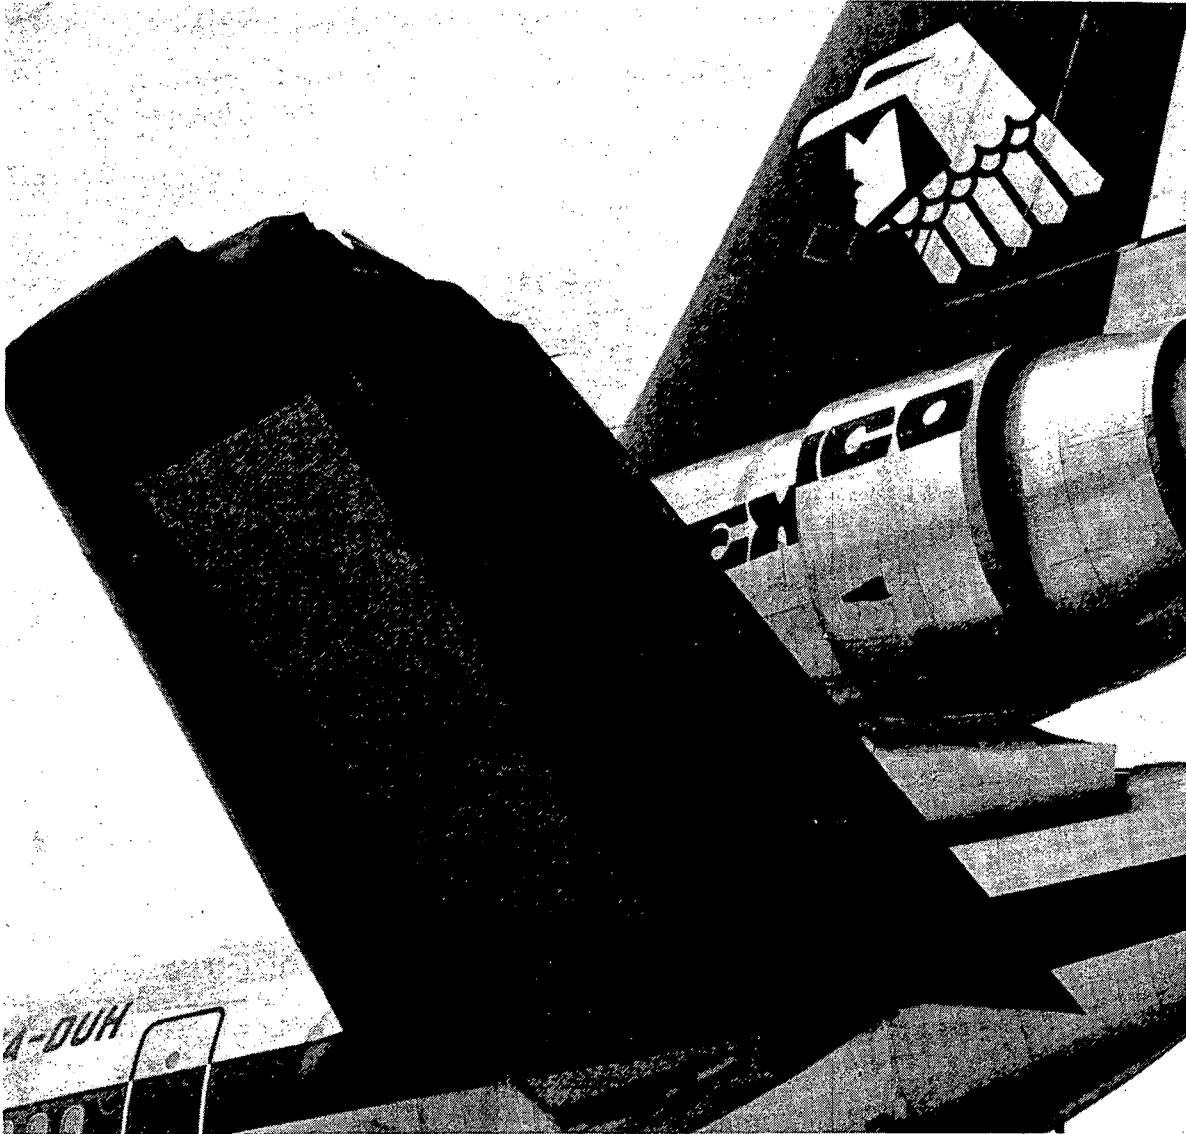
The aircraft damage was confined to both aircraft outboard elevator tips and related counterweights and the tail lower area access door. (See figures 1 and 2.)

Figure 1.--View of left outboard elevator tip.

Approximately 4 ft of the outboard ends of both outboard elevators were missing and had separated at almost identical locations. The approximate line of separation connected the trailing edge channel at Station XE 436 to the elevator spar at Station XE 455. The elevator outboard hinge fitting mounted on the elevator spar and the eyebolt mounted on the hinge fitting had separated with the outboard end of the elevators. Visual examination of the fracture surfaces on the elevator showed no indication of prior cracking. The fracture surfaces were clean and bright with smearing on some portions of the sheet metal surfaces.

The left outboard elevator hinge fail safe "A" frame attached to the horizontal stabilizer sustained minor damage. Scrape marks a few thousandths of an in deep were evident in the bore and flange of the bushing. The outboard lug of the two lugs on the outboard hinge "A" frame was broken about 1 in forward of the elevator hinge line. The inboard lug was bent inboard approximately 1/8 in, and

The tips of both the right and left elevators separated similarly indicating that the failures were produced by a symmetrical loading condition. The evidence indicated a torsional buckling failure of the elevator skin and an aft bending failure of the spar. Smearing on some of the sheet metal fracture surfaces was consistent with a cyclic load application.

12. The stall buffet which was encountered as the aircraft approached and entered the stall produced a dynamic load on the elevator balance weights which resulted in structural overload and failure of the outboard elevator tips.

The aircraft's left and right outboard elevator and the fuselage tail lower area access door were replaced and the aircraft was flown to Mexico City, on November 16, 1979, where it again went through a detailed inspection in accordance with AEROMEXICO's Approved Inspection and Maintenance Program. No discrepancies were found during the examination and testing of the aircraft. Later, it was released for scheduled line flight operations.

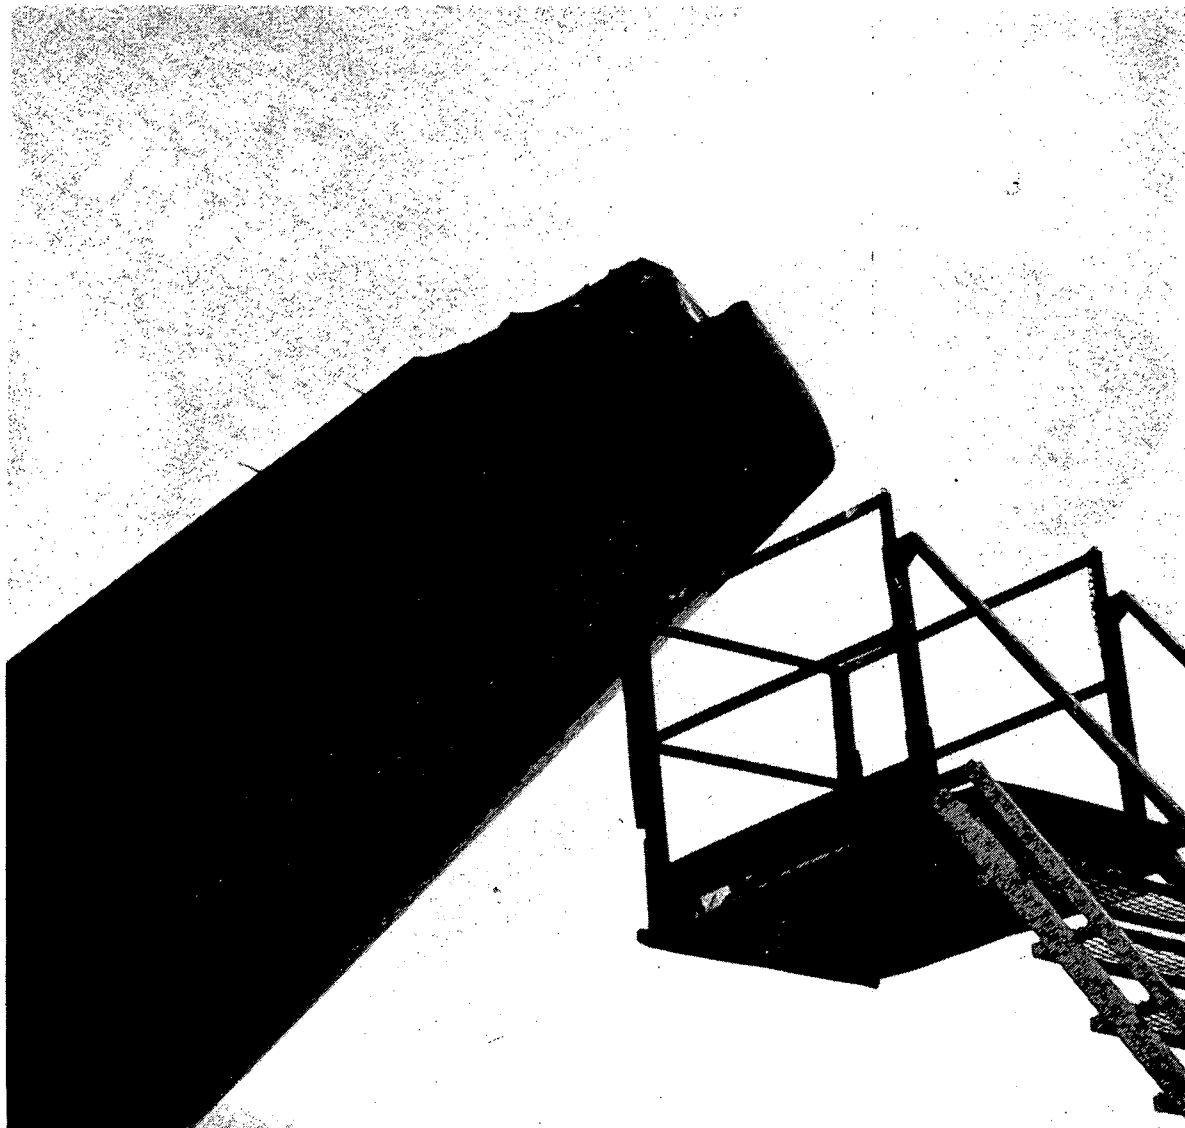
Figure 2.--View of right outboard elevator tip.

The right outboard elevator outboard hinge fail safe "A" frame attached to the horizontal stabilizer was broken about 2 in forward of the hinge line. No indication of prior cracking was evident. The outboard lug of the two lugs on the outboard hinge "A" frame was broken about 2 in forward of the hinge line. No indication of prior cracking was evident. The inboard lug was bent inboard about 1/2 in. A scrape mark approximately .005 in deep was observed on the outboard side of the inboard lug. The scrape mark extended from the edge of the hinge hole to the upper edge of the lug. The horizontal stabilizer tip fairing had two small buckles about .060 in deep and 2 in long located just forward of the aft closing rib. The aft edge of the fairing was bent outboard approximately 1/16 in and an impact mark was evident on the aft edge of the fairing.
