# **NATIONAL TRANSPORTATION SAFETY BOARD**

## **AIRCRAFT ACCIDENT REPORT**

**NORTHEAST JET COMPANY  
GATES LEARJET 25D, N125NE  
GULF OF MEXICO  
MAY 19, 1980**

**NTSB-AAR-81-15**

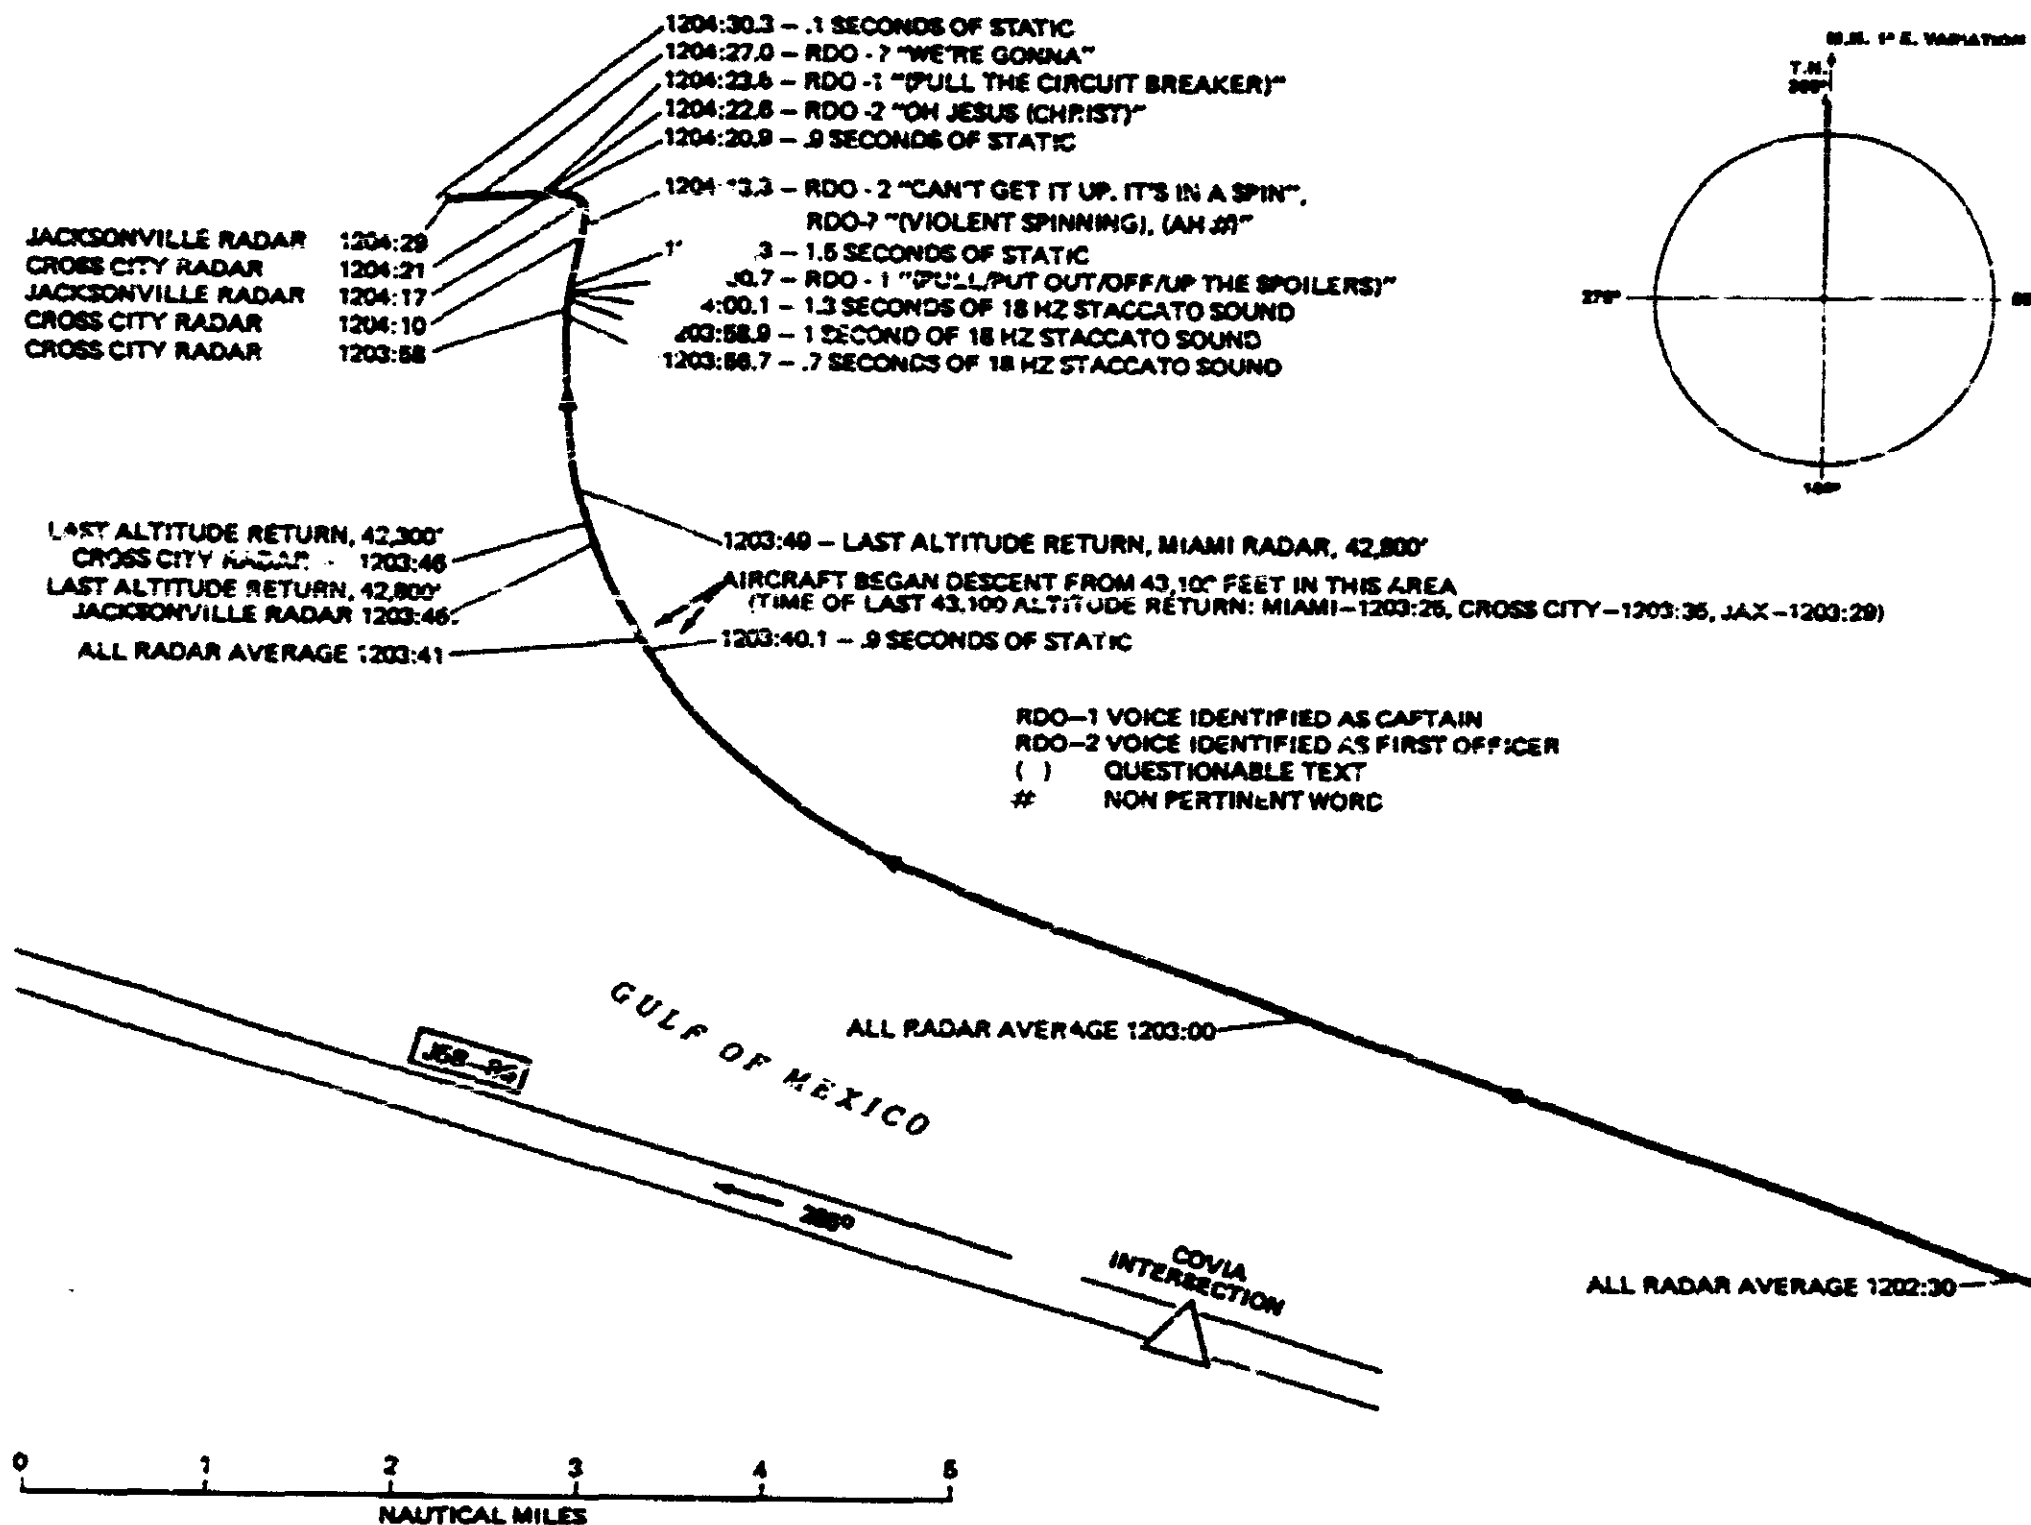
PROBABLE GROUND TRACK

Eight seconds after the burst of static, the calculated speed of the aircraft was Mach 0.81, a 0.04 Mach increase over that which the aircraft had been averaging about 4 seconds earlier. At 1203:56.7 (appendix B), the unusual staccato sound occurred. The Safety Board believes that the staccato sound was transmitted when the copilot keyed the microphone inadvertently because of his firm grip on the control wheel. It was noted that the signal level between the low frequency beats did not drop to the normal quiescent voltage level, but remained at the same value until the next frequency cycle began. The evidence supports the contention that the copilot had keyed the microphone continuously which resulted in the inadvertent transmissions. Immediately after the cessation of the staccato sound, at 1204:00.7, the pilot stated, "put-out the spoilers." His statement sounded weak, as if it was in the background, possibly due to his statements being amplified through the copilot's headset microphone. At 1204:13.3, 12.6 seconds later, the copilot stated, "Can't get it up . . . Its in a spin." Four seconds later, the aircraft made about a 90° deviation to the left in its ground track.
