# **NATIONAL TRANSPORTATION SAFETY BOARD**

## **AIRCRAFT ACCIDENT REPORT**

**A. E. STALEY MANUFACTURING COMPANY, INC.  
CANADAIR CHALLENGER CL-600, N805C  
HAILEY, IDAHO  
JANUARY 3, 1983**

NTSB/AAR-83/05

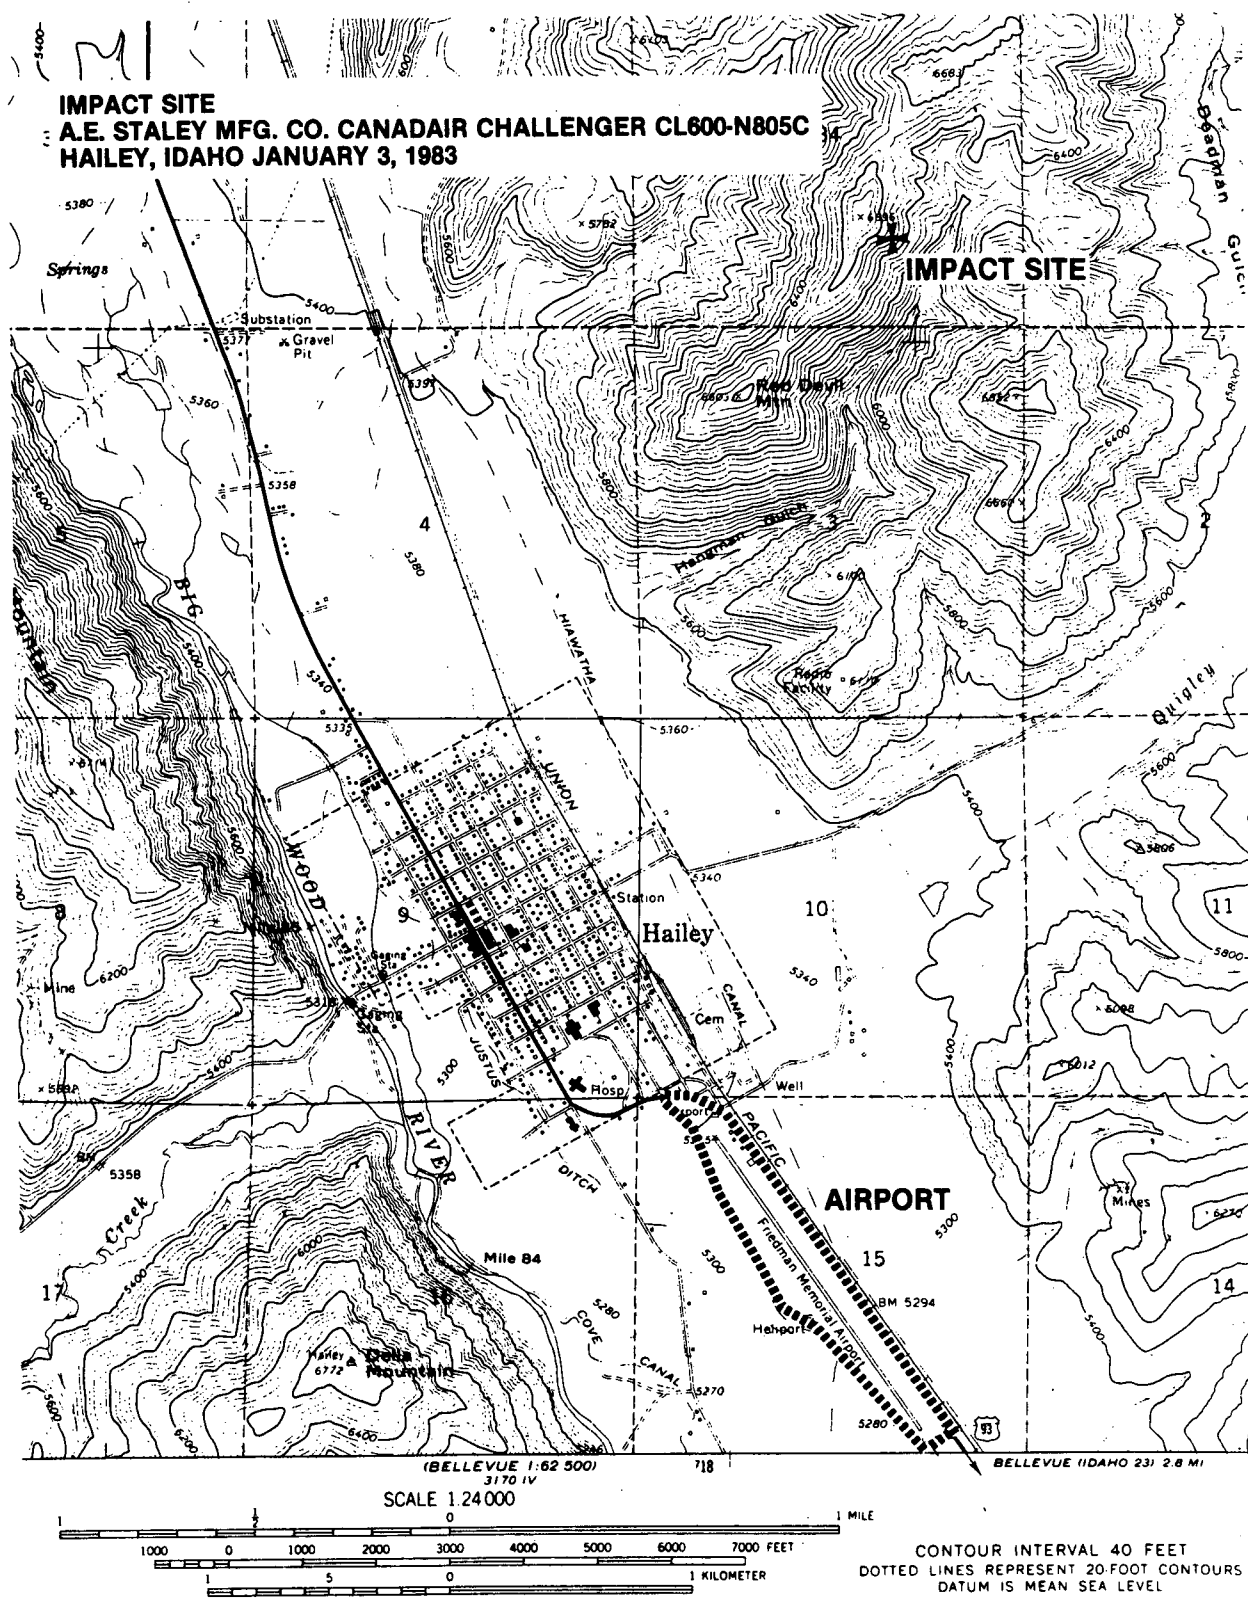
### IMPACT SITE

Local noise abatement procedures require turbojet engined airplanes to use runway 31 for landing and runway 13 for takeoff. The procedures recommend arrivals for runway 31 to fly toward the airport on the east side of the valley at 7,000 feet until the pilot is ready to start his landing approach. The procedures also recommend that the pilots fly over the eastern edge of Bellevue to intercept the final approach path to runway 31. (See appendix D.)

According to pilots flying into the Sun Valley Airport on January 3 -- pilots who were familiar with the area and terrain -- terrain and landmark definitions were obscured by snow. According to one pilot, these conditions in combination with the low overcast clouds produced a "white-on-white" situation that made visual navigation difficult. The pilot also stated that he could see the airport while on final approach, however, the runway was covered by snow and was "difficult to distinguish." Consequently, the Safety Board believes that the flightcrew of N805C, when faced with this situation, probably did not definitely establish its position visually as it flew toward the airport. Further, we believe that, as a consequence, the flightcrew might have misidentified the town of Hailey as the town of Bellevue, which is about 4.4 nmi southeast of Hailey and about 2.2 nmi southeast of the approach end of runway 31. Bellevue is the key landmark used by pilots for aligning the airplane with runway 31. (See appendix D.)
