# **NATIONAL TRANSPORTATION SAFETY BOARD**

## **AIRCRAFT ACCIDENT REPORT**

**MCCAULEY AVIATION, INC.  
MITSUBISHI MU-2B, N72B,  
NEAR JEFFERSONVILLE, GEORGIA  
MARCH 24, 1983**

**NTSB/AAR-84/01**

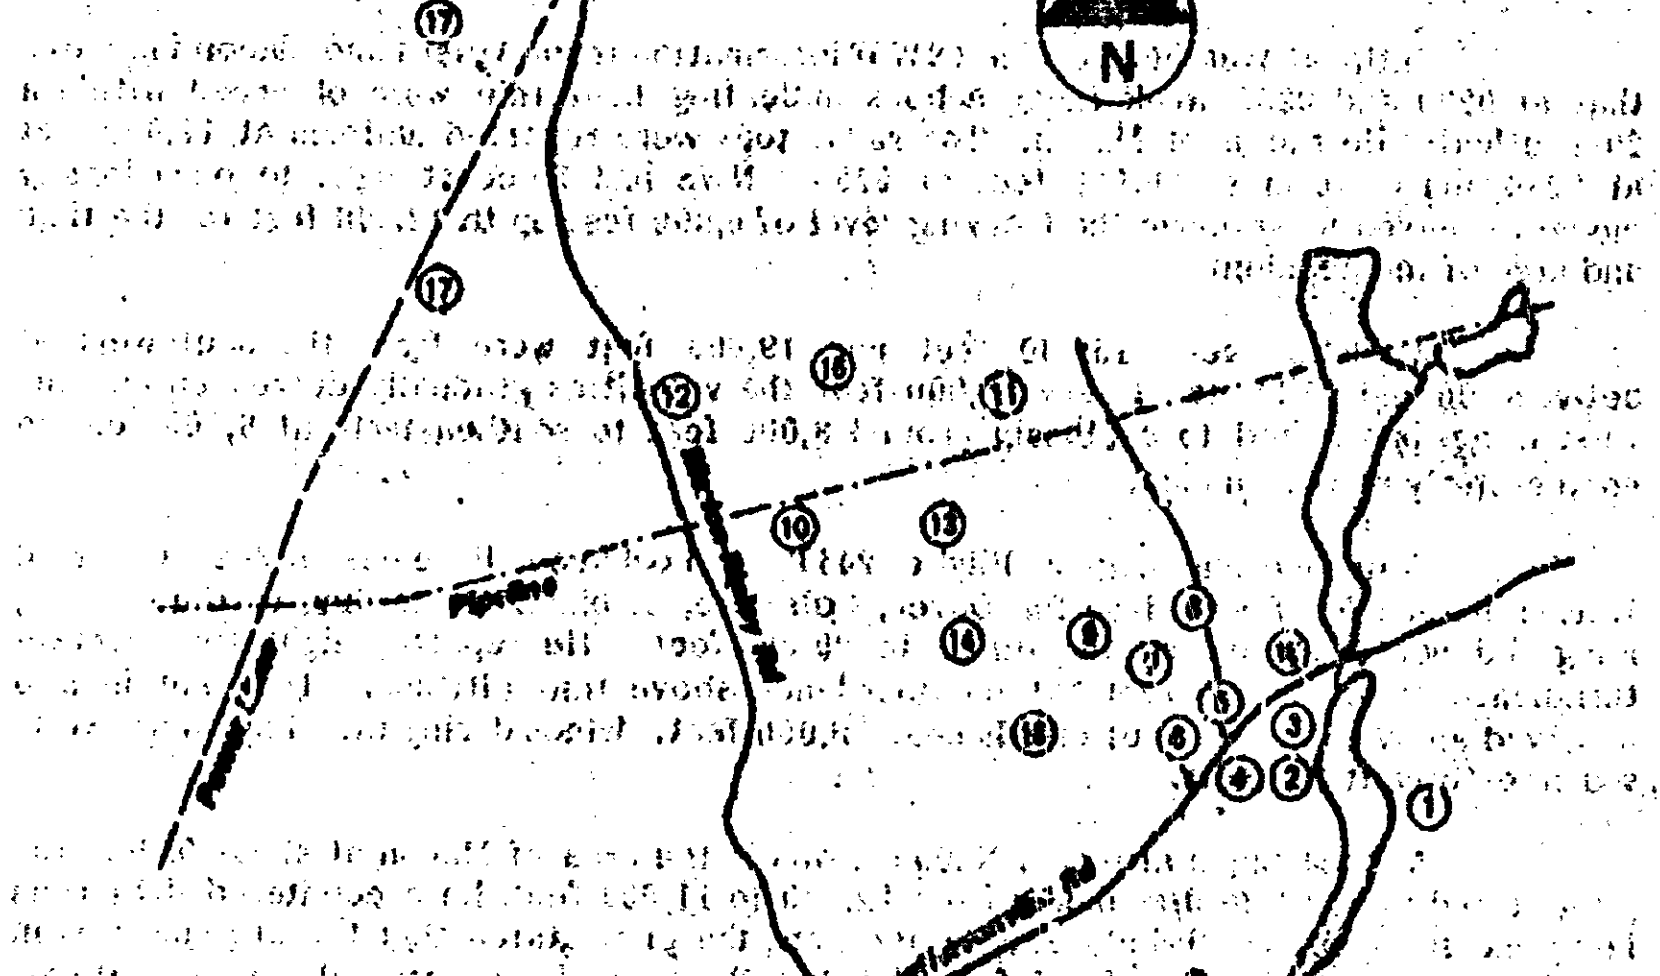
**Figure 1. - Wreckage distribution chart.**

Pieces of the airplane were scattered over a 7-mile area along a bearing of about 305°. (See figure 1.) The ground terrain was relatively level and consisted of forest, fields, and swamps. The fuselage section was the largest item recovered along the wreckage path and was found at the greatest distance from where the target disappeared from radar in a wooded swamp where the water was about 1 to 2 feet deep.

The widespread distribution of the wreckage indicates that the airplane broke up while in flight. The relatively small scatter pattern of the heaviest pieces of wreckage--fuselage, outer wings, center wing, and engines--indicates that there was not a long descent after breakup. If the airplane had broken up at high altitudes, the components would probably have been more widely separated. The lightest pieces of wreckage, most affected by winds, were the farthest away from the main wreckage and to the northwest of it. A meteorological analysis of the winds revealed that at the cruising altitude 18,000 feet, they were southwesterly at 55 knots, at 3,000 to 6,000 feet they were from the southeast at about 30 knots, and below 3,000 feet they were easterly with velocities of 4 to 6 knots at the surface. Because the wreckage was scattered along a southeast to northwest line, it can be concluded that the airplane broke up 6,000 feet or below. The lighter fragments, most subject to the influence of wind, were scattered away from the heaviest piece, the fuselage, in a northwest direction. If the break up had occurred above 6,000 feet, the higher velocity southerly and southwesterly winds would have produced a more widespread, less directional scatter pattern.
