## **AIRCRAFT ACCIDENT REPORT**

**CENTRAL AIRLINES FLIGHT 27  
HUGHES CHARTER AIR  
GATES LEARJET MODEL 25 (N51CA)  
NEWARK INTERNATIONAL AIRPORT  
NEWARK, NEW JERSEY  
MARCH 30, 1983**

**NTSB/AAR-84/11**

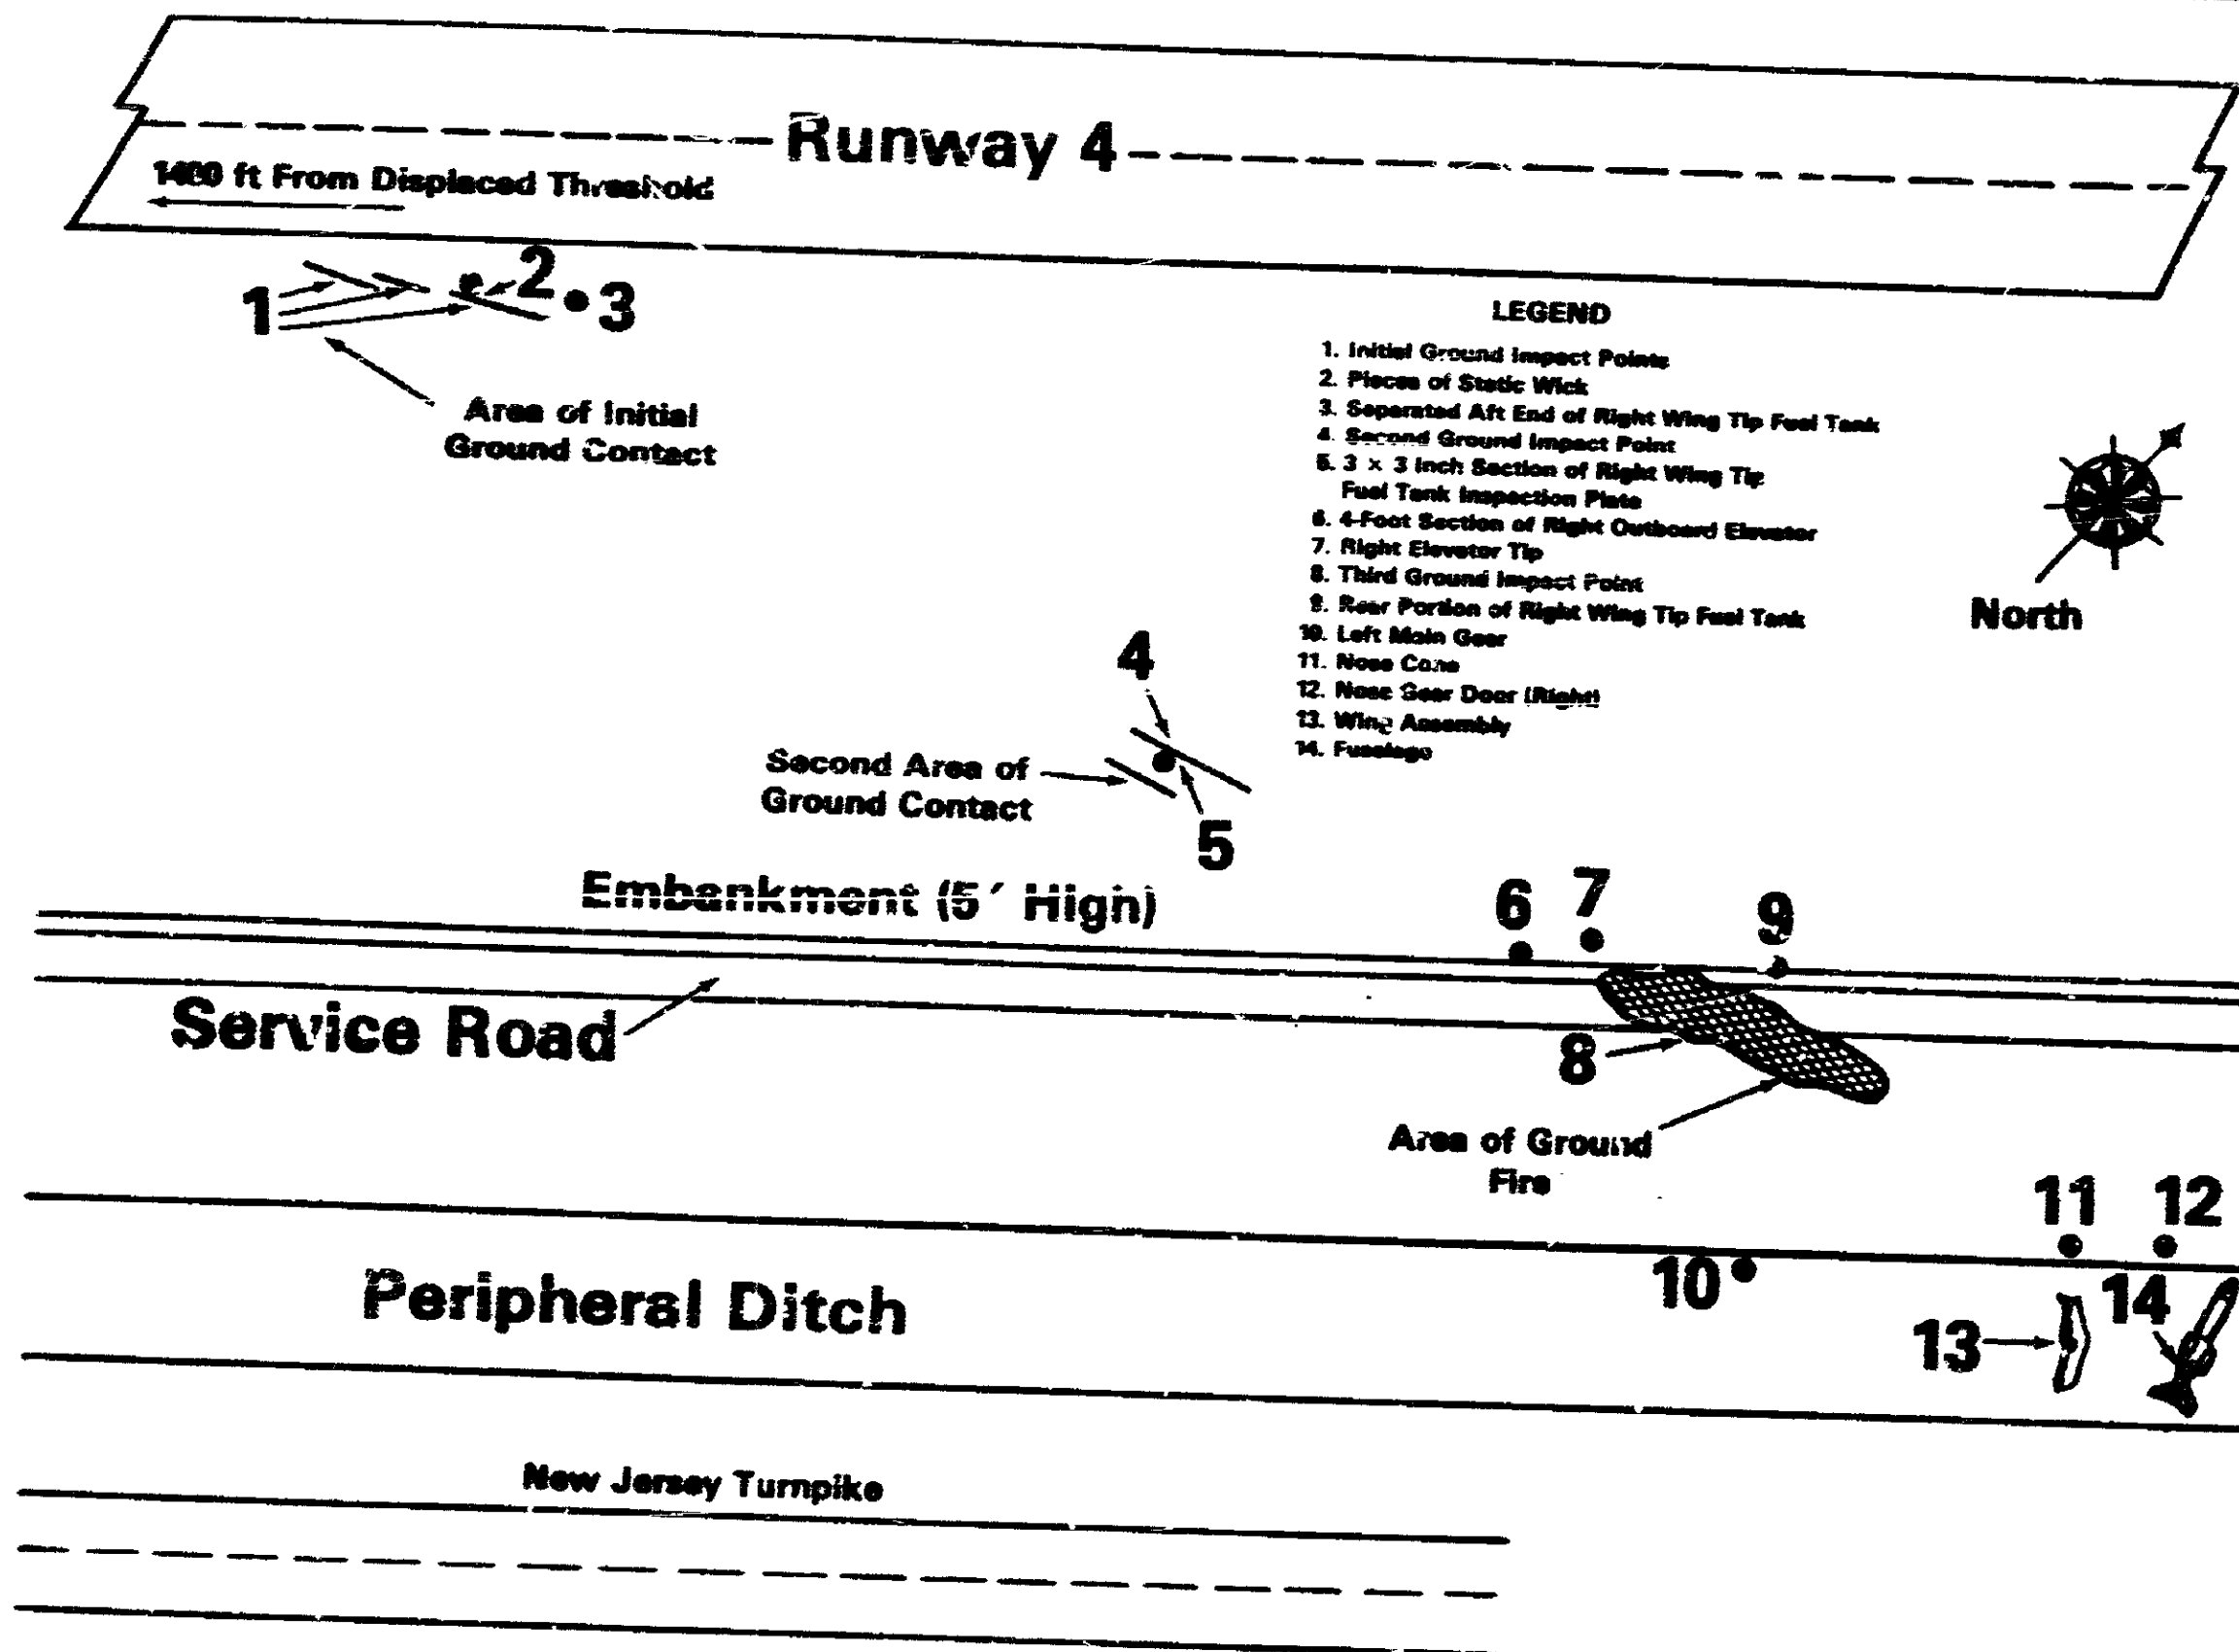
Figure 1.—Wreckage Diagram.

The airplane came to rest about 750 feet to the right of runway 4 right, about 1,500 feet from the point where it departed from the runway. (See figure 1.) The fuselage came to rest partially submerged in a canal alongside the New Jersey Turnpike. The wing section came to rest about 50 feet from the fuselage in the middle of the canal. The airport crash/fire/rescue crew extinguished the ground fire about 3 minutes after the accident. The accident occurred during dawn at location 40° 42' N and 74° 10' W.

The first identifiable marks on the ground made by N51CA were found about 18 feet to the right of the edge of runway 4R about 1,400 feet beyond the runway displaced threshold. No marks made by N51CA could be located on the runway surface where it presumably touched down. The initial impact area was an area of three ground scars made by the right wingtip fuel tank and the landing gear. The scars were aligned about 30° to the right of the runway heading. (See figure 1.) A second area of ground impact was located about 600 feet beyond the initial marks along a path oriented about 070°. These marks were gouges made by the right wing and right horizontal stabilizer/elevator.

There was evidence of fuel spillage and ground fire in the area of the road and up to the edge of the drainage ditch. Fire had damaged a small area on the left lower fuselage aft of the wing root attachment. The remainder of the airplane was not burned.
