PB94-910402  
NTSB/AAR-94/01

## AIRCRAFT ACCIDENT REPORT

RUNWAY DEPARTURE FOLLOWING LANDING  
AMERICAN AIRLINES FLIGHT 102  
McDONNELL DOUGLAS DC-10-30, N139AA  
DALLAS/FORT WORTH INTERNATIONAL AIRPORT, TEXAS  
APRIL 14, 1993

**Abstract:** This report explains the runway departure of American Airlines flight 102, a DC-10-30, after landing at Dallas/Fort Worth International Airport, Texas, on April 14, 1993. The safety issues discussed in the report include weather conditions affecting the flight, flightcrew and air traffic control training and procedures, airplane emergency evacuation lighting, and runway maintenance. Recommendations concerning these issues were made to the Federal Aviation Administration, Dallas/Fort Worth International Airport, and American Airlines, Inc.

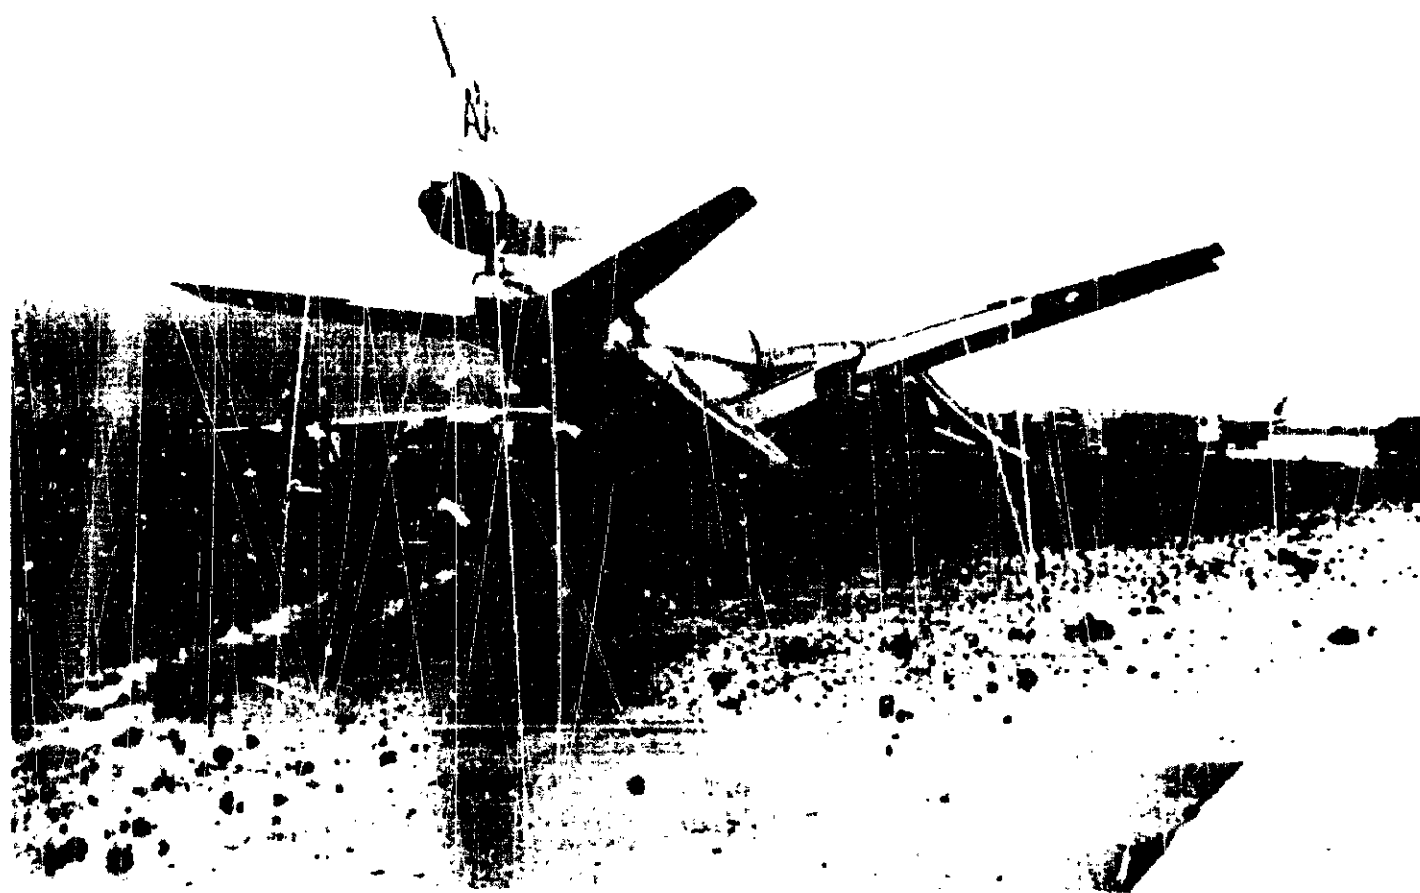
The first tire marks found on the runway were traced to the left and right main landing gear, and started at 4,303 feet from the beginning of the runway. The tracks approximately paralleled the runway centerline for about 1,700 feet, then turned gradually to the right until they departed the runway.

Figure 3b.--Tire marks on high speed taxiway 3S, and trenches in the soil leading to the final resting position of the airplane.

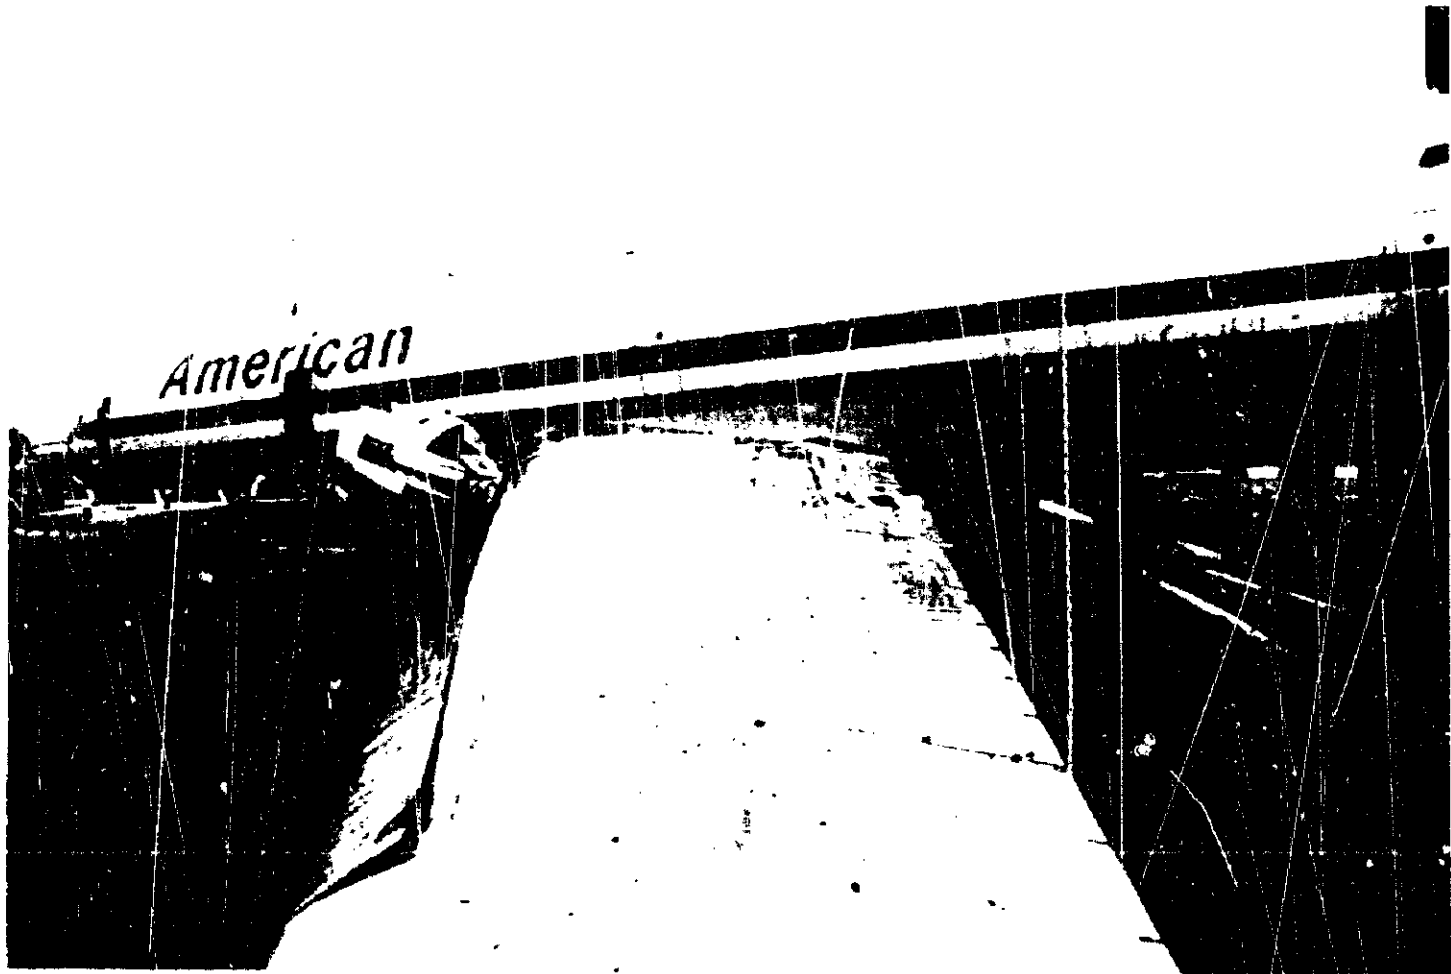
Figures 4a and 4b.--Airplane resting attitude and location.

The airplane came to rest supported by the forward fuselage, the center and right main landing gear, and the left wing and No. 1 engine. The left main gear strut was fractured and the nose gear strut was folded aft. The airplane came to rest slightly nose low and about 10 degrees left wing low. In its final resting position, the left wing and forward fuselage, as well as the right main and center gear, provided support and areas of ground contact.

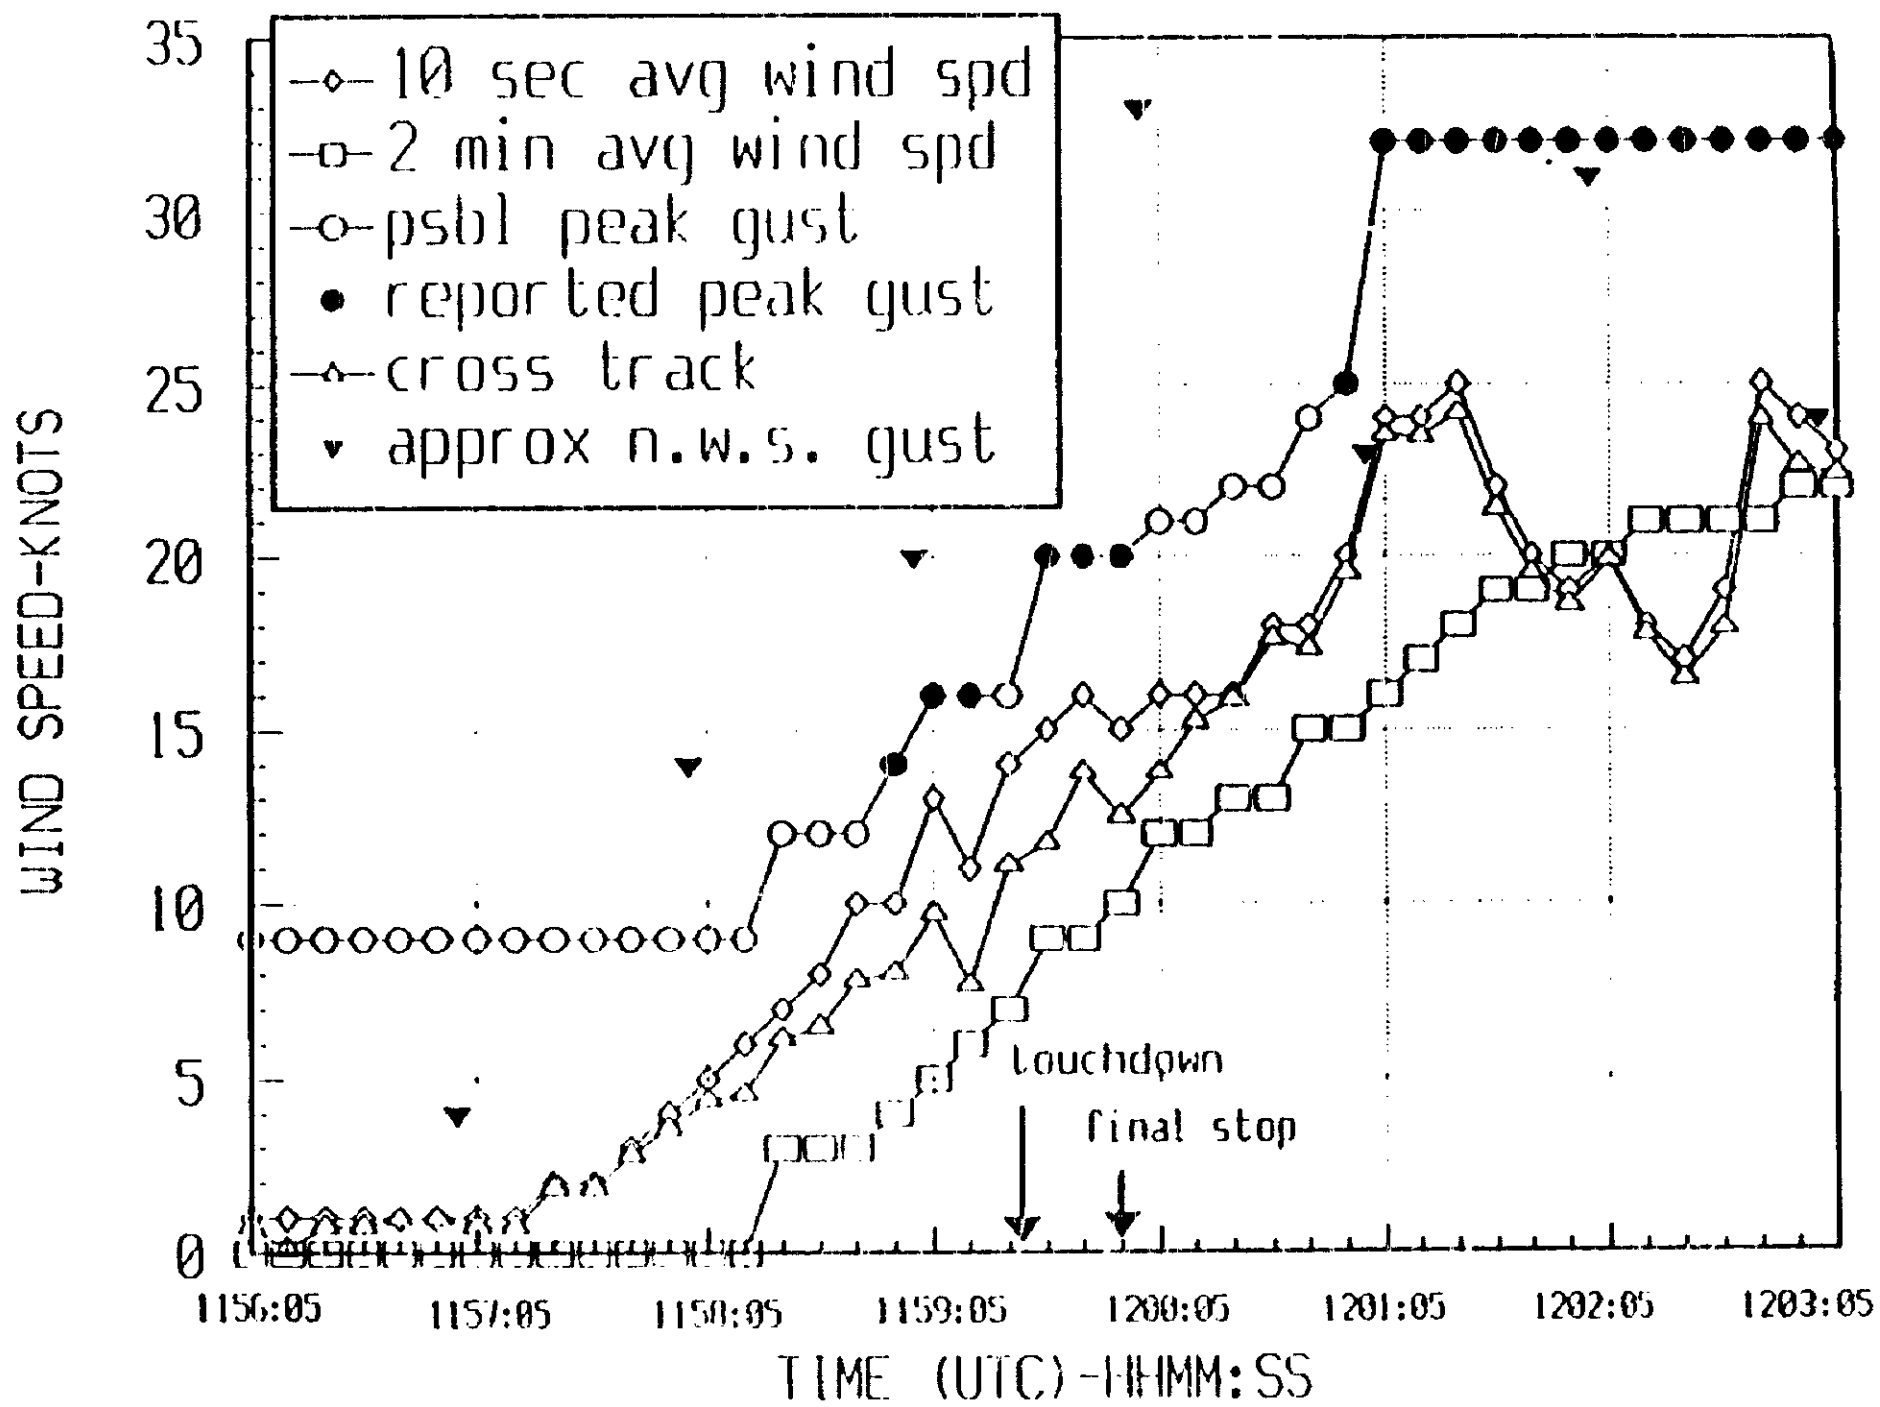
Figure 5.--LLWAS data.

all six sensors. The northwest, west, and center field sensors were found to be out of tolerance. The three anemometers were shipped to the manufacturer and under direction of the Safety Board's Investigation Weather Group Chairman, the "out of tolerance" anemometers were further evaluated. The sensor from the center field was found to be within manufacturer's tolerances. The generator output from the sensor from the northwest DFW field position was found stable, and tested root mean square errors were found only slightly out of tolerance. The sensor from the west field station at DFW failed potentiometer tests in nearly every direction, with high root mean square errors.

Belfort Instrument, the manufacturer of the sensors, concluded that the northwest and center field sensors were unlikely to have contributed to significant LLWAS errors. Considering the large magnitude of error in the west sensor's potentiometer, the manufacturer surmised that the potentiometer may have been damaged by an electrical transient.
