## AIRCRAFT ACCIDENT REPORT

CRASH DURING EMERGENCY LANDING  
PHOENIX AIR  
LEARJET 35A, N521PA  
FRESNO, CALIFORNIA  
DECEMBER 14, 1994

**Abstract:** This report explains the accident involving the Phoenix Air Learjet 35A that crashed while attempting an emergency landing at Fresno Air Terminal, Fresno, California, on December 14, 1994. Safety issues in the report focused on maintenance, inspection and quality assurance. Safety recommendations concerning these issues were made to the Federal Aviation Administration, Phoenix Air, and the Department of Defense.

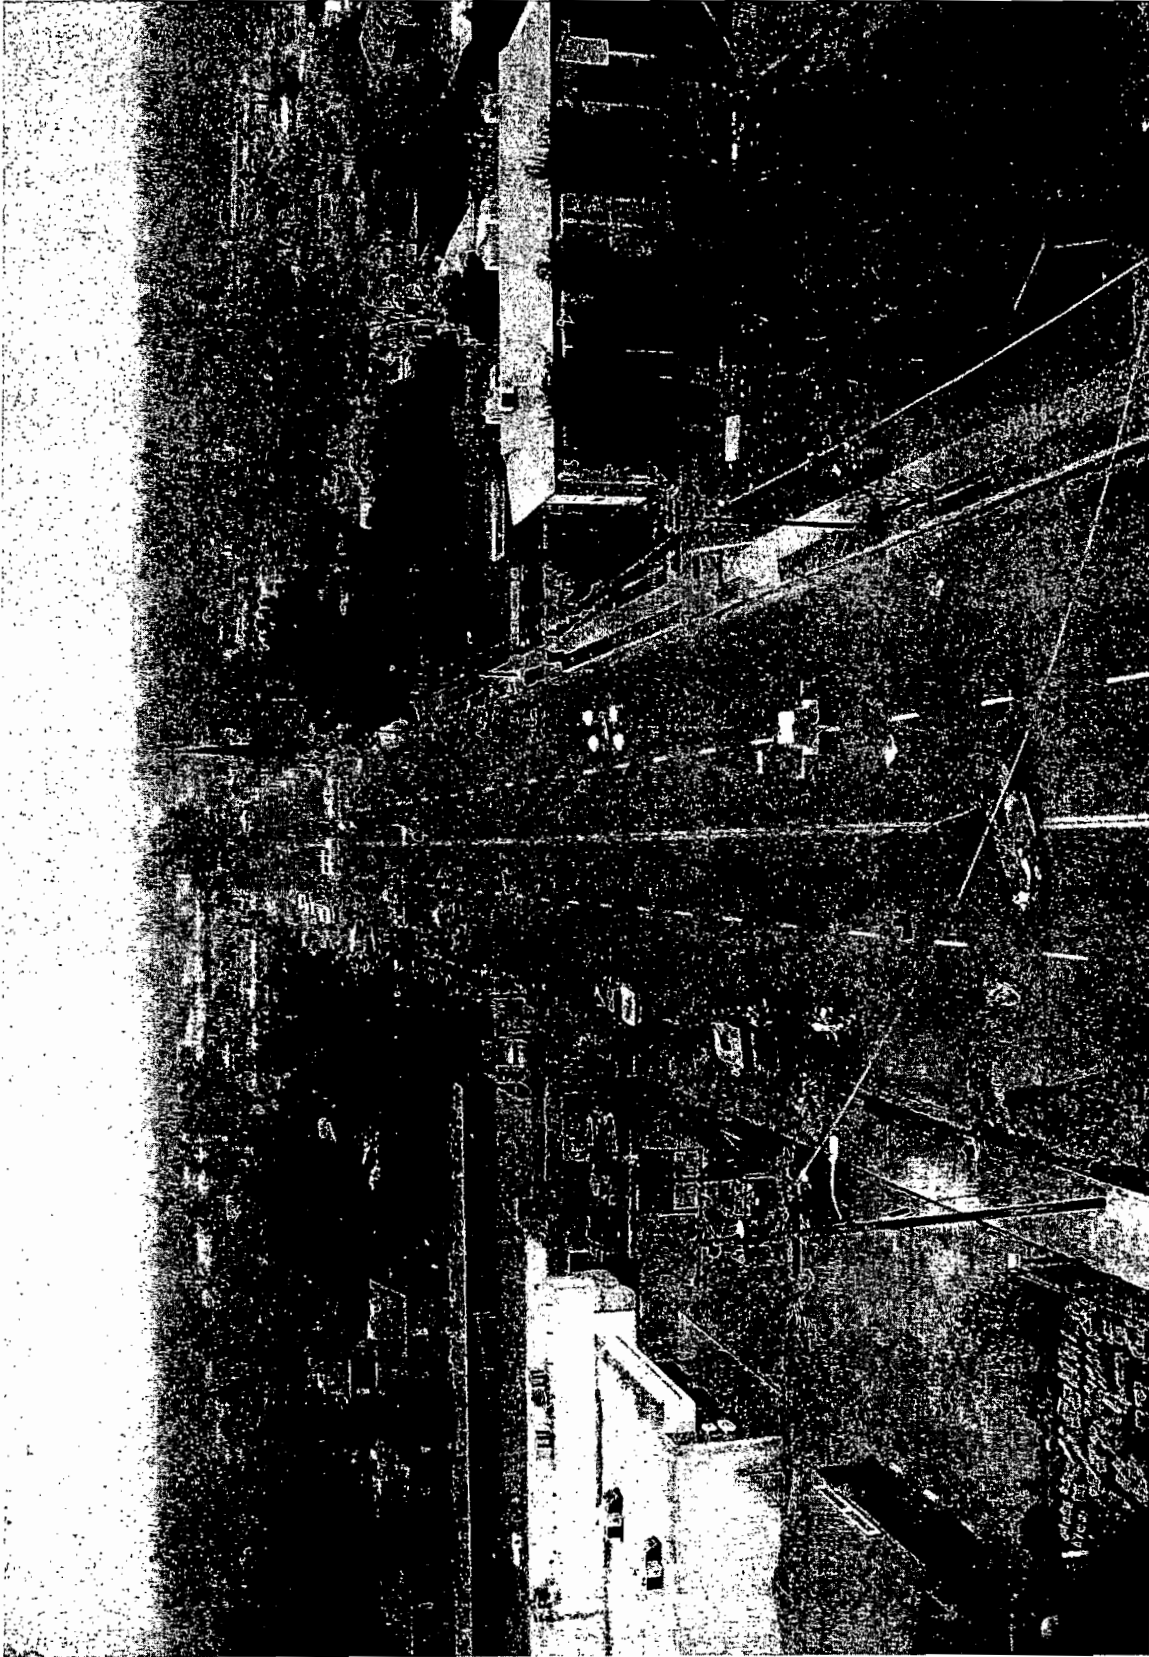
Figures 2b.--View to the east on E. Olive from immediately east of N. Sierra Vista. Last major portions of wreckage in wreckage path are near the bottom of the photograph.

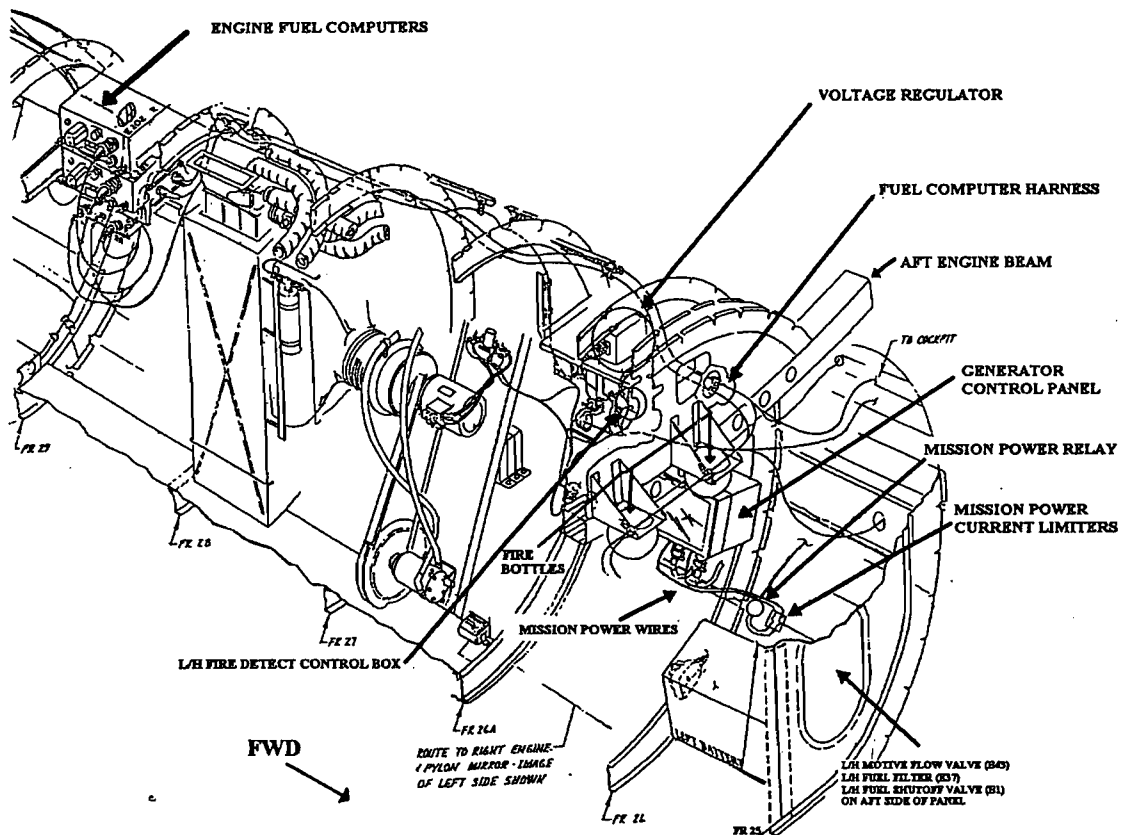
Figure 3a.--Components in tailcone.

The investigation found that in the actual mission equipment wiring of N521PA, the power wires were routed directly to the battery charging bus. (Figure 3a is a drawing of major components in the tailcone. Figure 3b shows the intended versus actual routing of the power wires in N521PA.)

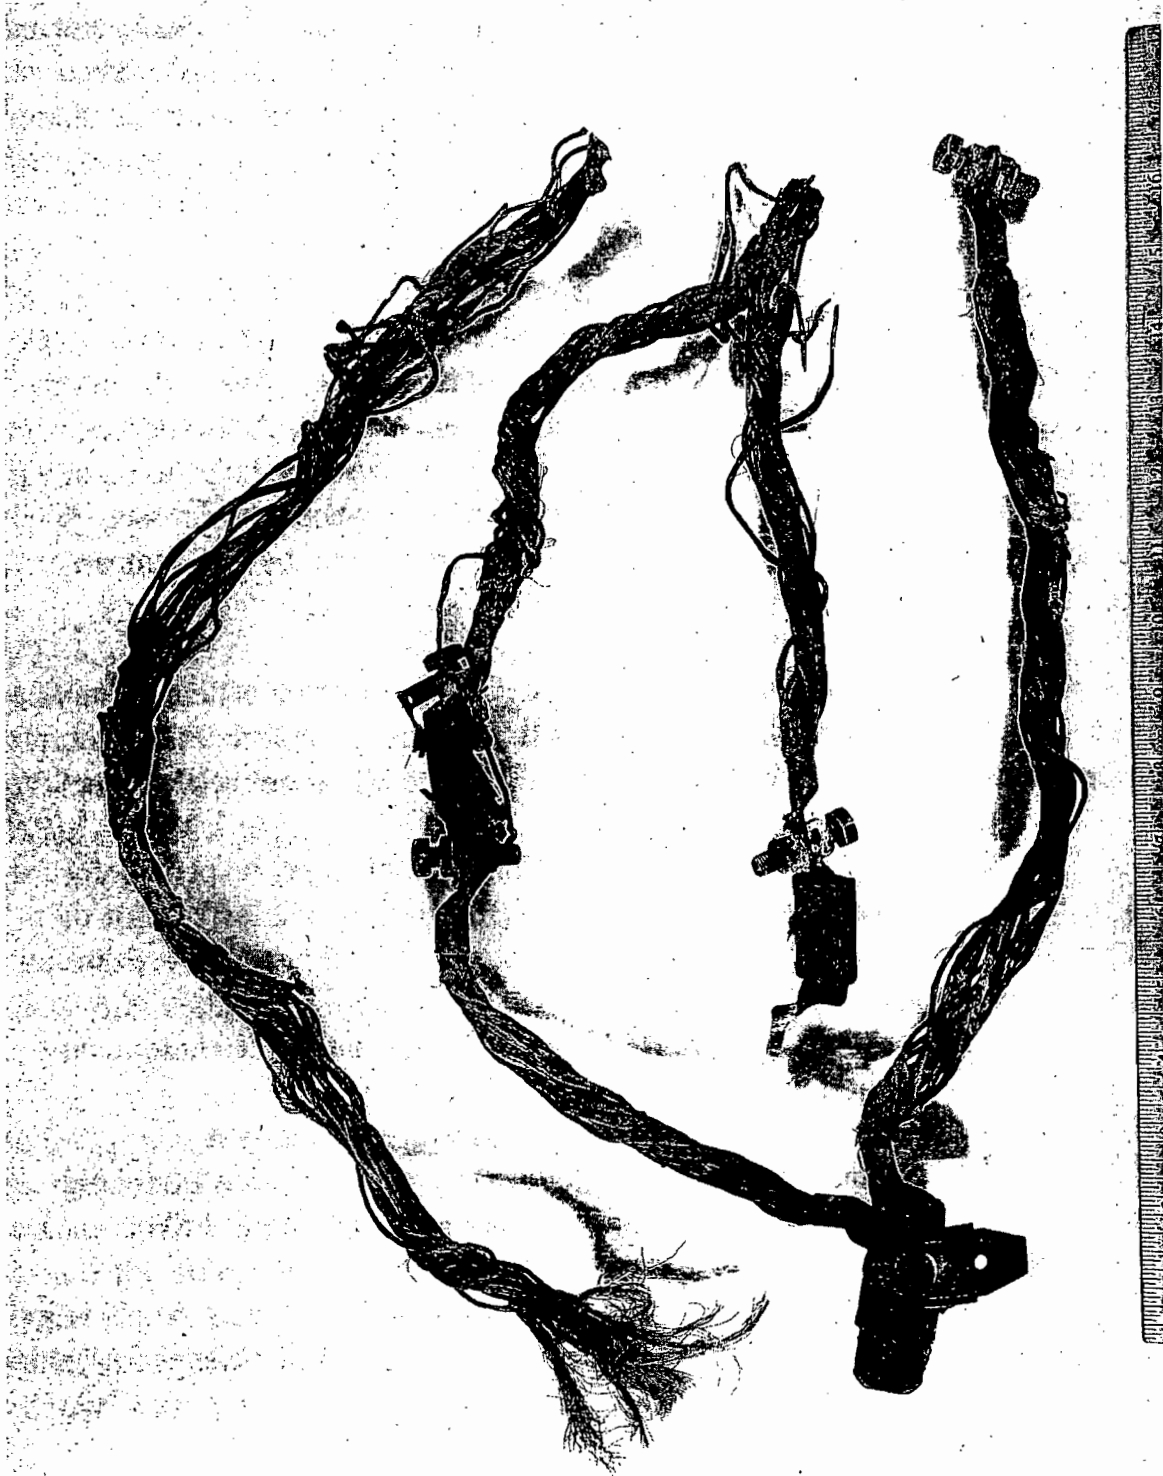
Portions of the wires, identified as part of the electrical power source for the special mission package, were size No. 0 awg and were found on E. Olive, near the wheel of an unburned vehicle. The wires had evidence of high heating prior to impact, including areas fused together for about 2 inches in length, and individual strands of the wires had a beaded appearance. (See figure 4.) Current limiters (fuses) were found attached to the nonwelded ends of one of the two sets of wires. In subsequent testing, the current limiters were found to provide electrical continuity (in the closed position).

Figure 4.-- View of cables as received for examination.
