**DATA SUMMARY**
**LOCATION**

| Registration | <b>EC-IBY</b> |
| Type and model | <b>PILATUS PC-6 B2-H4 Turbo Porter, S/N: 815</b> |
| Operator | <b>Skydive Lillo</b> |

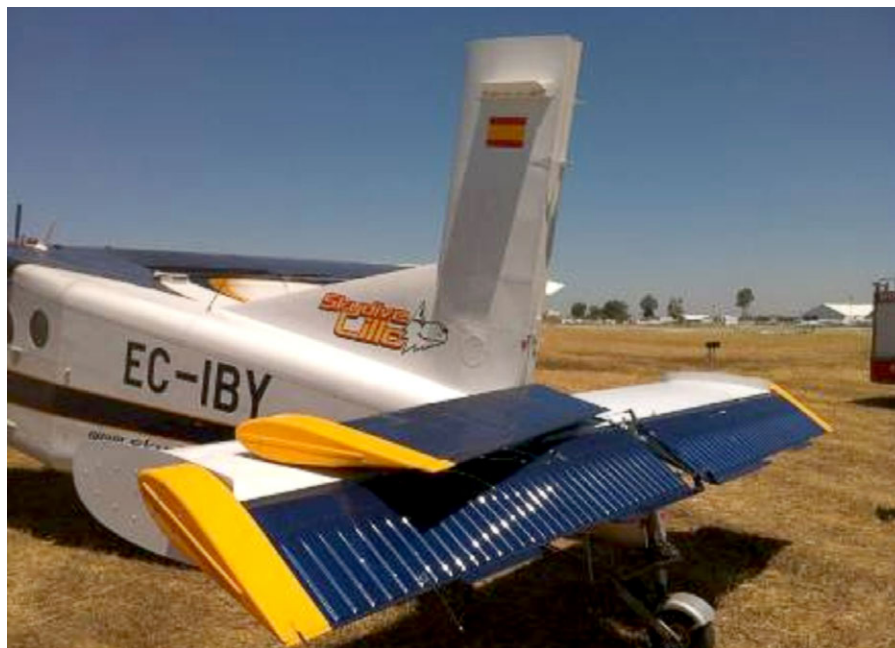
Figure 1. Condition of the tail section after landing

An examination of the aircraft revealed that the upper axle on the rudder and the point where it attached to the tailfin were missing. This caused the lower support to bend and partially break, along with the torsion tube and the rudder, which fell to the left on top of the left horizontal stabilizer and associated elevator, as shown in figures n.º 1 and n.º 2. The skin on the left elevator had been torn by the rudder trim tab lever, which limited the rearward motion of the rudder after it fell on the stabilizer.

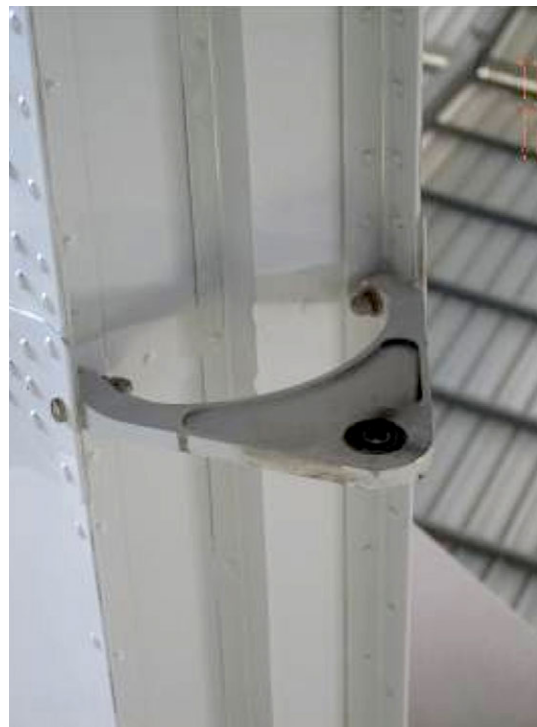
The design of the PC-6 is over 50 years old and thus follows the criteria used back then. For example, the direction of the hinge bolt on the rudder, from bottom to top, which from a modern perspective is not a recommended practice.

Close-up 1. Rudder support fitting in the tailfin

Based on this event findings happened in Evora, Pilatus reviewed the design of the rudder hinge bolt and have plans to modify it in a way that the bolt is now installed from the top. Pilatus informed that this modification is outlined in the recommended SB 55-003 which will be issued soon.

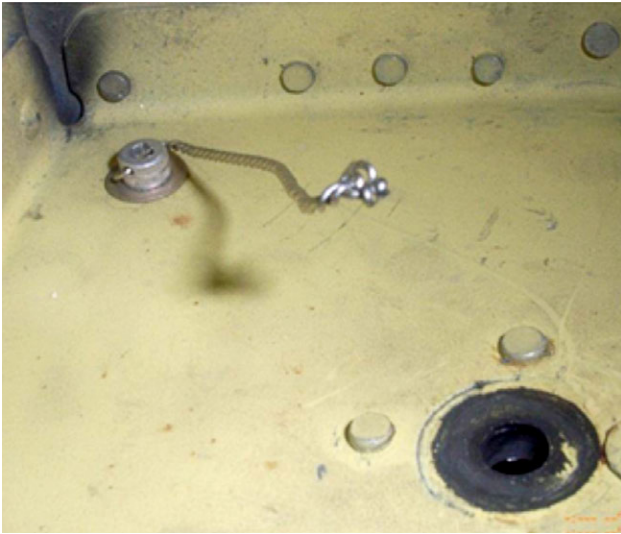
When the service cover for the removal/installation of the rudder was opened, the missing upper hinge bolt was not found within the rudder structure. It is presumed that the bolt was lost during the flight. Only the bolt's washer was found inside the rudder, along with the lockwire, which was attached to the locking screw. The lockwire itself was broken and twisted at the hinge bolt end (see figure n.º 2). The locknut on this screw was found riveted in place, on the top part of the tooling hole.

Figure 2. Lockwire on the rudder's hinge bolt

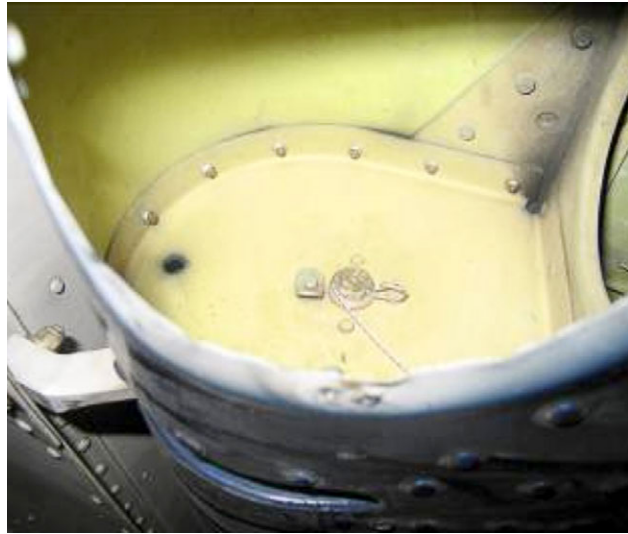
The outboard hinge bolts on both elevators were examined through the service covers. These were also modified by SB 55-001 Rev. 1, as noted in point 1.2.1. The lockwires on both were found to be installed in the counter clockwise, or loosening, direction (see Close-up 2).

Close-up 2. Lockwire on the left elevator hinge bolt, installed counterclockwise

- The improper installation of the lockwire on the hinge bolts on both elevators was verified on the aircraft (counterclockwise, opposite the tightening direction).

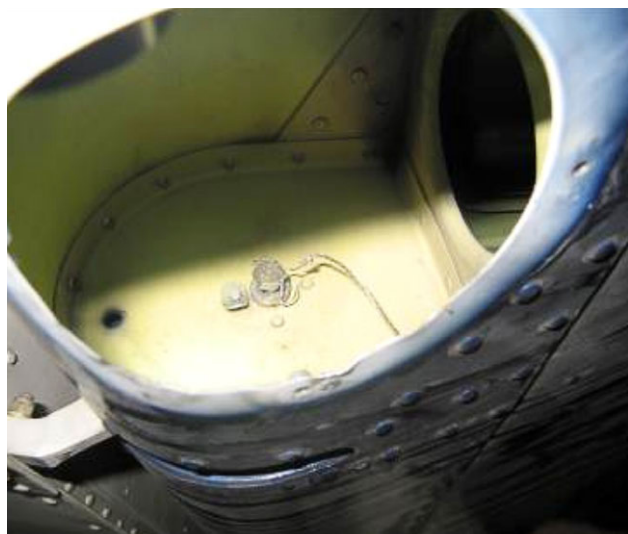
To check the behavior of one of these components in the as-found condition, the hinge bolt on the left elevator was loosened, with the following result: the torque needed to start it turning was 70 lb./in. (the tightening torque specified in the SB is 45 lb./in. plus the run-down torque). The lockwire allowed the bolt to be rotated  $2/3$  of a turn without offering any resistance. The wire remaining after this initial turn allowed the bolt to continue loosening. The force needed to loosen the bolt kept decreasing gradually after the initial turn. The lockwire broke before the hinge bolt was out of the hole, its final appearance being very similar to that of the lockwire on the rudder hinge bolt (see figure 3).

Figure 3. Lockwire on the left elevator hinge bolt, after being broken

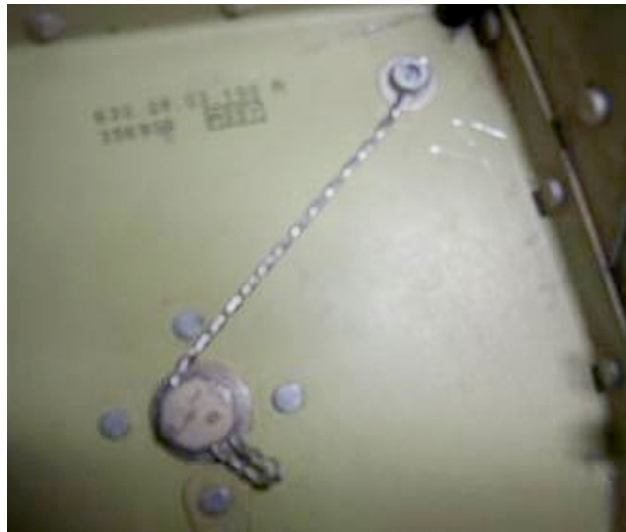
In both aircraft the directive and SB were verified to have been properly implemented with the correct installation of the lockwires on the hinge bolts, none of which showed signs of loosening.

Figure 4. Example of SB implementation on the right elevator of another aircraft
