Report EXT Punta Cana 2009

Accident involving an Airbus
330-343 aircraft, registration
EC-JHP, in Punta Cana
International Airport
(República Dominicana),
operated by Iberworld (Orbest),
on 18 January 2009

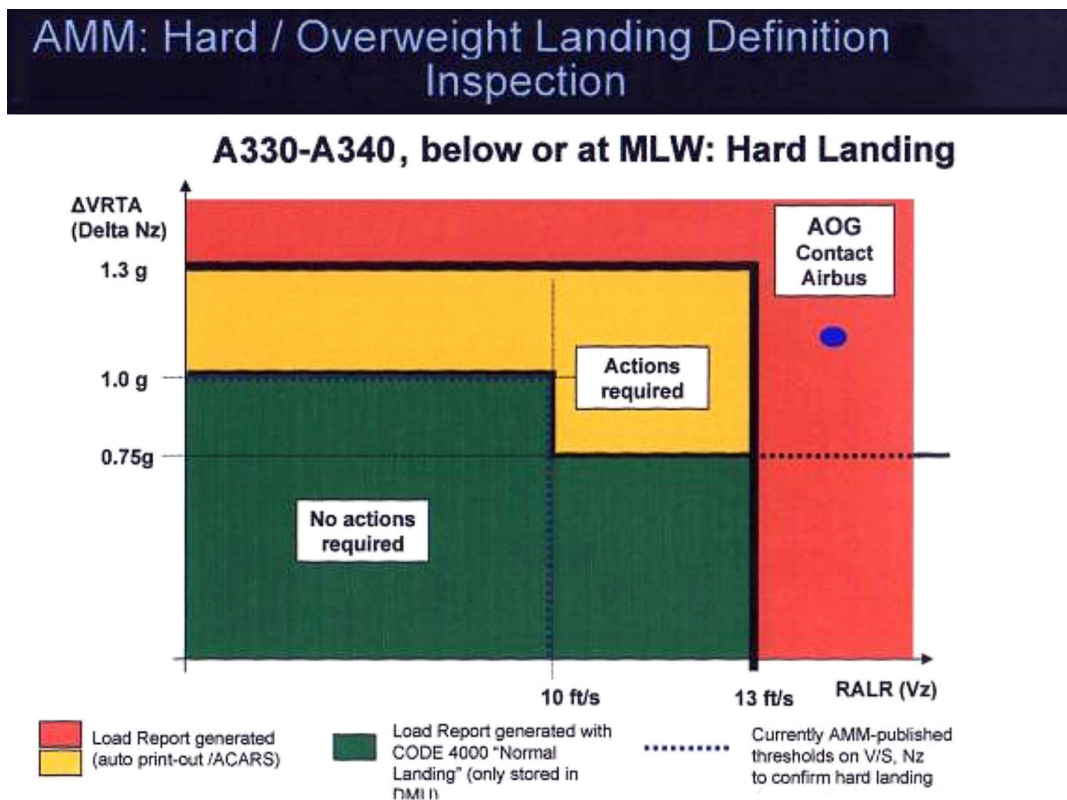
Figure 1. Landing zones

The DFDR data confirmed the severity of the hard landing experienced during the incident, classified as being in the AOG Zone, in keeping with the criteria of the diagram in Figure 1, which is taken from the airplane's Maintenance Manual, with a delta value for vertical acceleration of 1.11 g's and a descent rate of 14.7 ft/s.

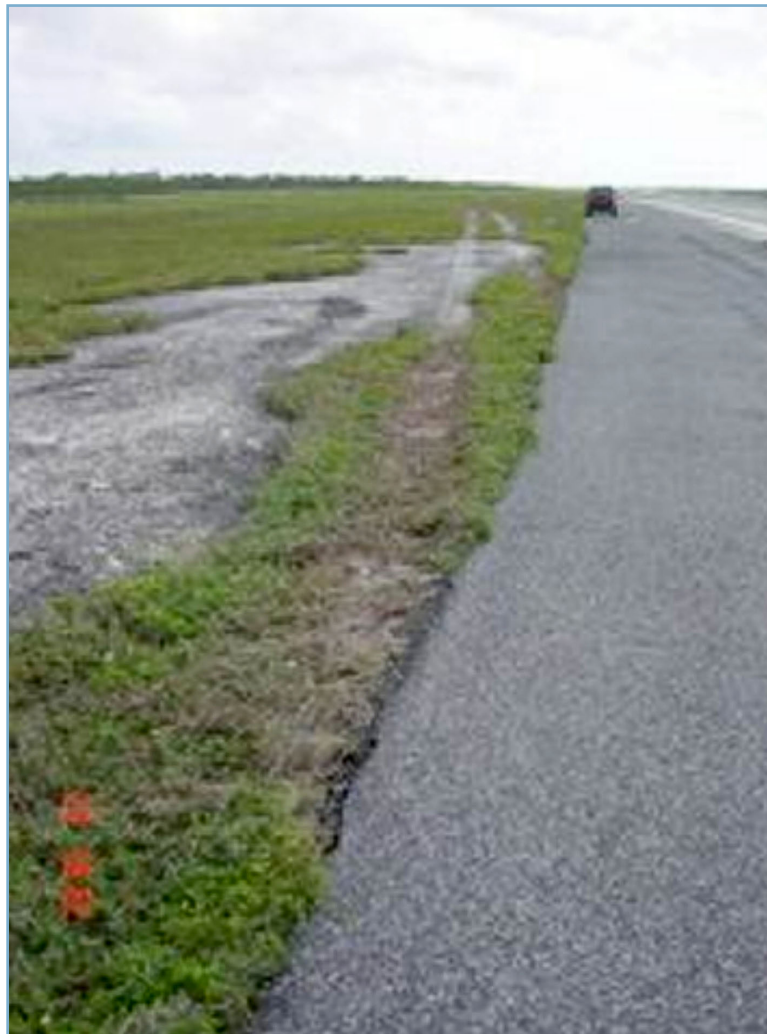
Figure 2. Tracks of left main landing gear

The tracks left by the airplane on the landing run allowed investigators to accurately reproduce its path as it departed the runway to the left, see Figure 2. The ground was fairly compact and able to absorb the load from the tires without having them sink. The tracks reached a depth of 15 cm. The total length of the runway excursion was about 650 m (figure 2) (figure 3).

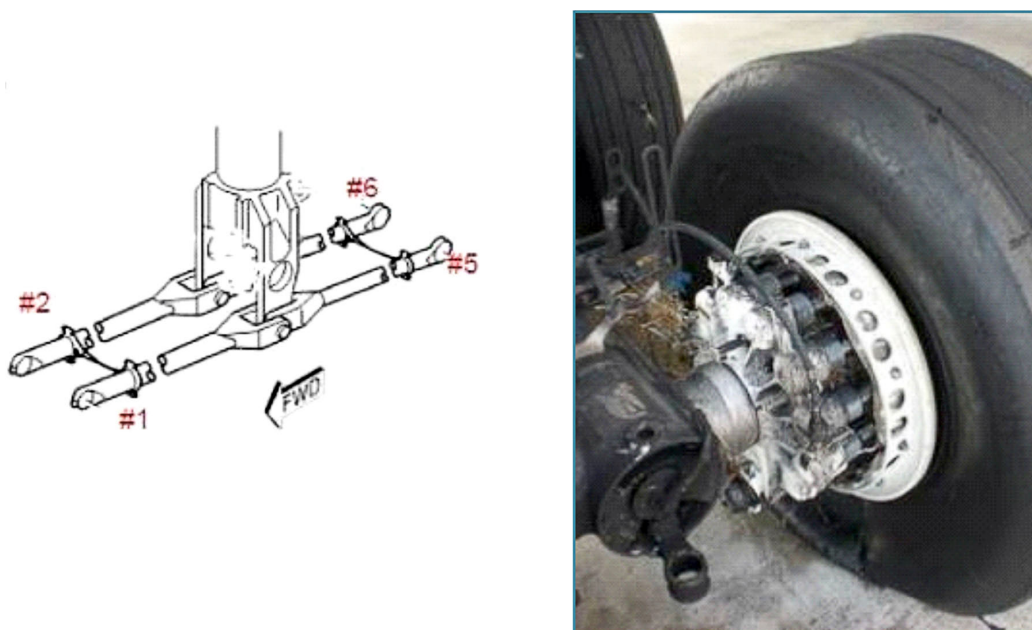
The nose gear (NLG) and the right main landing gear (MLG RH) were intact, though tire #6 on the left main landing gear (MLG LH) blew out (figure 4).

Figure 4. Close-up of MLG LH. Condition of tire

All of the damage found resulted from scratches and impacts with material that was lifted from the ground or with debris from the blown tire and the runway lights and signs that were run over by the airplane.

The main struts had no apparent damage but were replaced as a precaution and inspected for overloading.

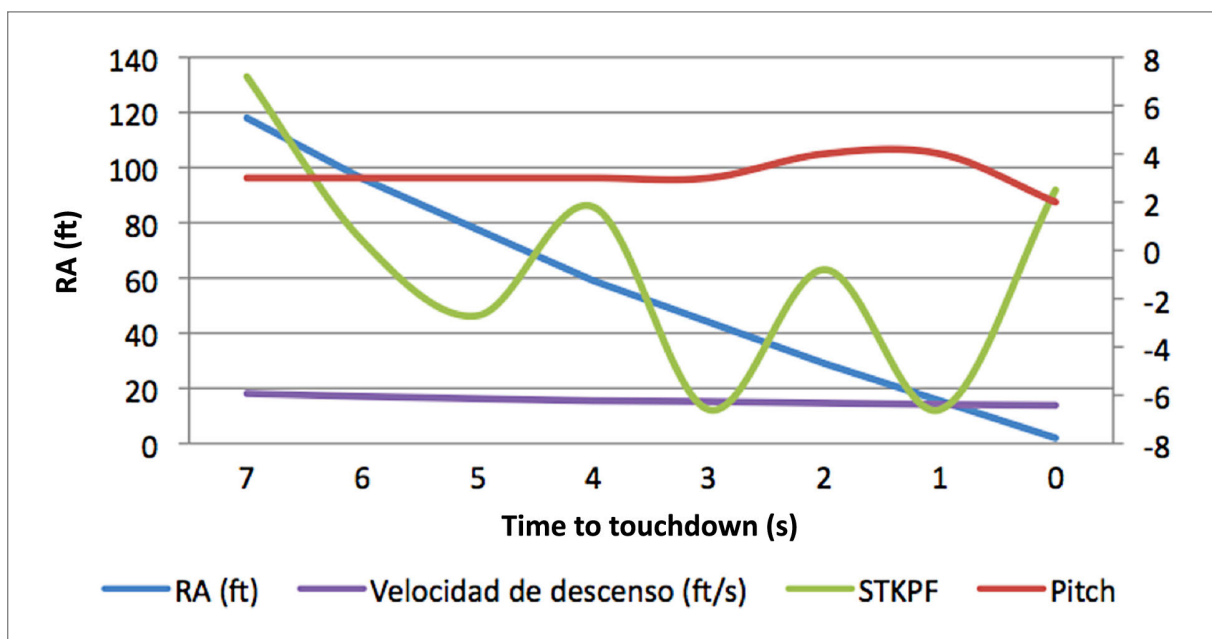
Figure 11. Pitch inputs to sidestick

- Pitch inputs were made to the sidestick (STKPF >0) after the start of the flare. The pitch angle was between 4° and 2° (figure 11). The left spoilers deployed before touchdown. CAS was 135 kt and the vertical speed was 14 ft/s. The pitch angle on touchdown was 4.2° . A vertical acceleration of 2.109 g's was recorded at the instant of touchdown.

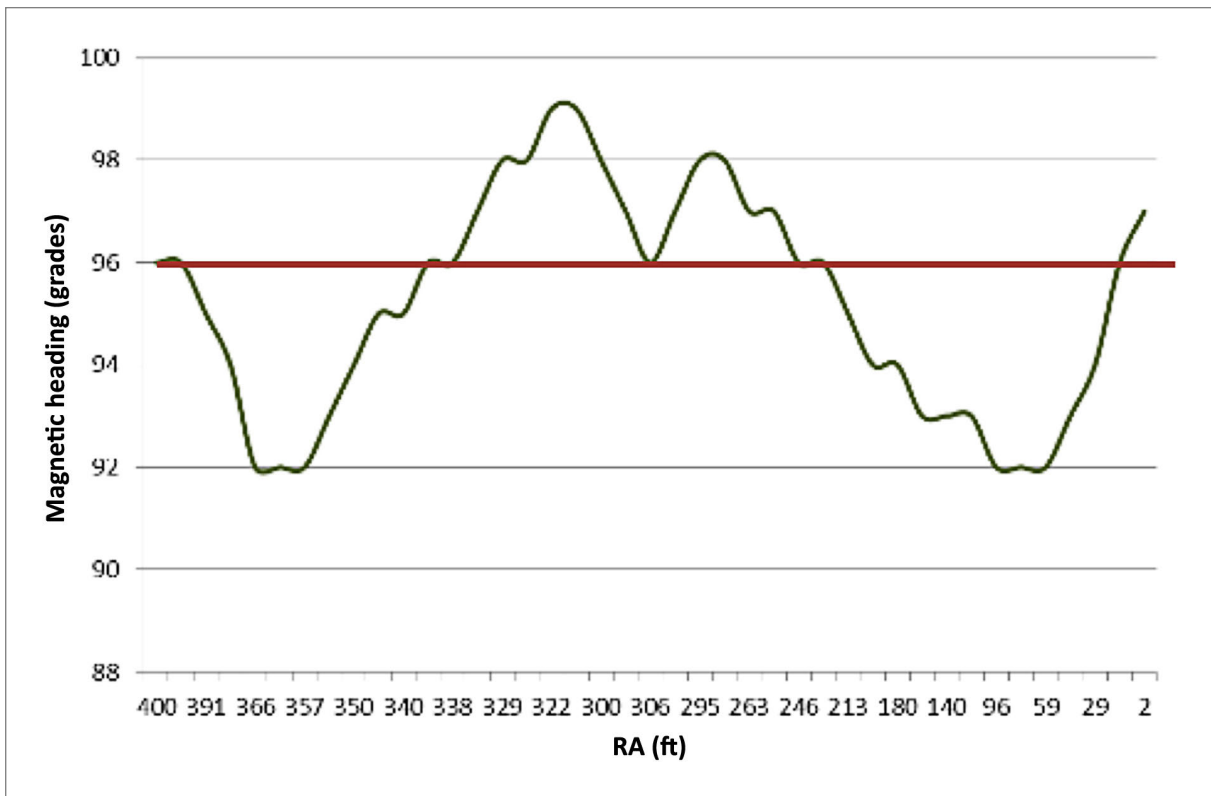
Figure 12. Variations in aircraft heading

Figure 12 shows the aircraft heading with respect to that of the runway (96°).

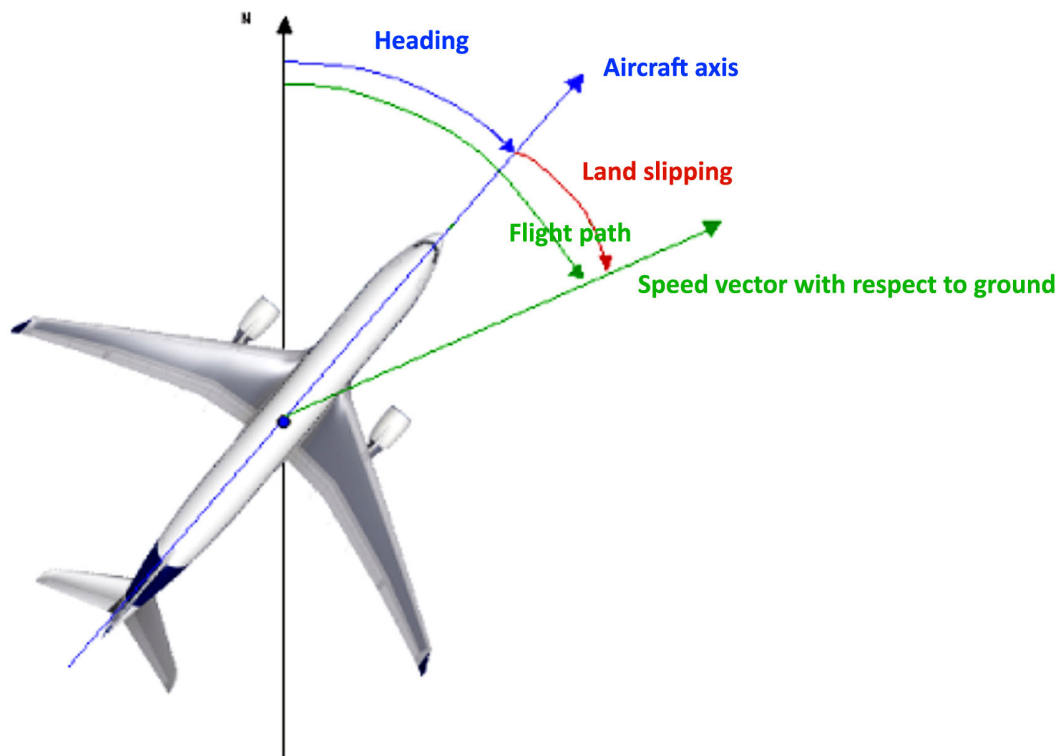
Figure 14. Heading, flight path and ground slip angles

When it first made contact with the ground, the aircraft was oriented 3° right of the runway centerline and the flight path was 2° left with respect to the runway centerline, meaning that the aircraft's slip angle was 5°.

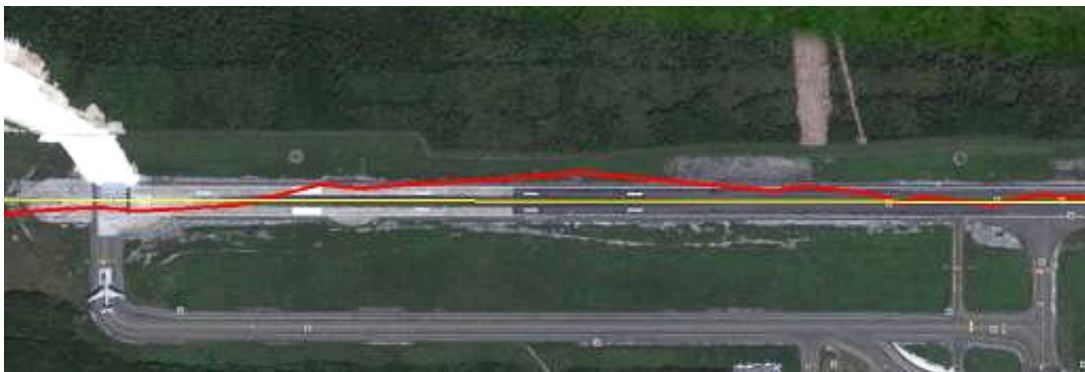
Figure 15. Representation of the runway excursion made by the aircraft

- The lateral acceleration reached a value of 0.566 g's four seconds after the initial contact, indicative of a high acceleration to the right coinciding with the deployment of the ground spoilers.
- The heading and trajectory were the same ten seconds after touchdown.
- The aircraft's coordinates during its trajectory, as determined by the primary navigation system, were recorded by the DFDR. These are shown in Figure 15 overlaid on a digital photograph of the terrain. The diagram shows how the airplane deviated on short final, turned toward the runway centerline and then deviated again after touchdown.
