Date: November 18, 2013

UNEXPECTED AUTOPILOT BEHAVIOUR ON ILS APPROACH

Potential severe pitch-up upset when intercepting the instrument landing system (ILS) glide slope from above, which can lead to (approach to) stall conditions.

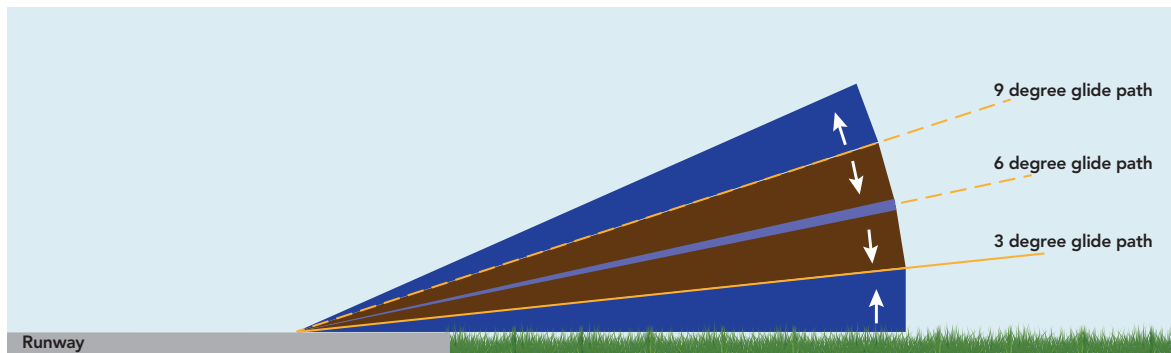
Analysis of the measurements show that between the 3 and 9 degree glide path, signal strength changes. For the pilot this can result in observable movement of the ILS glide slope marker on the primary flight display. At this time two important characteristics of the M-array ILS antenna 'glide slope field' have been identified:

1. A signal reversal was always present at approximately 9 degree glide path.
2. A signal reversal was sometimes present at approximately 6 degree glide path.¹

Figure 1: Cross section view of the M-array ILS antenna system. Schematic overview of the "Fly up"(blue) and "Fly down"(brown) indication.

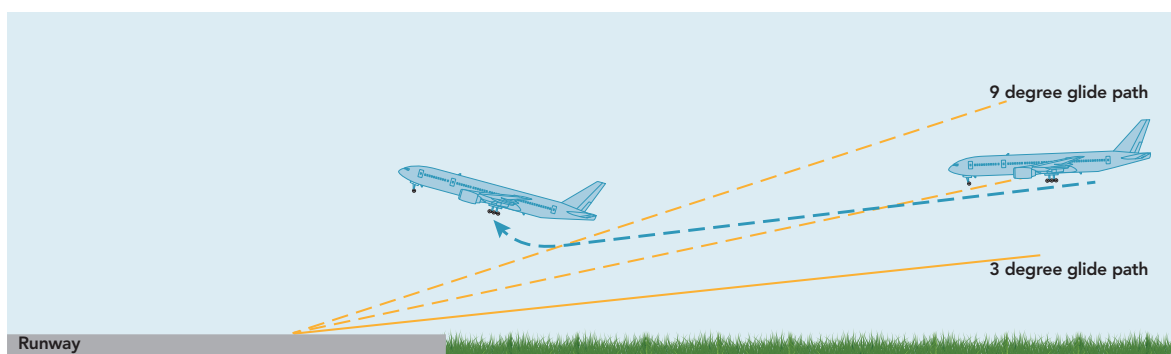
Figure 2: Example of glide slope capture with a pitch upset above 3 degree glide path.

Depending on the glide slope field, signal reversal occurs occasionally at 6 degree, and always at the 9 degree glide path. This reversal activates the glide slope capture mode after which the autopilot follows the glide slope signal without restrictions. During flight tests the reversal resulted in the automatic flight control system commanding a severe pitch-up. Immediate flight crew intervention was required to regain aircraft control.

Pilots should be aware of the ILS glide slope signal characteristics and the dangers accompanying flying in the area above the 3 degree glide path during the approach. In particular the aircraft behaviour while flying on autopilot with the glide slope mode armed should be noted.

Operators should consider the need to implement additional operational procedures or provide additional guidance in order to mitigate the risks of unexpected autopilot behaviour when on ILS approaches.
