DUTCH
SAFETY BOARD

Quarterly Aviation Report

July - September 2018

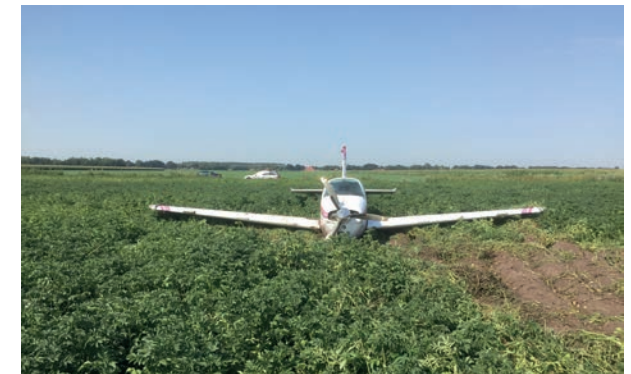
The single-engine plane registered in Germany with two people on board was en route from Norderney, a German island in the East Frisian Islands, to Nordhorn-Lingen Airport in Germany. In the vicinity of Bourtange (in the Province of Groningen), at an altitude of approximately 2,000 feet, the engine started to make a strange noise and lost full power shortly afterwards according to the pilot's statement. After performing a number of standard operations, which failed to increase the engine power, the pilot decided to perform an emergency landing. The pilot chose a potato field for this manoeuvre and performed the emergency landing with the landing gear retracted and without putting the flaps into the landing position. According to the pilot, this procedure was intended to prevent the aircraft from flipping over. The aircraft came to a standstill on its belly and sustained minor damage. The passengers were unhurt.

The shortened investigation by the Dutch Safety Board is focussing on the causes of the engine failure; the performance of the emergency landing procedure is not being investigated.

The Beechcraft A36 after the emergency landing.

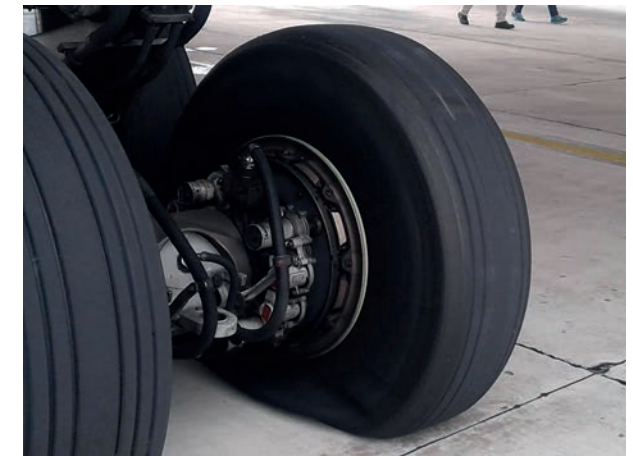
After a flight from Juan Gualberto Gómez Airport in Cuba to Cancun International Airport in Mexico, a deflated tyre and damage to a wheel rim were observed in the main landing gear of a Dutch-registered Boeing 787.

The flat tyre. (Source: Mexican DGAC)

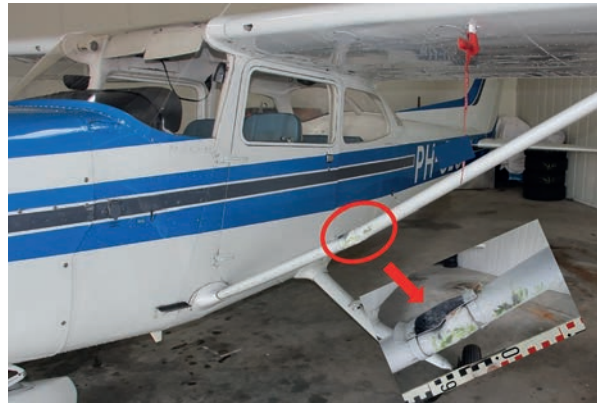
The Dutch-registered Reims F172 was on a cross-country flight to Stadtlohn in Germany. The Schleicher ASW 20, a glider, was making a local flight. The aircraft collided with each other, then landed at Borken Airport with substantial damage. The occupants were unhurt.

The Reims F172 and Schleicher ASW 20 after the collision. (Source: BFU)

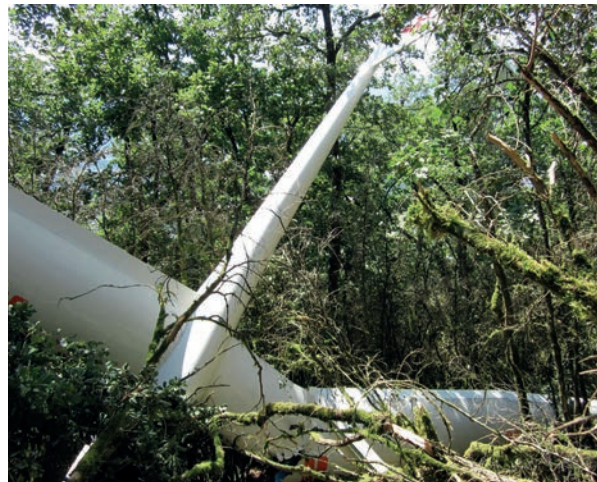
The Dutch-registered glider took off from Challes-les-Eaux in France with a pilot and an instructor on board. While executing a turn, the glider came too close to the mountainside. The instructor then took over control and set a course for the valley. Given the height of the terrain in the locality, this action was taken too late. As a result, the glider hit the treetops horizontally with its wings and lost speed. This circumstance caused the glider to crash. The pilot broke his lower leg, the instructor was uninjured. The glider was totally destroyed.

The Janus B after the accident. (Source: BEA)

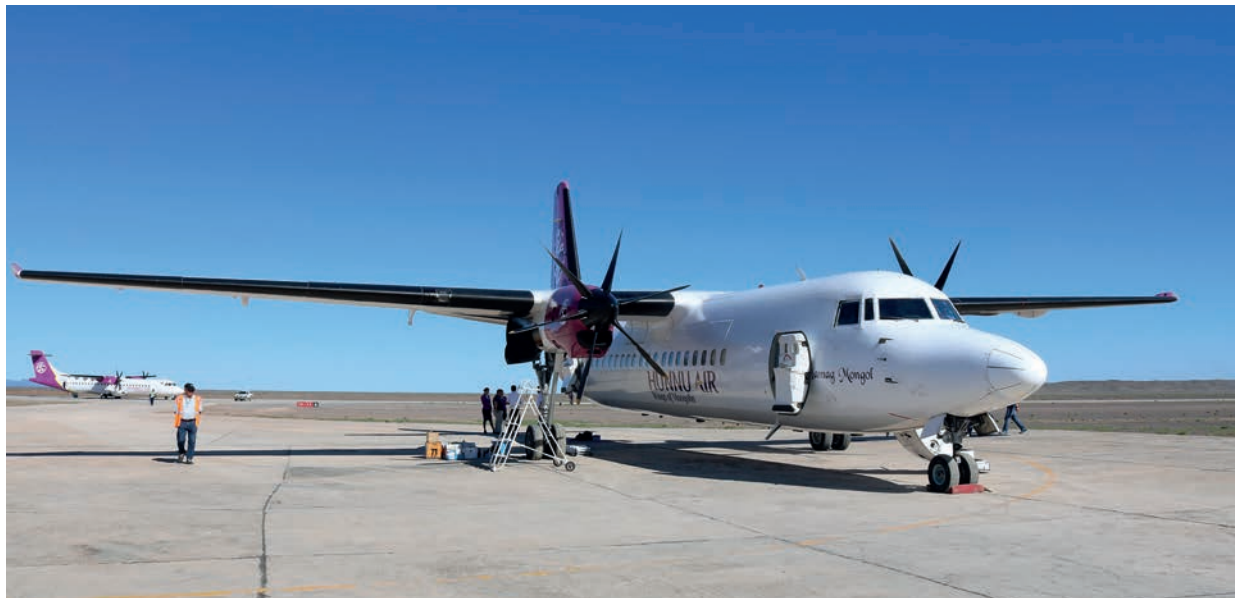
The Fokker 50, with five crewmembers and fourteen passengers on board, was flying from Ovoot Airport to Chinggis Khaan International Airport in Mongolia. During the climb away from Ovoot Airport, engine torque in the right-hand engine decreased. The crew decided to switch off this engine and return to the airport. The landing was completed without further problems.

The Fokker 50 after landing. (Source: Mongolian AAIB)

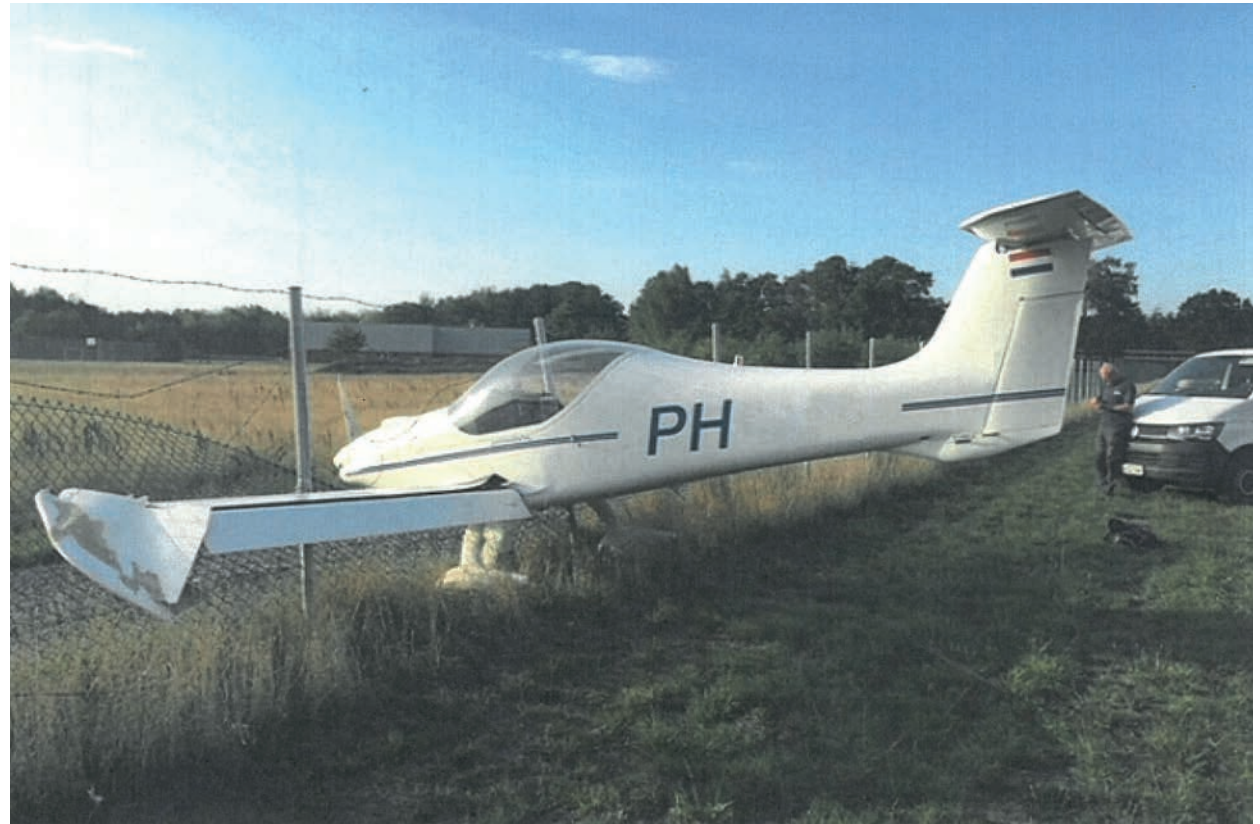
After a flight from Fassberg to Rotenburg in Germany, the aircraft veered off the runway during landing and suffered damage. The pilot and passenger were unharmed.

The plane after the runway excursion. (Source: BFU)

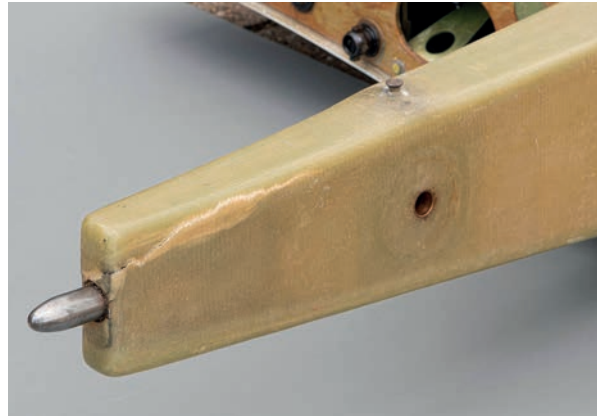
An inspection after the flight showed that the underside of the trailing edge of the left wing was cracked, close to the end of the glass-fibre reinforced plastic (GFRP) spar. Further investigation showed that the crack was already present before the incident. The aluminium insert in the wing spar had become detached from the GFRP material, which led to a certain degree of play that in turn caused severe, localised stresses in the spar. It is likely that the spar finally gave way due to the high stress at the end of the loop. The reason why the aluminium insert had come loose was impossible to establish with certainty.

Crack in the left wing spar. (Source: NLR)

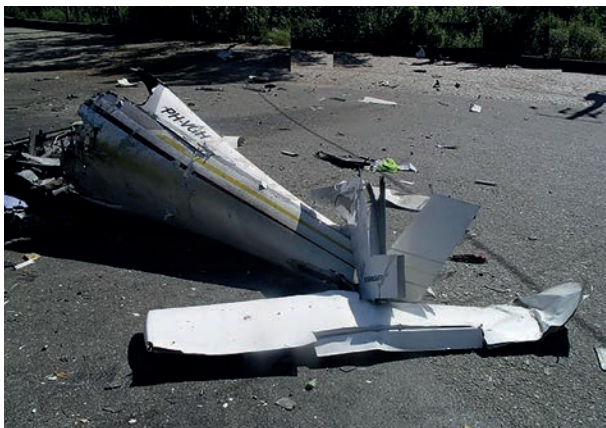
The pilot lost control of the aircraft as a result of asymmetrically extended flaps. This situation was caused by the failure of the flap operating system, which in turn was caused by a worn bronze nut in the actuator. An Airworthiness Directive applies to this nut, which states that the nut must be replaced; however, this replacement was not done.

Wreckage of PH-VGH. (Source: GPIAA)

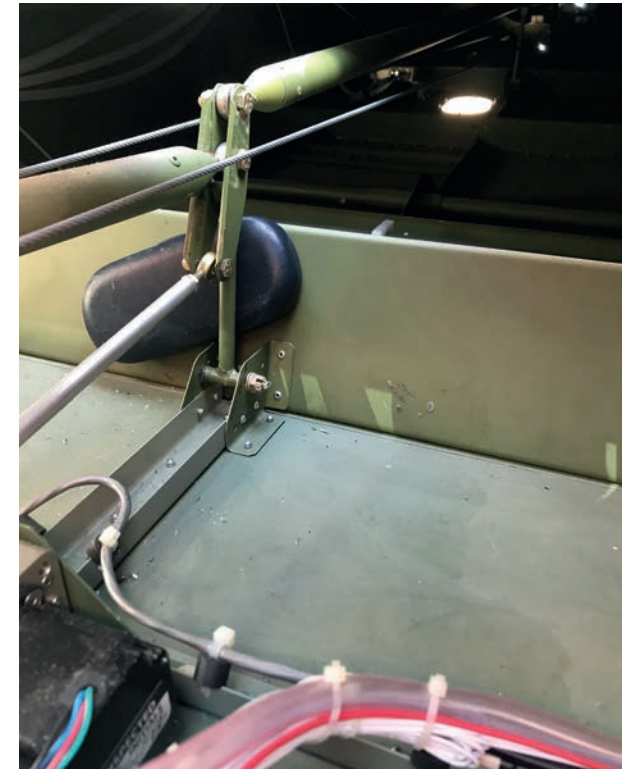
After the emergency landing, a glasses case was found in the vicinity of the control mechanisms. The crew stated that the sudden nose dive could not have been caused by this glasses case, because the plane had been flying steadily on autopilot without any course or altitude corrections. According to the crew, the case ended up in that position due to the jolt of the emergency landing or when they were taking their personal possessions out of the plane.

The Dutch Safety Board did not visit the crash site and was unable to establish how or when the glasses case came to be in the vicinity of the control mechanism. The Dutch Safety Board did not conduct an investigation into the functioning of the electric trim or autopilot and can neither confirm nor rule out the glasses case scenario as a possible cause of the operating problems.

The glasses case. (Source: Police aviation division)

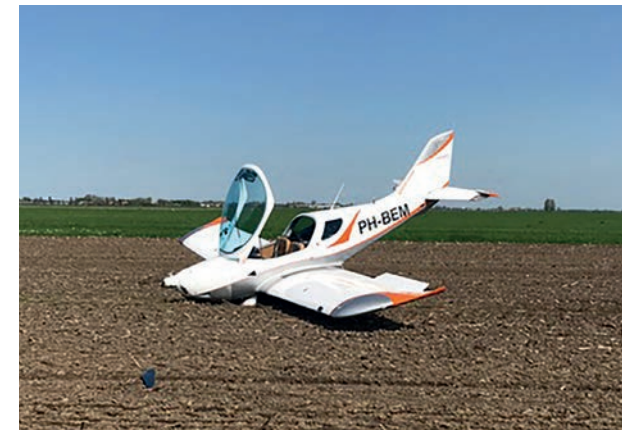
PH-BEM after the emergency landing.
(Source: Police aviation division)

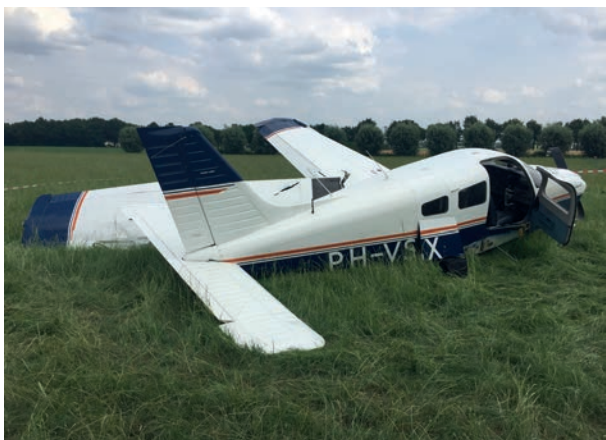
The New Piper PA-28-181 after the runway excursion.

This runway excursion was caused because the pilot had performed the approach and landing at a high speed, after which he had failed to execute a go-around. The runway excursion was preceded by the fact that the downwind leg was flown at an altitude which was greater than the prescribed altitude. Although he extended the downwind leg in order to fly a longer final approach, the aircraft still had a lot of power at the moment of landing. There was also very little wind at that moment. This situation meant that the aircraft could not have been brought to a stop before the end of the runway. Marks before the end of the runway showed that the pilot started to brake at some point, after which the plane left the runway on the right-hand side. There were no known defects in the aircraft that could have contributed to the incident. The Dutch Safety Board conducted an investigation on site, but no technical investigation was performed on the aircraft.

The pilot stated that he had also flown higher than the prescribed altitude in circuits at other airports, because he disliked flying low over buildings. The Board emphasises that flight procedures including circuit altitudes, as specified in the AIP, are mandatory. Failure to follow these procedures creates a collision risk, because other pilots who are flying at the prescribed altitude in the circuit might not be expecting descending traffic. In addition, the pilot must always be prepared to perform a go-around during an approach, in the event that circumstances prevent the approach from being completed safely.
