**NATIONAL
TRANSPORTATION
SAFETY
COMMITTEE**

AIRCRAFT ACCIDENT REPORT

Manunggal Air

Kamov K-32 Helicopter RA-31029

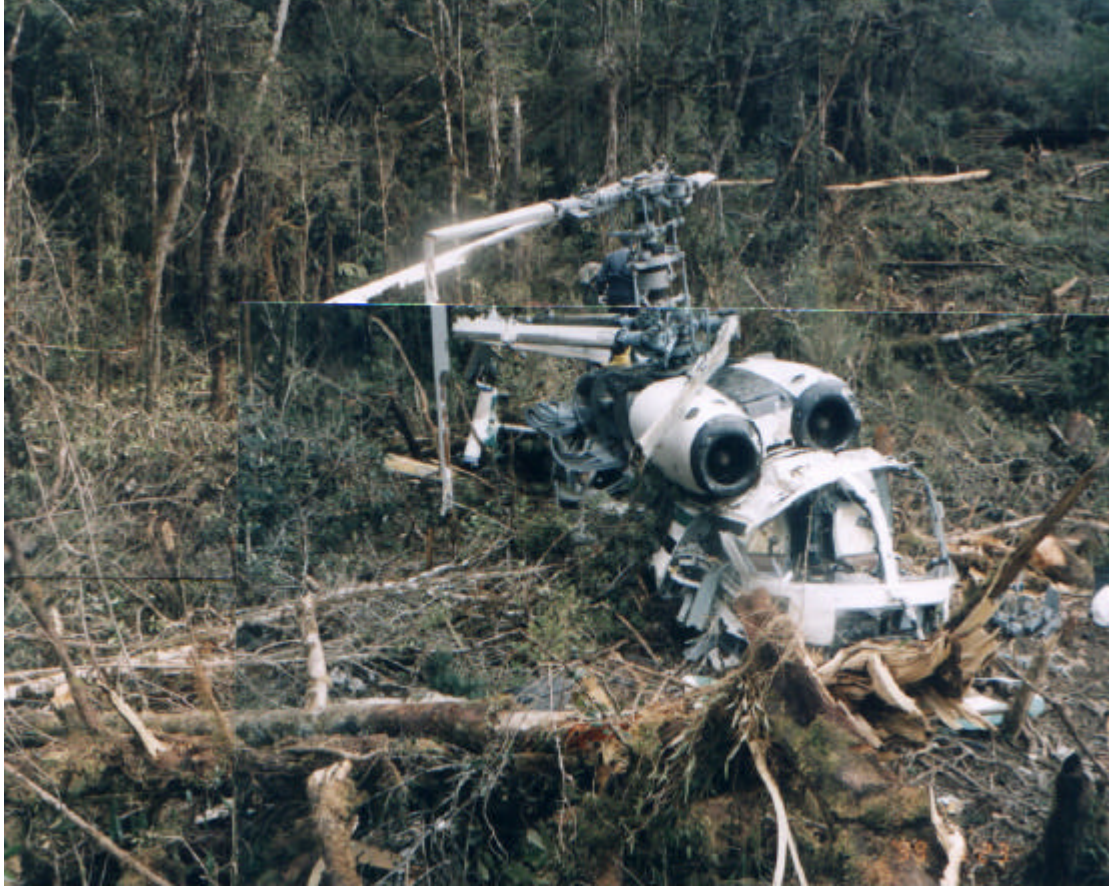
The fuselage was crushed by the weight of its engine and gearbox during the impact. Some parts of the fuselage were buckled and the cockpit windows were shattered due to large deflection. The heavier buckling mode occurred on the right side of the helicopter. This indicates that the direction of the crash may not be perpendicular to the ground. Instead it was tilting a little bit to the right.

Picture 1. Structural and Surrounding Area Damages

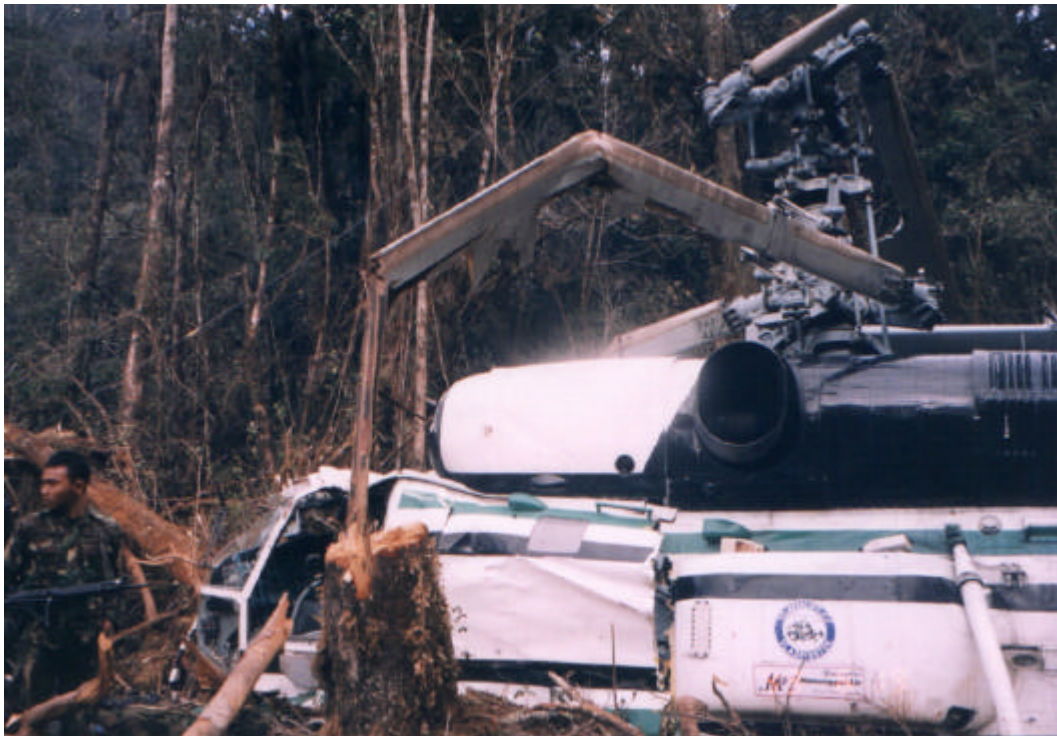
The damages on the rotor blades show that the blades were damaged by excessive static loading in the direction from leading edge to trailing edge. Some of the blades were pulled back on their drag hinges. These and the broken flap stopper indicate that the blades still rotated upon impact and hit another object.

Picture 2. Damages on the rotor blades indicating rotation at impact

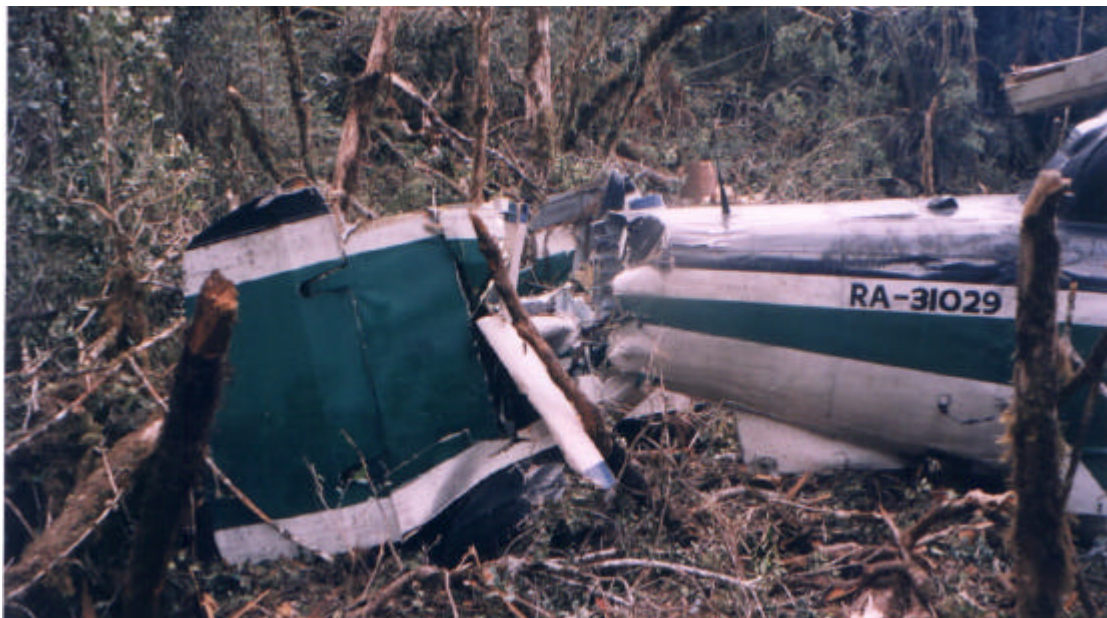
The tail was broken in the cantilever bending type damage. This indicates the damage happened upon impact. The connecting rods to the vertical tail moveable back section were broken. The surface torn of the tail collars and rudders are likely due to hit with the surrounding trees upon impact.

Picture 3. Static loading damage on the tail
