Aircraft Serious Incident Investigation Report

KNKT/06.06/08.02.37

PT. Adam SkyConnection Airline

PK – KKE

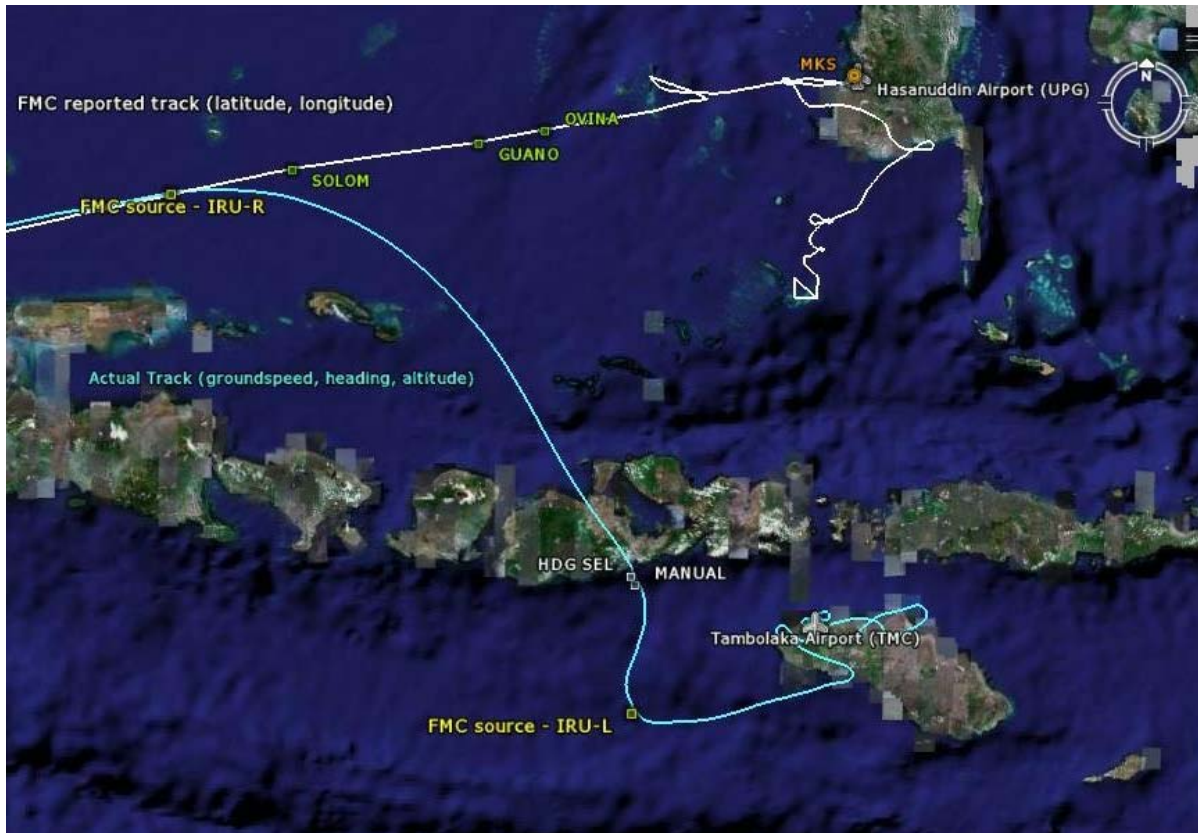
Figure 3 : Flight paths (FMC and actual) following switch to IRU - R

The FMC utilised the right IRU for approximately 52 minutes during which time the aircraft was on a south-easterly heading with the FMC believing it was travelling in a north-easterly direction. The FMC switched back to using the left IRU at 01:25:53. At this time the aircraft was being flown manually on the required heading for ANY to Makassar. The recorded FMC position when the FMC was switched to the left IRU was also erroneous for the remainder of the flight.

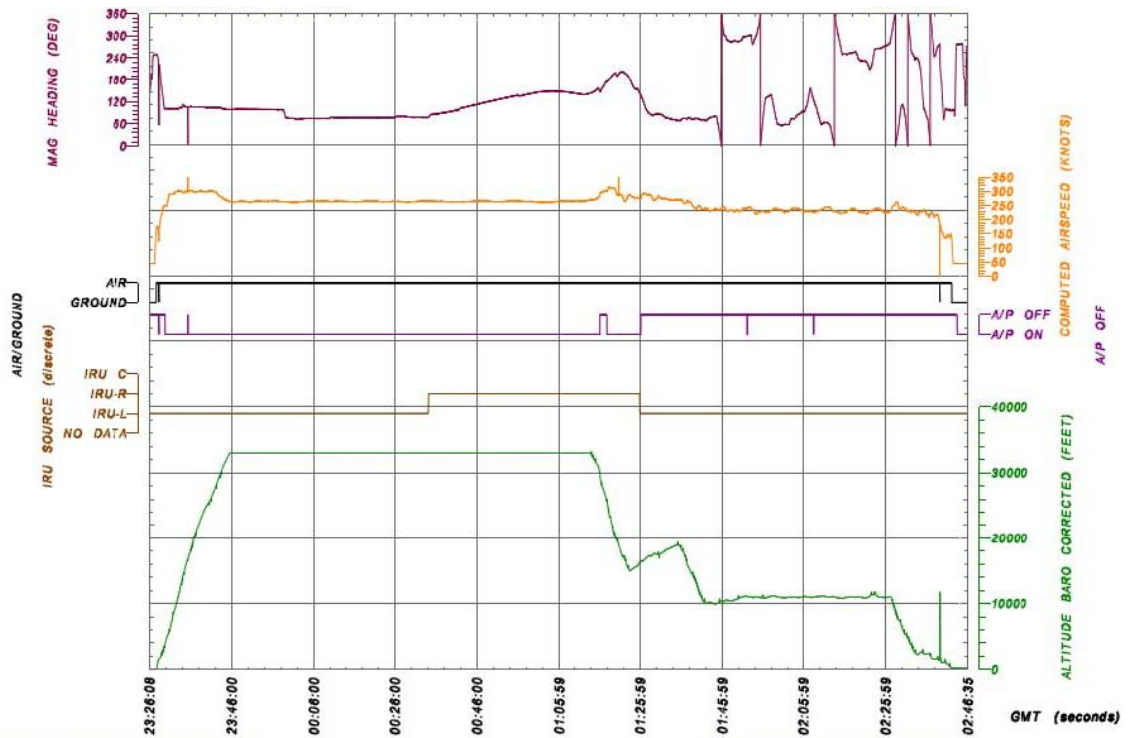
Figure 7: FDR plot between 23:26:08 and 02:46:35

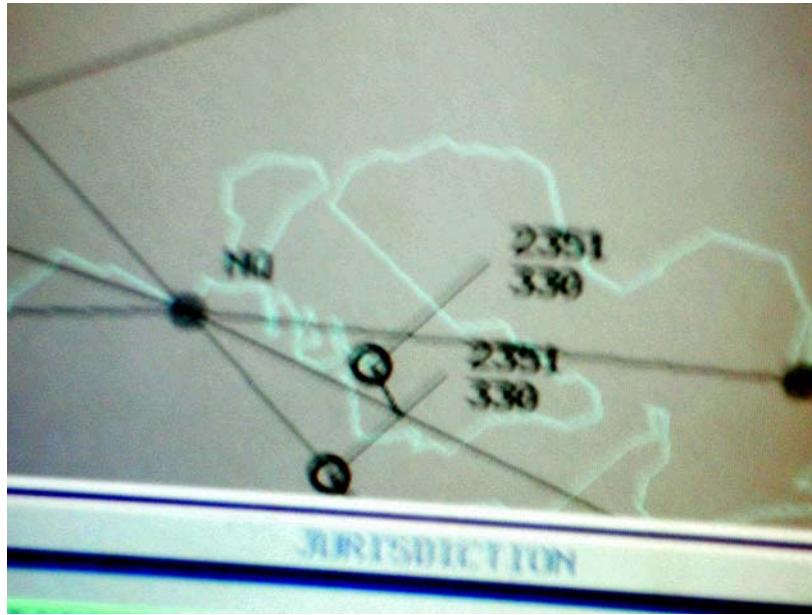
Figure 10: The aircraft's (radar track) at near waypoint *NQ* and captured by two radar heads (dupe) Ngurah Rai and Waingapu radars

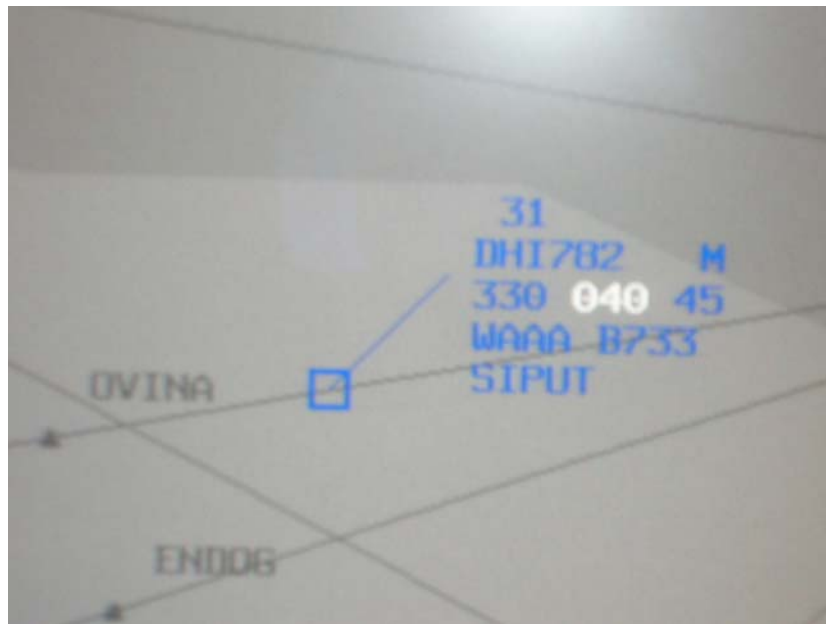
Figure 11: The aircraft's flight plan track (not actual target) coming to Ujung Lower area, but the target was square; the primary radar did not capture the target

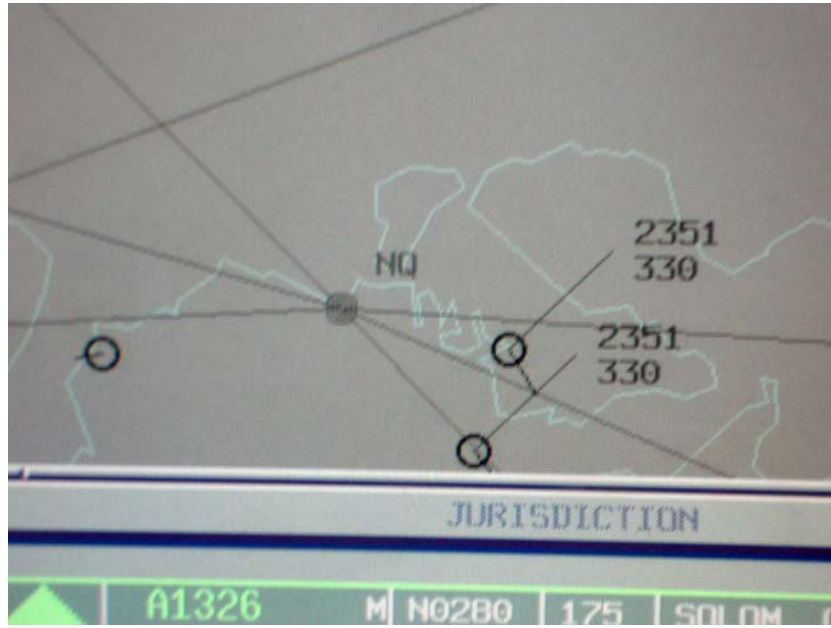
Figure 12: The aircraft at 01:06:51, was still at FL 330 (altitude 33,000 feet) and captured by two radar heads

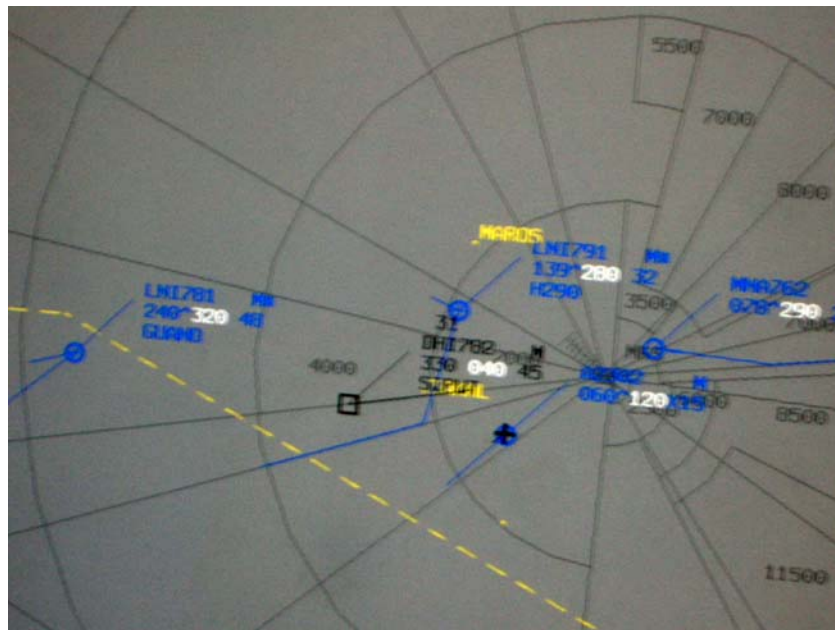
Figure 13: The flight plan track close to MKS (about 20 miles) showing the icon square and black colour; the primary radar did not capture the target
