**Quick Recommendation**  
**Aircraft Accident Investigation PC-6 Pilatus Porter Reg. PK-VVQ,**  
**operated by PT. ASI Pudjiastuti Aviation at Muara Ritan Kutai**  
**Kertanegara, East Kalimantan on 25 April 2012**  
Nomor : KNKT/ 001/ 4 /V/REK.KU/2012

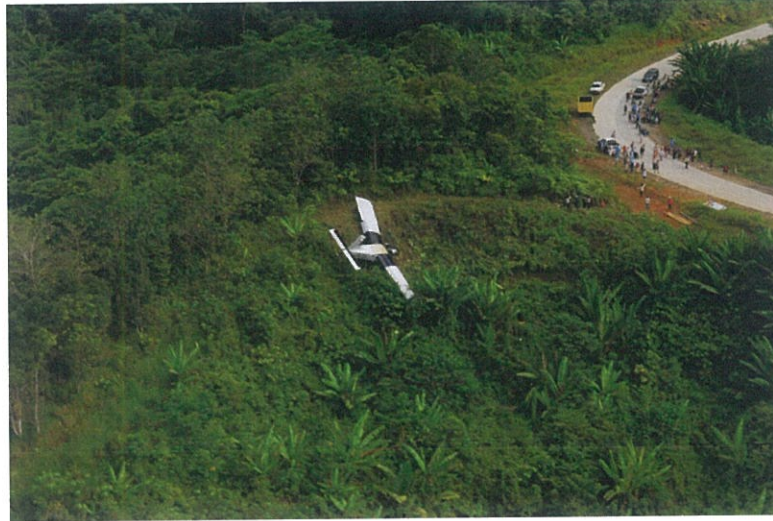
Gambar 1. posisi terakhir pesawat

- The aircraft was about 35 degrees right bank and about twenty five degrees pitch down at the crash site.
- The left wing leading edge was wrinkle rearward, the left wing flap torsion tube was broken, and the left underwing fuel tank was detached, the quantity of the left underwing fuel tank fuel was full.
- The right wing was wrinkle rearward and the tip was broken, and the right under wing fuel tank was torn at the skin around the attachment, and the quantity of underwing fuel tank fuel was full.
- The both of main fuel tank were empty and no evident of fuel leak and smelt at the crash site.

- The main landing gear was collapsed rearward, The propeller blade was on feather hit the ground with out any scratch impact sign.
- The accident site located about 50 meters from the local maining road.

- To review the flight management especially on the areal survey flight and operation fuel management system.
- Ensure that all of the crews were using shoulder hardness and the passenger were using seat belt during takeoff, landing and on the emergency or on the critical condition.

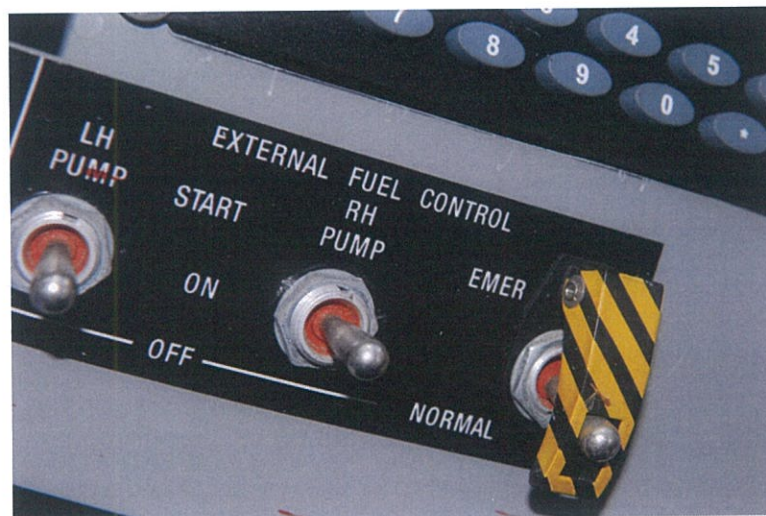
Gambar 2. posisi external fuel control

- The auxiliary fuel pump Switch was “ON” position, and the fuel transfer switches were in “ON” position and the EMERGENCY fuel switch was in “GUARDED”
