AIRCRAFT INCIDENT REPORT

PT Merpati Nusantara – Post Maintenance Test Flight

CN235 PK-MNM

25 January 2000

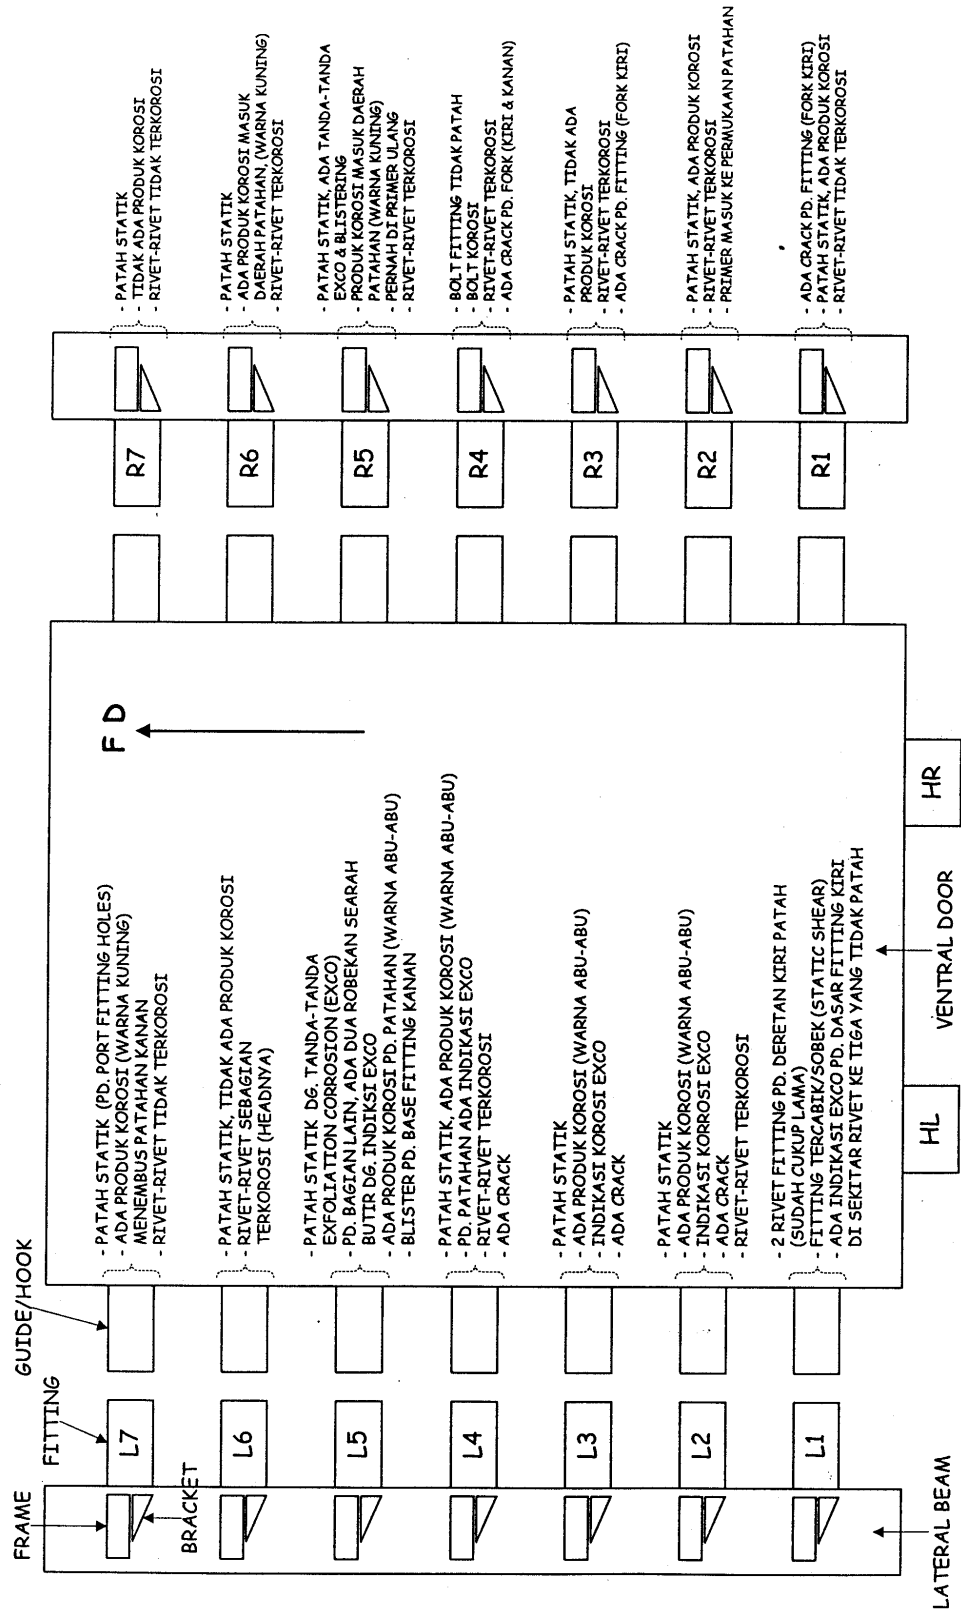
**Figure 1. Corrosion Finding at Ventral Door.**

The examination of the aircraft, performed by an NTSC team supported by engineers from the DGAC, the operator and the manufacturer, revealed that thirteen fittings of the ventral door side frames were broken (Figure 1 and Photograph 1 B). Most of the fractures occurred along the grain direction. Other fractures showed static overload failures.

For comparison purposes, visual inspections on 10 PT Merpati Nusantara CN235 aircraft were carried out. The inspection revealed corrosion occurring on most of the port fittings, hooks, reinforcements and their assemblies, some severely, especially corrosion of the reinforcements. The worst damage found showed similar characteristics to the PK-MNM case, where all the fourteen port fittings were corroded, of which eleven were showing severe exfoliation corrosion. Cracks along the grain directions were found in several of the fittings examined.

- 1) The Directorate General of Air Communication to issue a directive to inspect port fittings and related parts of all CN235 aircraft flying in Indonesia by means of appropriate techniques.

- 2) The manufacturer to perform a review on the structural significant items, especially on:
  - a. Corrosion control program. An additional corrosion protection process immediately after anodization step is strongly recommended (this measure has been applied to the fittings since 1993). The application of an additional coating containing primer, top coat and corrosion inhibiting compound (CIC) is also recommended on particular parts that can potentially be attacked by corrosion.

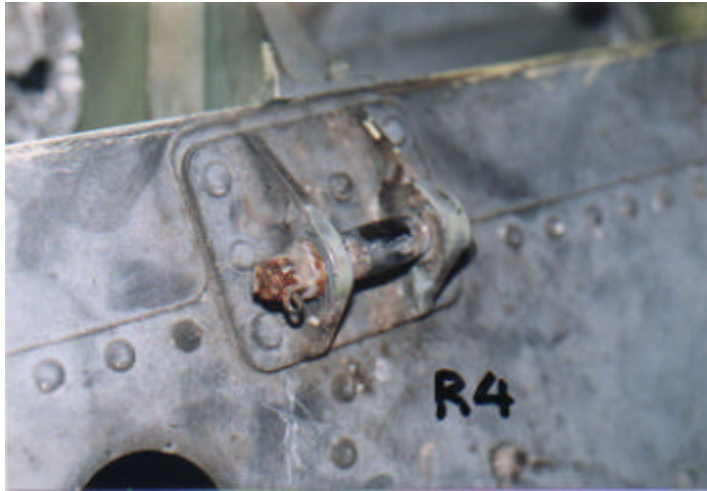
**Photograph 1A. One Remaining Unbroken Fitting**

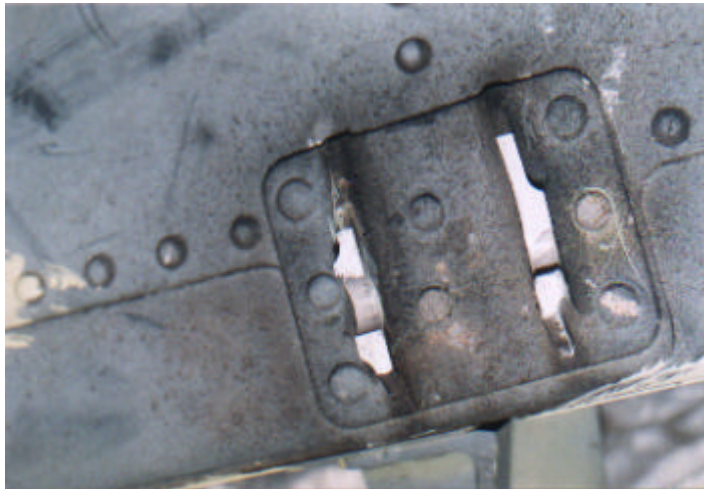
The examination also found that 13 of the 14 fittings of the ventral door were broken.

**Figure 1B. Broken Fitting on Ventral Door Structure (13 fittings)**

- b. Material selection. It is recommended that Al2024, instead of Al7075, be used for the hinges.
  - c. Manufacturing process. It is recommended to take into consideration the grain direction relative to the load in the manufacturing of the hinges.

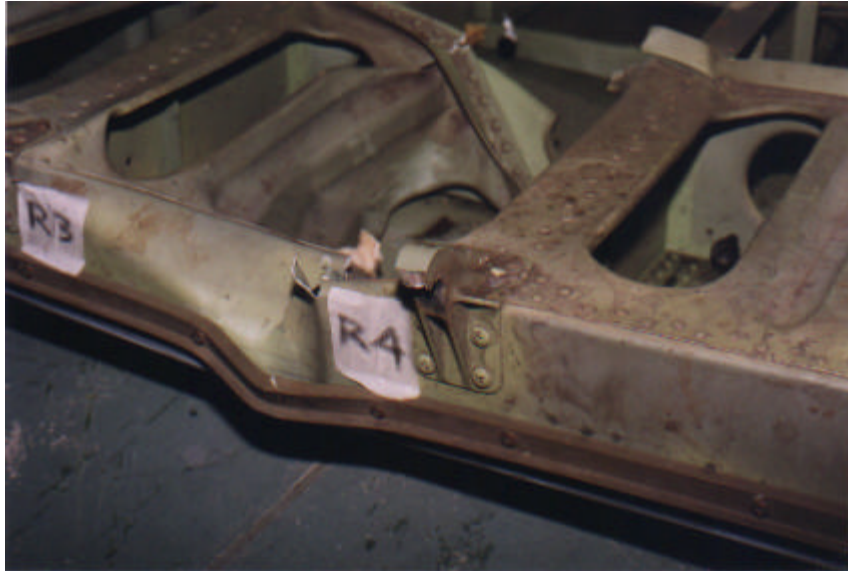
One of 14 hooks on the ventral door was found broken with its fracture surface indicating a static failure mode. The fracture surface indicated a static mode occurrence (Figure 1 and Photograph 2). Two hinge fittings and the ventral door attachment to the actuator at the rear frame were also broken statically (Photograph 3).

**Photograph 2. Broken Guide Hook (R4)**

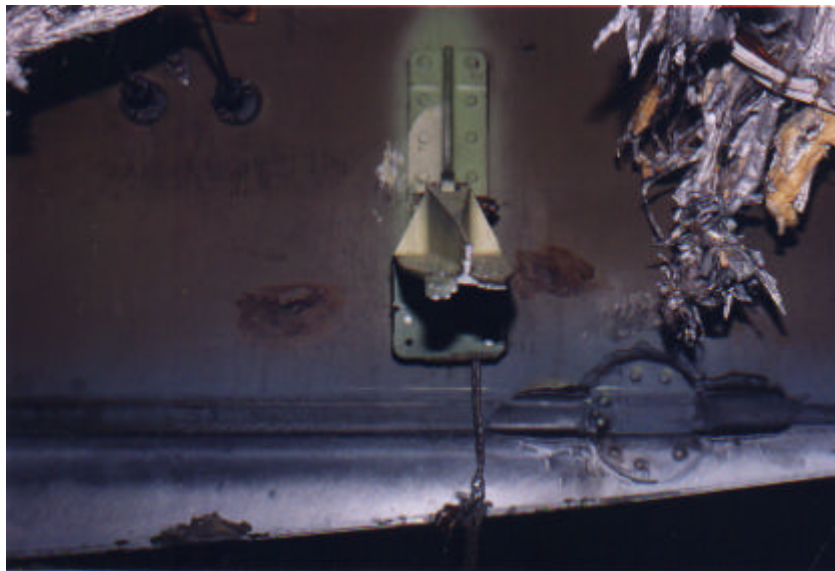
Additional aerodynamic loads were exerted on the protruding ventral door, causing failures of the remaining fittings, included the two hinge fittings at the rear. The aerodynamic drag pulling resulted in the failure of the actuator attachment on the door, as well as bend tear fractures on fuselage frame #43. The right hand fittings were broken, starting at the corroded ones. Depressurization forces, i.e. air rushing from inside the aircraft then caused the baggage compartment and one of the partition walls to be pushed out through the ventral door opening.

**Photograph 3. Broken Hinge and Half Hinge Assembly**

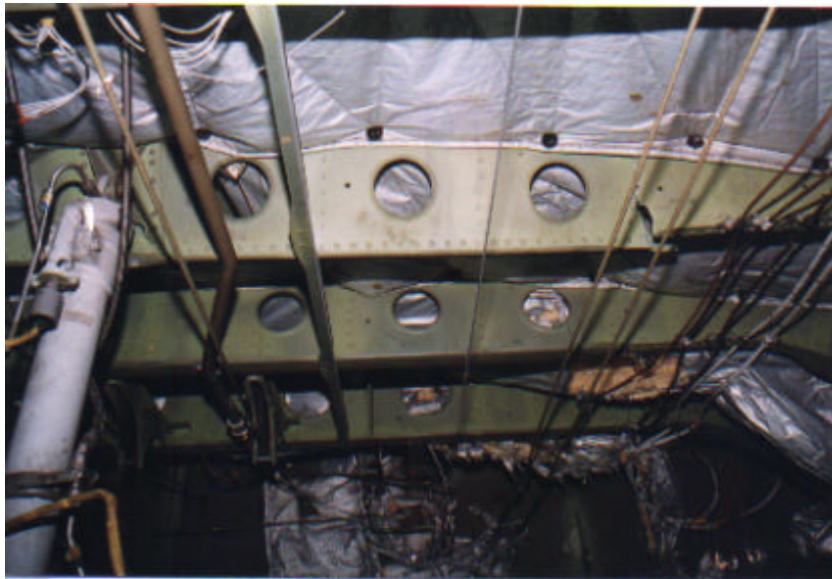
Frame # 43 in the rear fuselage to which the actuator was connected, was bent and partly torn (Photograph 4).

**Photograph 4. Bend and Tear out on Upper Frame #43**

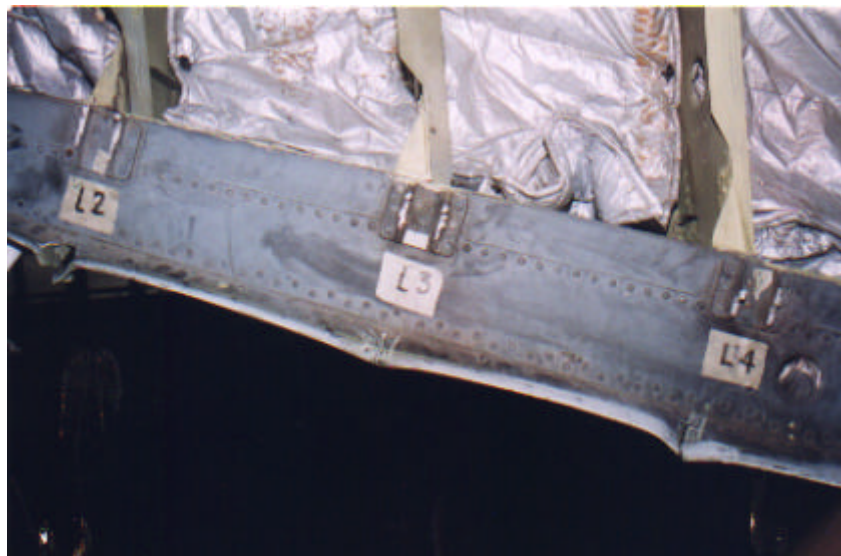
The skin panel lips of the fuselage opening were found deformed, with the deformation on the left hand side found larger than the deformations on the right hand side (Photograph 5). (Note: left and right hand referred to an observer looking in the direction of flight)

The nature of fractures of the port fittings and rear hinges, and the deformation of the fuselage lips, indicated that there was a weakening of the several port fittings. The normal pressurization caused the left of the ventral door to detach, starting from the left-hand side. This was indicated by the greater deformation observed on the left side fuselage lip or edge panel.

**Photograph 5. Deformation on Rear Fuselage Skin Panel Lips (left-hand side)**

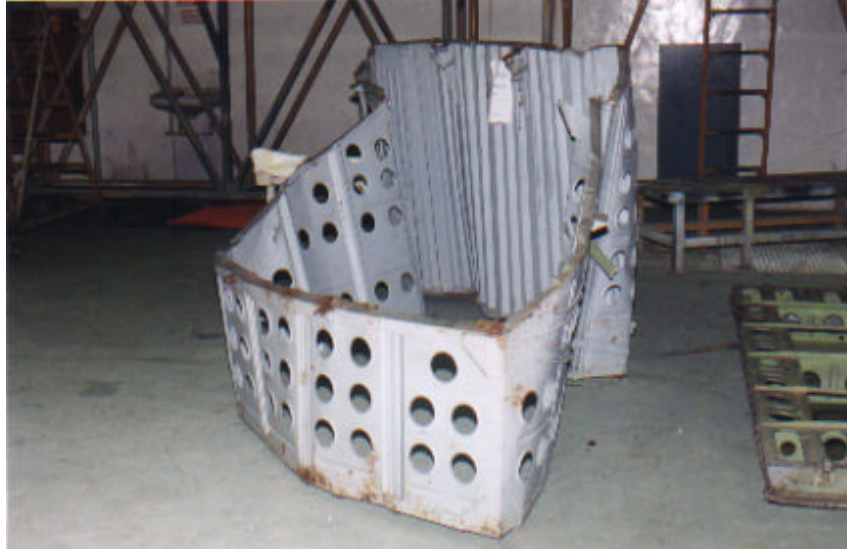
Other damaged and broken structure parts found separated were the baggage cage, which was bolted to the ramp door, and a partition panel. The baggage cage was recovered, while the partition panel was not found (Photograph 6).

**Photograph 6. Baggage Basket (Compartment)**

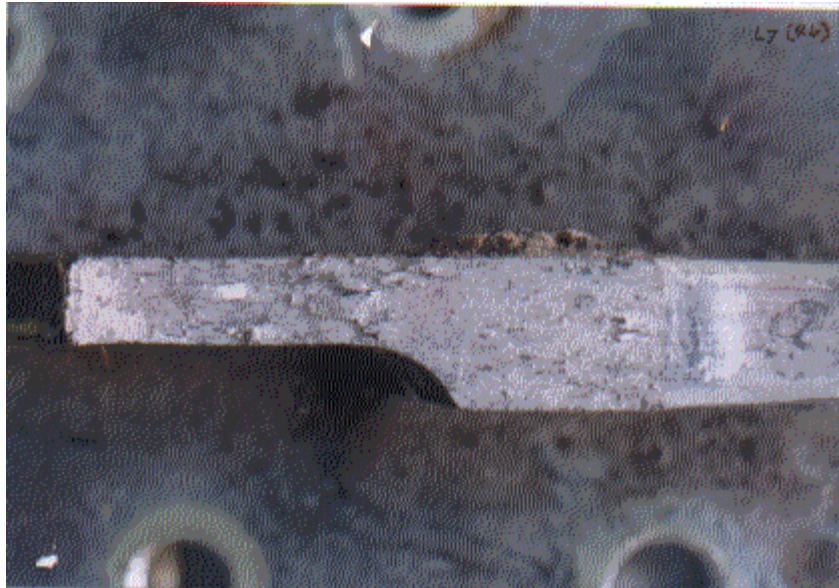
The Metallurgical Laboratory of the Mechanical Engineering Department, Institut Teknologi Bandung, conducted special tests. Utilizing a stereomicroscope the examination confirmed that the fracture was due to corrosion, more specifically of the exfoliation type, as shown by the fracture occurring along the grain direction, and revealing a fibrous wooden like surface. Corrosion that was white gray colored, were found on the fracture surfaces, and the formations of lamellar aluminum along the grain direction can be observed. These are characteristics of exfoliation and stress corrosion.

Static failure modes were found on several port fittings and the two hinge fittings at the rear of the aircraft. The static mode failures occurred after corrosion failures happened, ultimately causing a weakening the structure, until a static overload mode of failure occurred at the remaining fittings (Photographs 7 and 8).

Static failure modes were found on several port fittings, and the two hinge fittings at the rear of the aircraft. The static mode failures occurred after corrosion failures happened, ultimately causing a weakening of the structure, until a static overload mode of failure occurred at the remaining fittings (figures 7 and 8).

**Photograph 7. Macroscopic Photograph on L7 Port Fitting Fracture Surface**

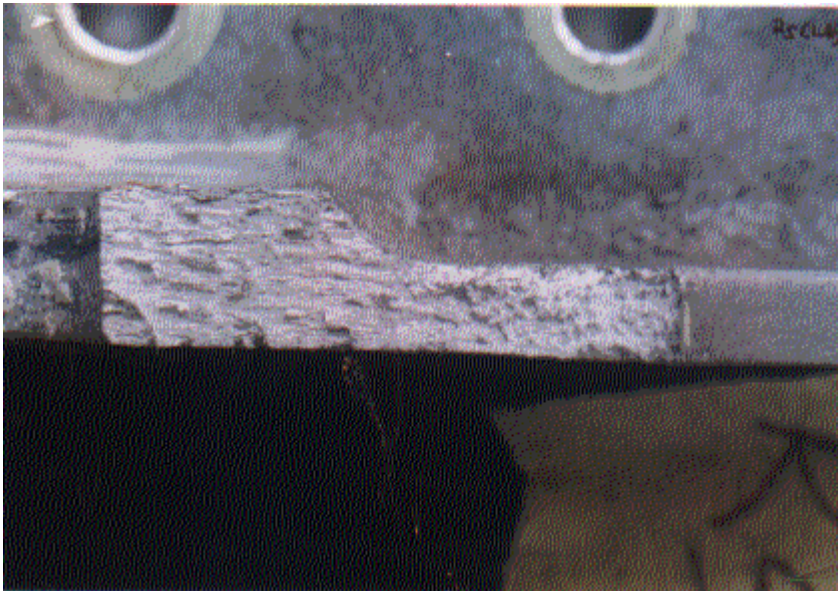
**Photograph 8. Macroscopic Photograph on R5 Port Fitting Fracture Surface**
