**KOMITE NASIONAL KESELAMATAN TRANSPORTASI
REPUBLIC OF INDONESIA**

Aircraft Accident Investigation Report

PT. Wings Abadi Airlines

ATR 72-212A; PK-WGW

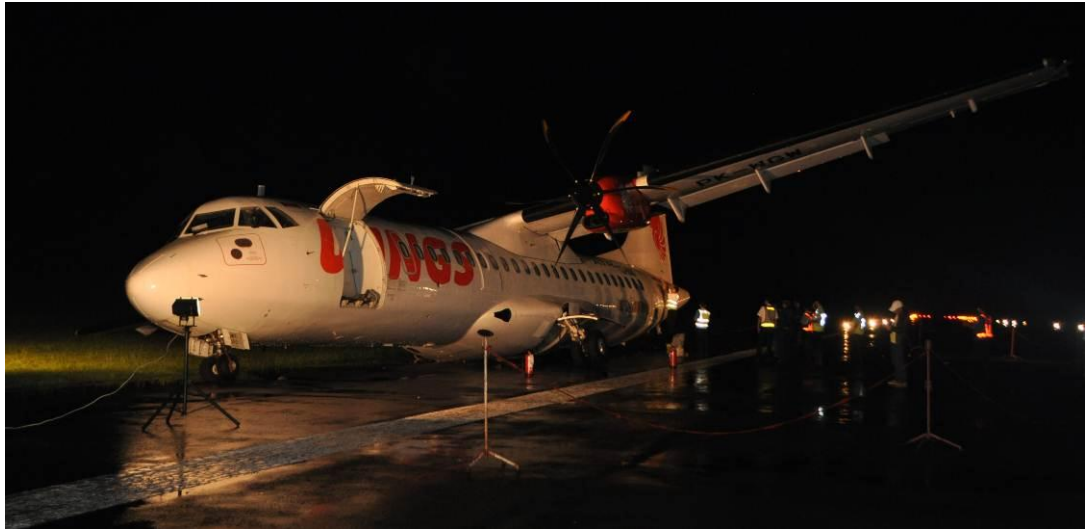
Figure 1: The aircraft condition after stopped

Passenger evacuation completed at approximately 10 minutes after the aircraft stopped.

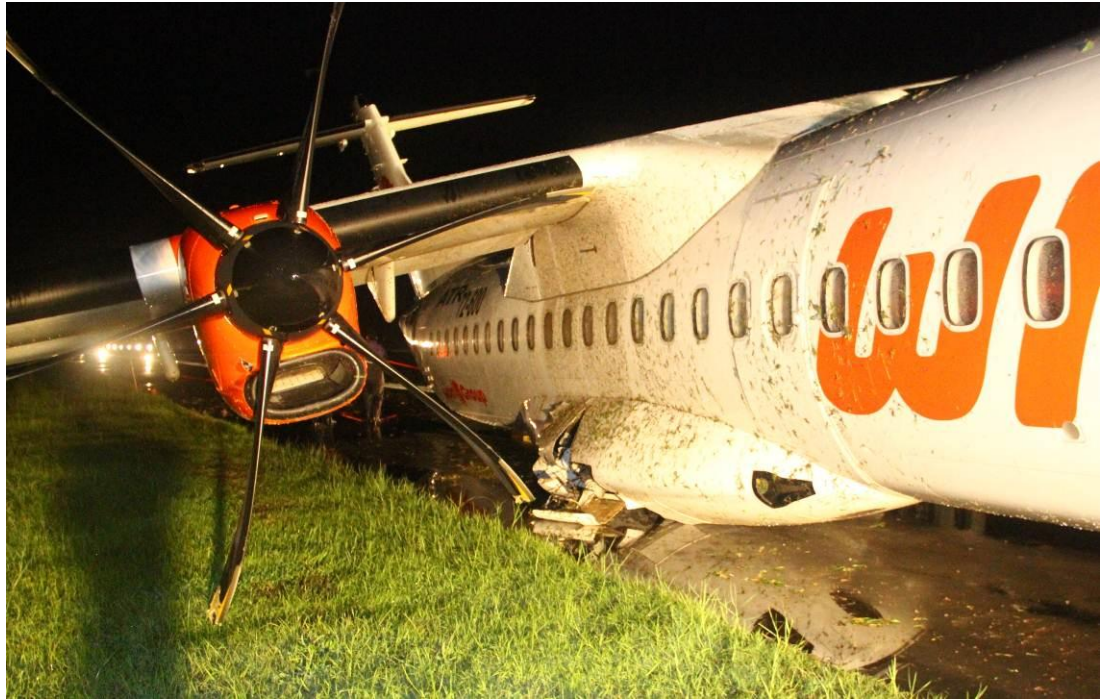
Figure 2: The damaged main landing gear and propeller

The aircraft was substantially damaged. The right main landing gear folded inward and the propellers tip of the engine number 2 broken at about 26 cm from the tip.

The right main landing gear was examined in the metallurgical engineering laboratory of Bandung Institute of Technology (*Institut Teknologi Bandung -ITB*). The examination indicated that no previous defect on the landing gear. The detail of the examination will be included in the final report.

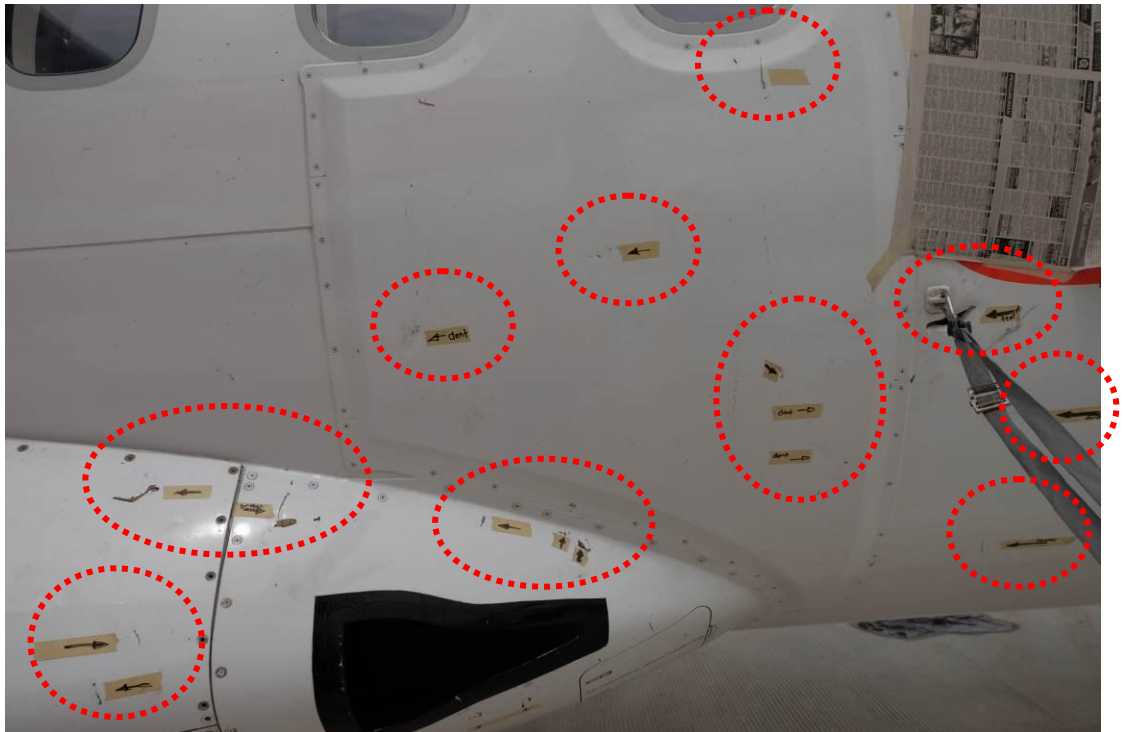
Figure 3: Several dent and damage on the right fuselage

On the right fuselage of the aircraft, there were several dents and damages.

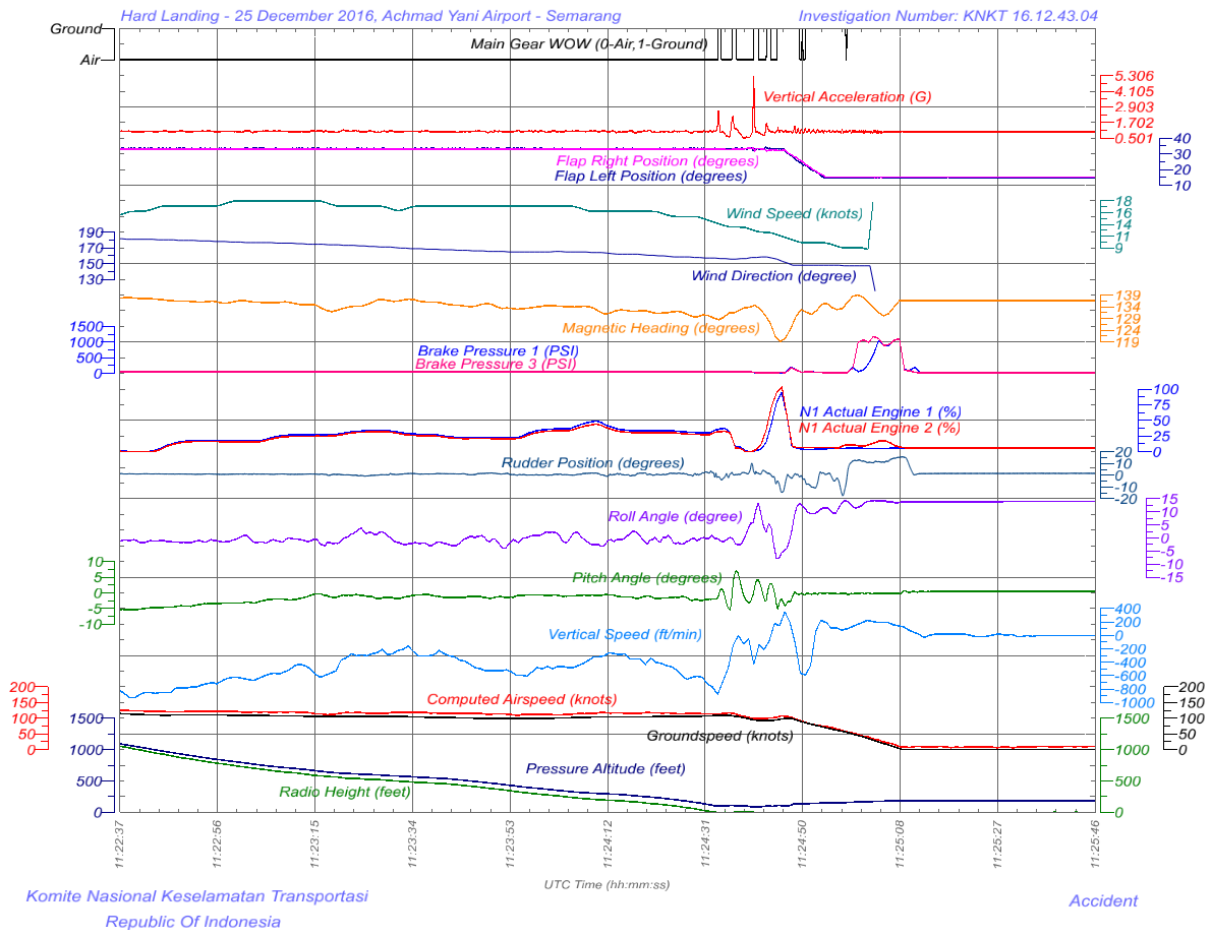
Figure 8: The significant FDR parameters

The FDR graph showed significant parameters to be analyzed for the final report such as vertical acceleration and number of touchdown, wind condition, aircraft attitude and aircraft speed.

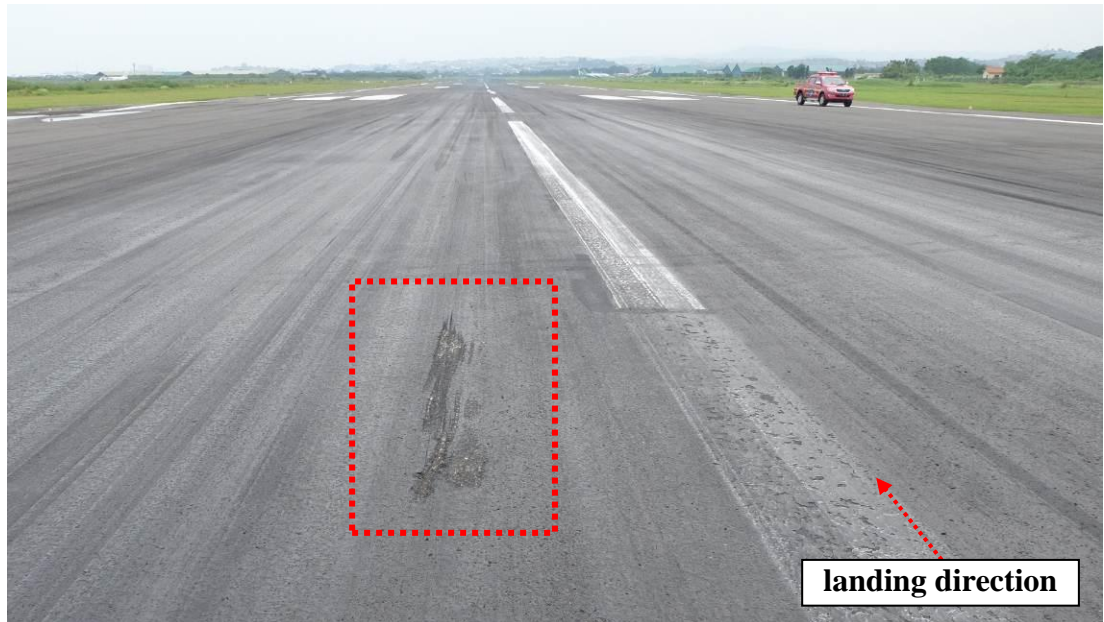
Figure 9: The first scratch

There were several scratch marks on the runway, the first scratch mark was found at about 500 meter from the beginning runway 13 on the left of runway centerline, the dimension was 150 cm long and 20 cm width (figure 9).

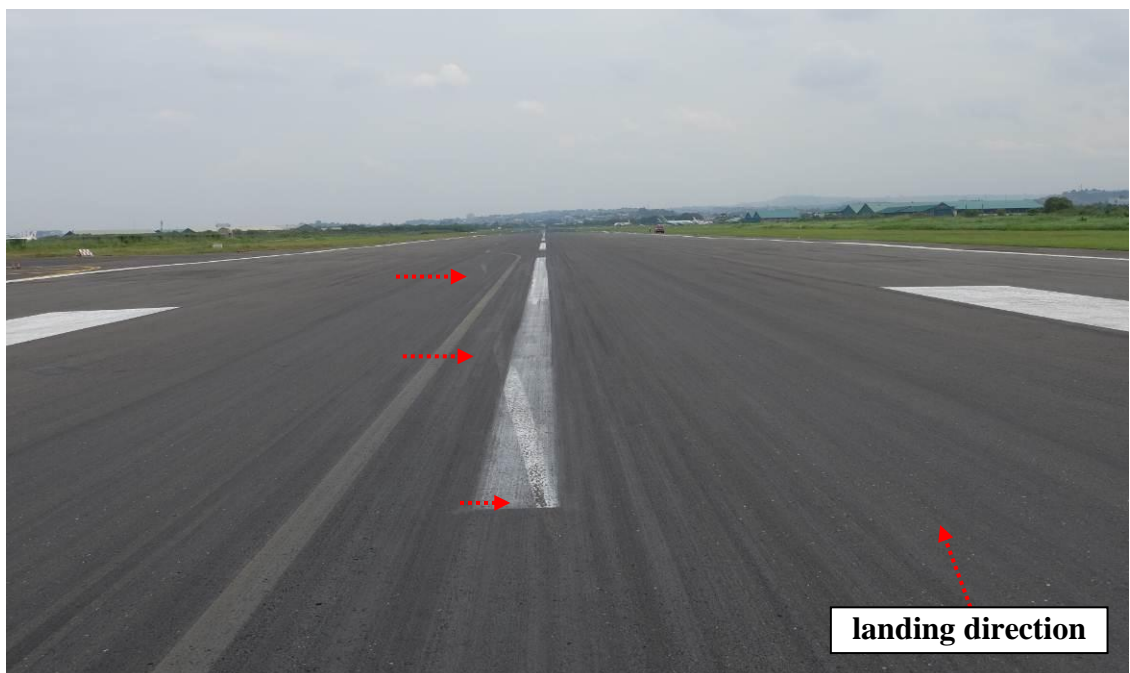
Figure 10: The white marking crossed from left to right runway centreline

At about 390 meters from the first scratch mark, it was found white paint mark which crossed from right to the left of runway centerline (figure 10) and then at about 190 meters the white paint mark continued to cross from right to left runway centerline until the location of the aircraft stopped (figure 11).

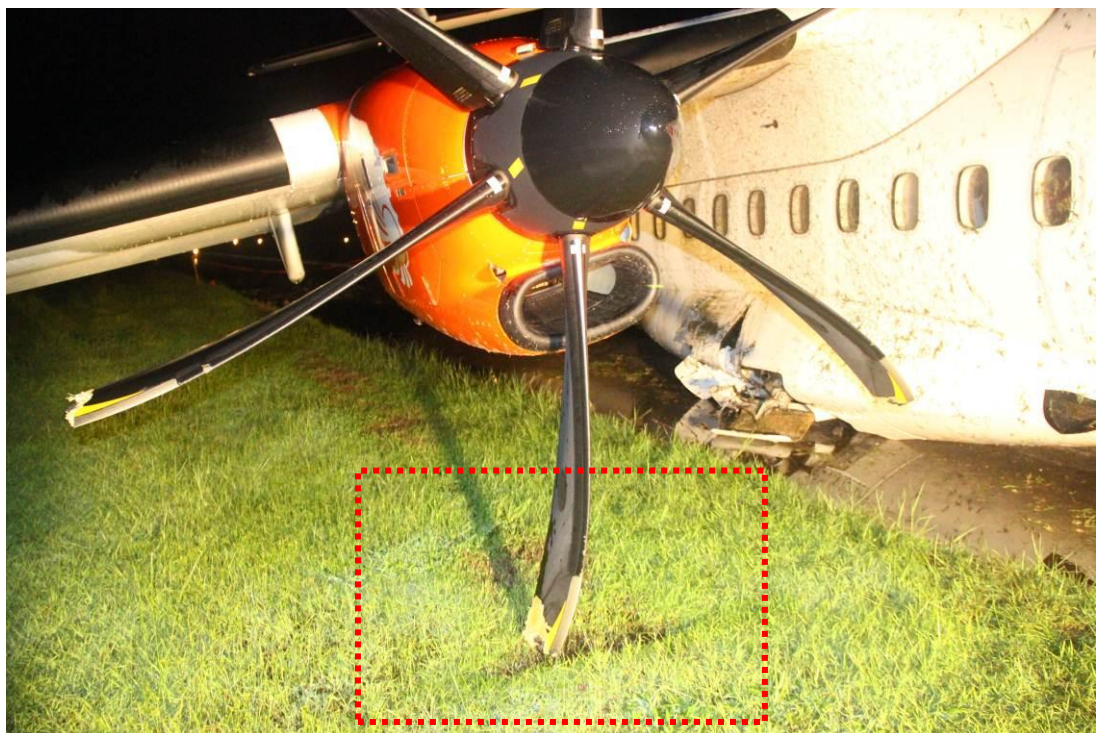
Figure 12: The propeller scratch mark on the ground

On the right shoulder near the aircraft stopped there was propeller mark on the ground (figure 12).
