PRELIMINARY
KNKT.16.05.13.04

Aircraft Accident Investigation Report

**Etihad Airways
Airbus A330 -243; A6-EYN
Near Bangka Islands
Republic of Indonesia
4 May 2016**

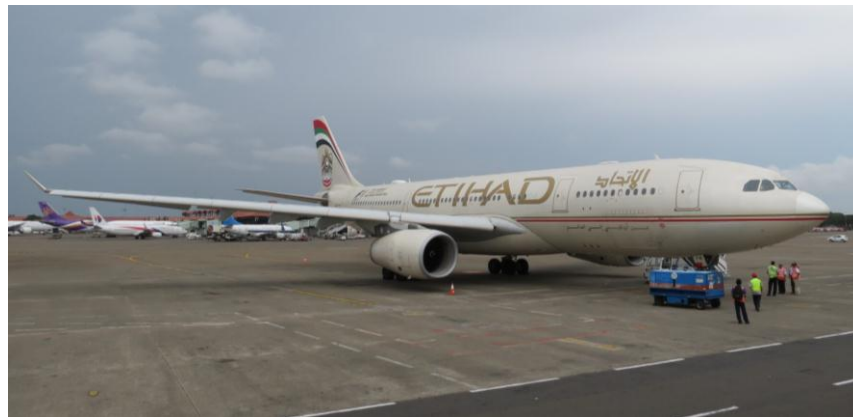
Figure 1: The A6-EYN a day after the occurrence

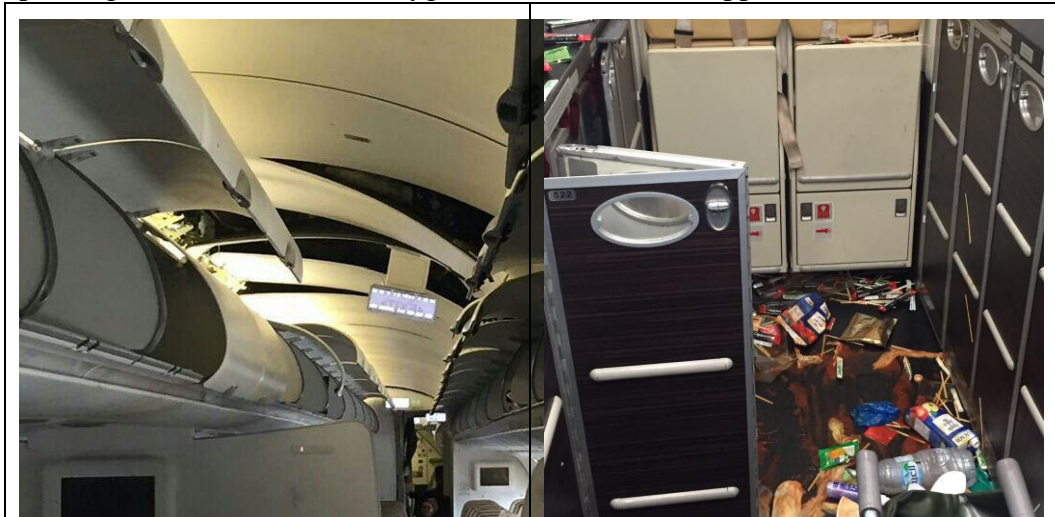
The aircraft had several interior parts damaged such as detached ceiling, broken passenger service units and oxygen mask container dropped.

Figure 2: Cabin ceiling and mid galley condition post the severe turbulence

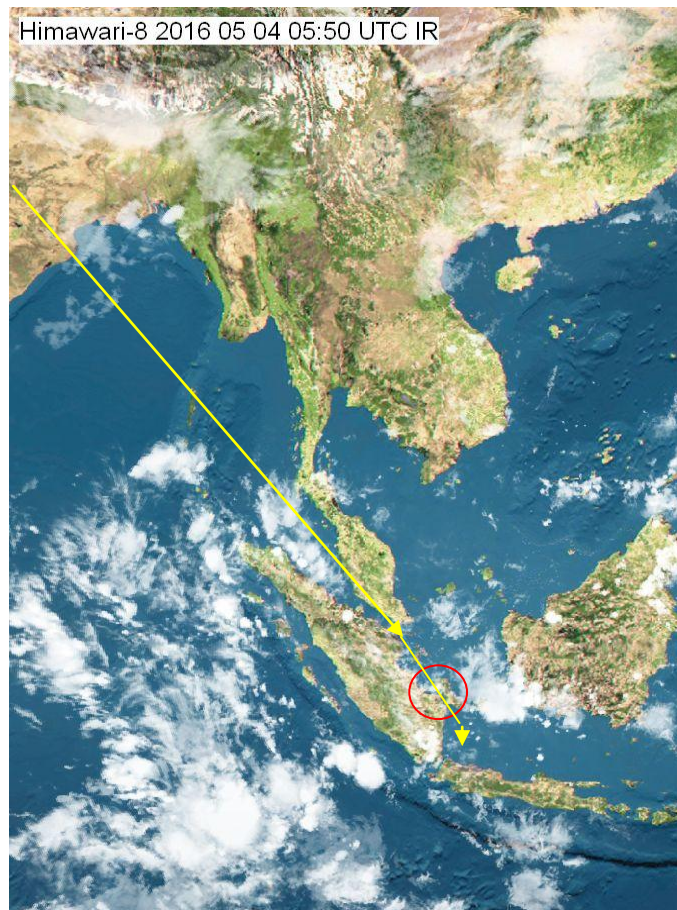
The figure below shows satellite weather image at about 20 minutes prior to the severe turbulence occurrence and the illustration of flight track. The area of turbulence occurrence indicated by red circle and it was no significant cloud formation.

Figure 3: The weather of 20 minutes prior to the accident (red circle)

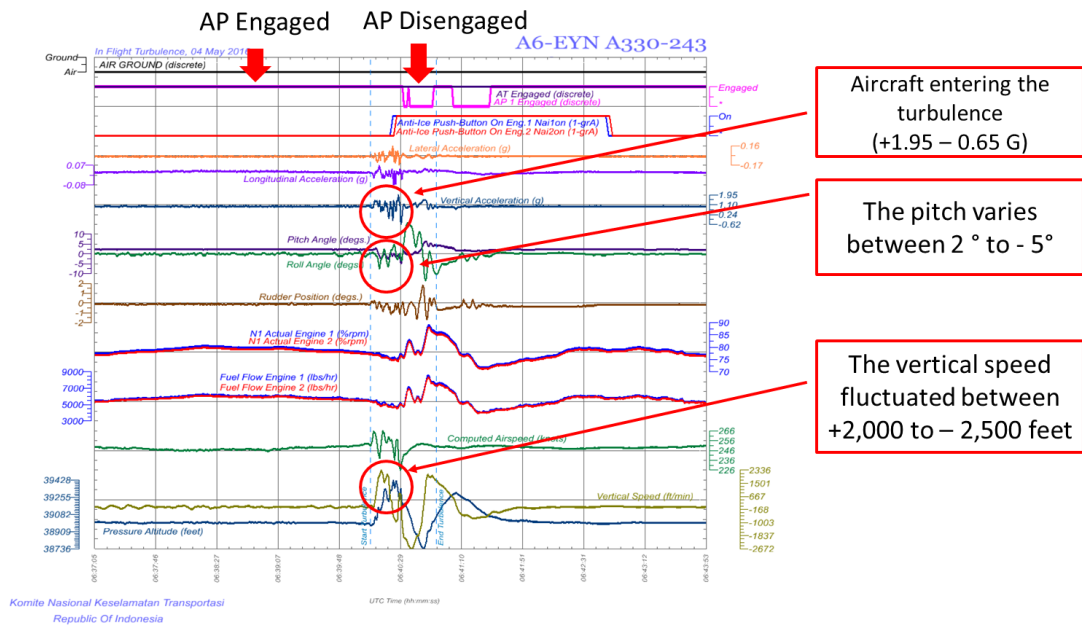
Figure 4: The relevant parameters downloaded from FDR

- 06:38:45 UTC, approximate 2 minutes prior to the occurrence the aircraft was almost steady at altitude 39,000 feet.
- Between 06:40:10 to 06:40:33 UTC.
 - The aircraft altitude varied with the highest of 39,450 feet and the lowest

of 38,750 feet and followed by the vertical speed fluctuated approximate between +2,000 to -2,500 feet/minute.

- The Autopilot (AP) reacted to correct the altitude and this indicated by the aircraft pitch changes ranging from +2° to -5°.
- The Vertical Acceleration recorded between +1.95 to -0.65 G.
- AP disengaged 06:40:32 UTC
 - The AP disengaged.
 - The AP reengaged at 06:40:35 UTC for one second then disconnected again one second later.
- AP reengaged
 - 06:50:54 UTC, the aircraft stabilized at 39,000 feet and the AP reengaged.

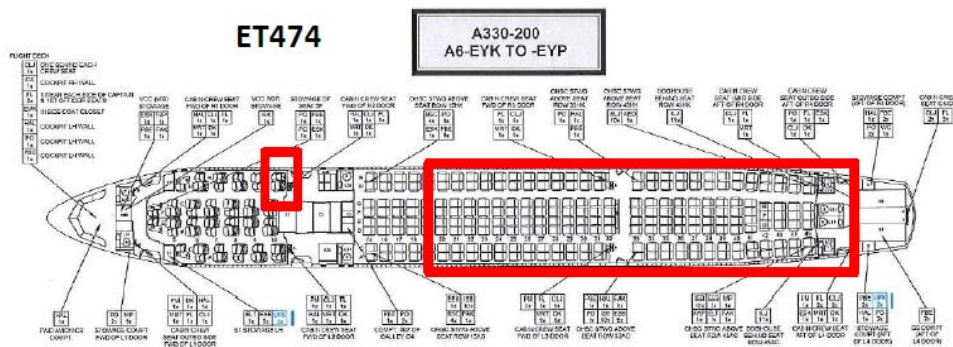
The aircraft had several interior parts damaged such as detached ceiling, broken passenger service units and oxygen mask container dropped. The damaged occurred on the seat 10H and the other damage cabin ceilings were spread out in the aft cabin between seat rows 21 to 45.

Figure 5: The area of the injured passenger seats and the damaged ceiling
