**PRELIMINARY**  
KNKT.15.08.20.04

**Aircraft Accident Investigation Report**

**PT. Cardig - Air  
Boeing 737-300 F; Reg. PK-BBY  
Wamena Airport  
Republic of Indonesia  
28 August 2015**

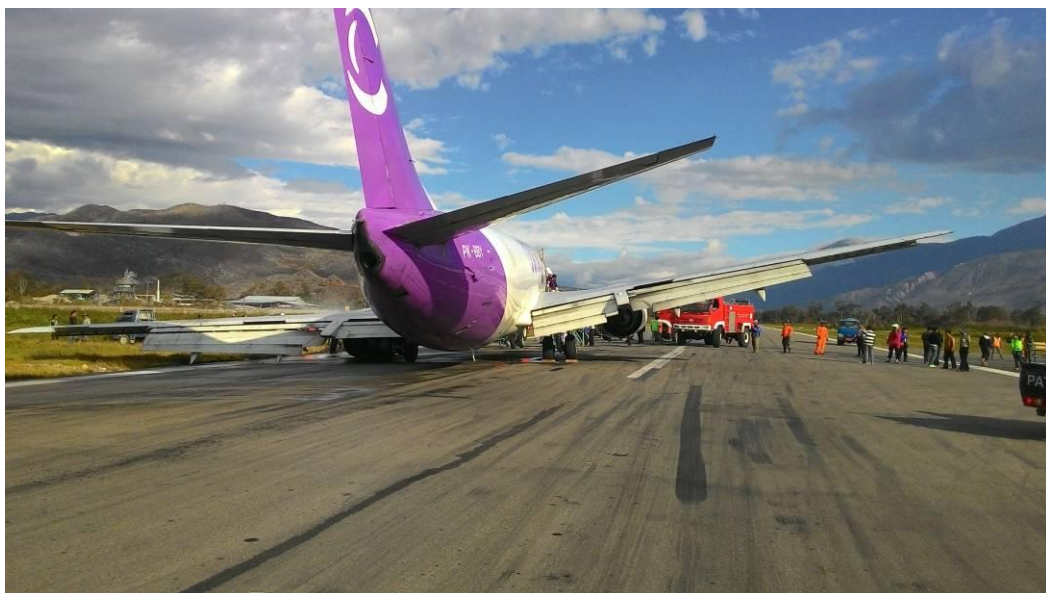
AT 0647 UTC, the aircraft touched down about 35 meter before the beginning runway 15 with vertical acceleration of 3.68 G and stopped at about 1500 meters from runway threshold. The left main landing gear collapsed and the left engine scratched the runway surface.

**Figure 1: The aircraft last position**

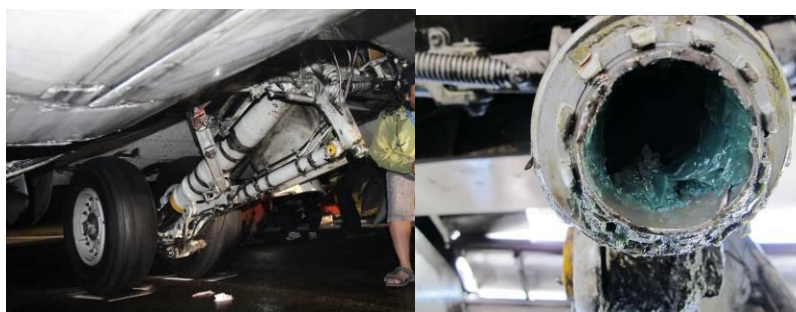
The trunnion link of the left MLG assembly was broken, the left MLG collapsed, the Left landing gear access panel lower fairing damaged, and the shock strut of the right MLG leaked and deflated.

**Figure 2: The collapse left MLG and broken trunnion link**

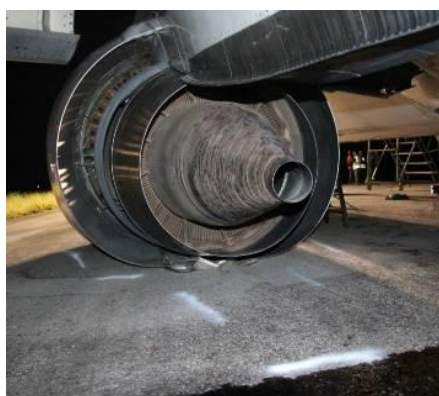
**Figure 3: The left engine**

The detail damages on the left Engine are as follow:

- Lower Fan cowling outer damage;
- Lower Fan cowling inner damage;
- Lower Gearbox Casing scratch
- Lower C-Duck thrust reverser inner damage
- Lower C-Duct thrust reverser outer damage

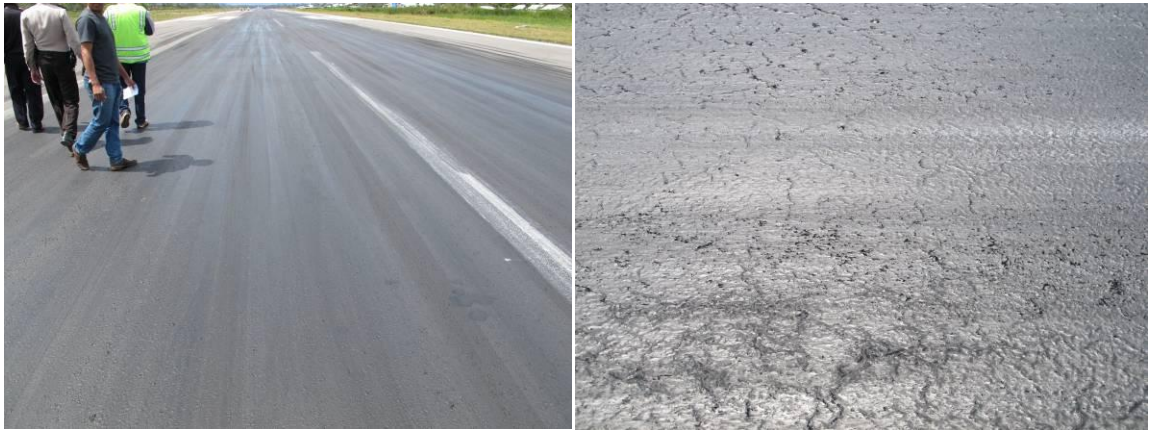
The surface of runway 15 found excessive rubber deposit at about 600 meter started from the runway threshold. The investigation did not found specific aerodrome

maintenance program and the inspection system applicable to the runway and other facilities of Wamena Airport.

**Figure 4: Rubber deposit on runway 15**

- a. To develop an aerodrome maintenance programme.
- b. To review and improve the runway inspection system.
- c. To install VASI on the runway 15.

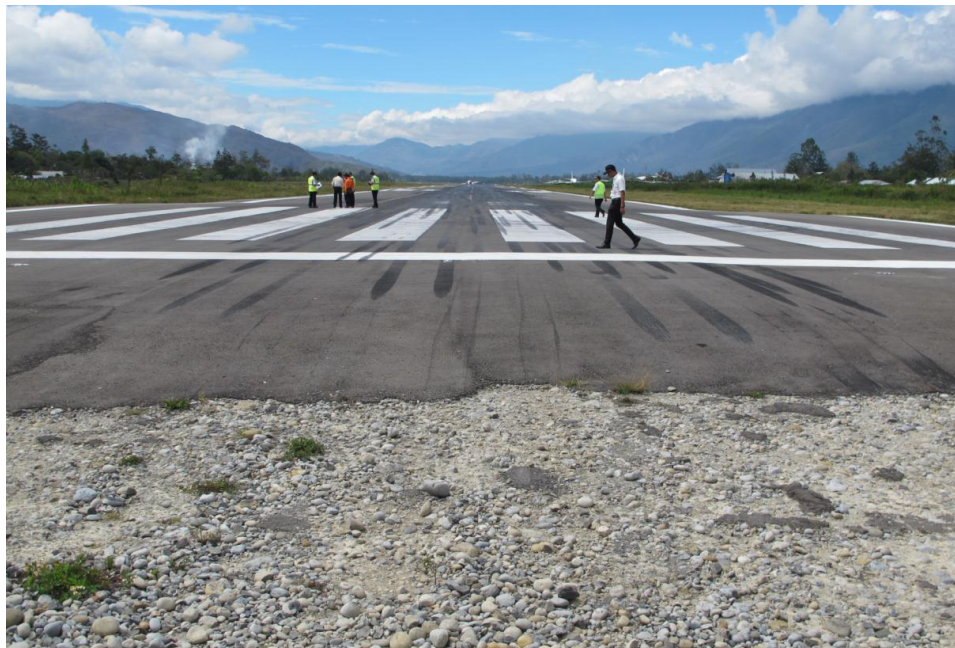
The investigation found several touchdown marks on the pavement before the runway 15.

**Figure 5: Touchdown marks found on the pavement before the runway 15**

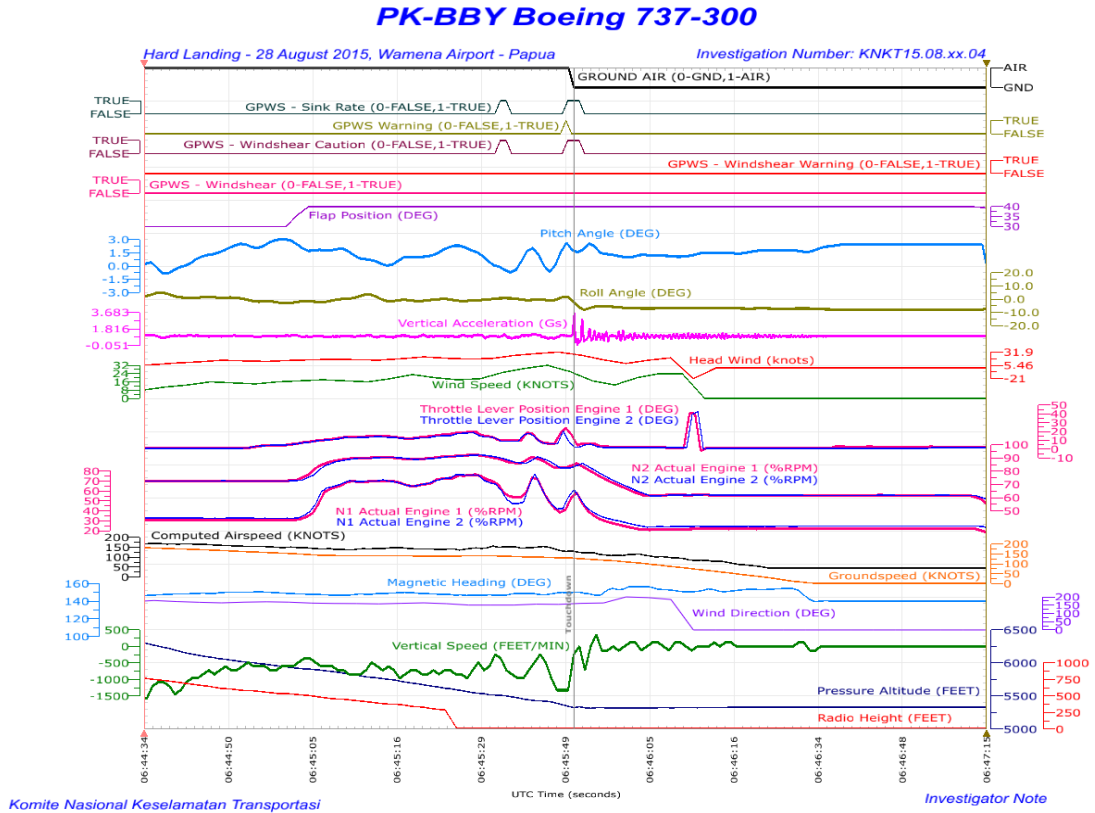
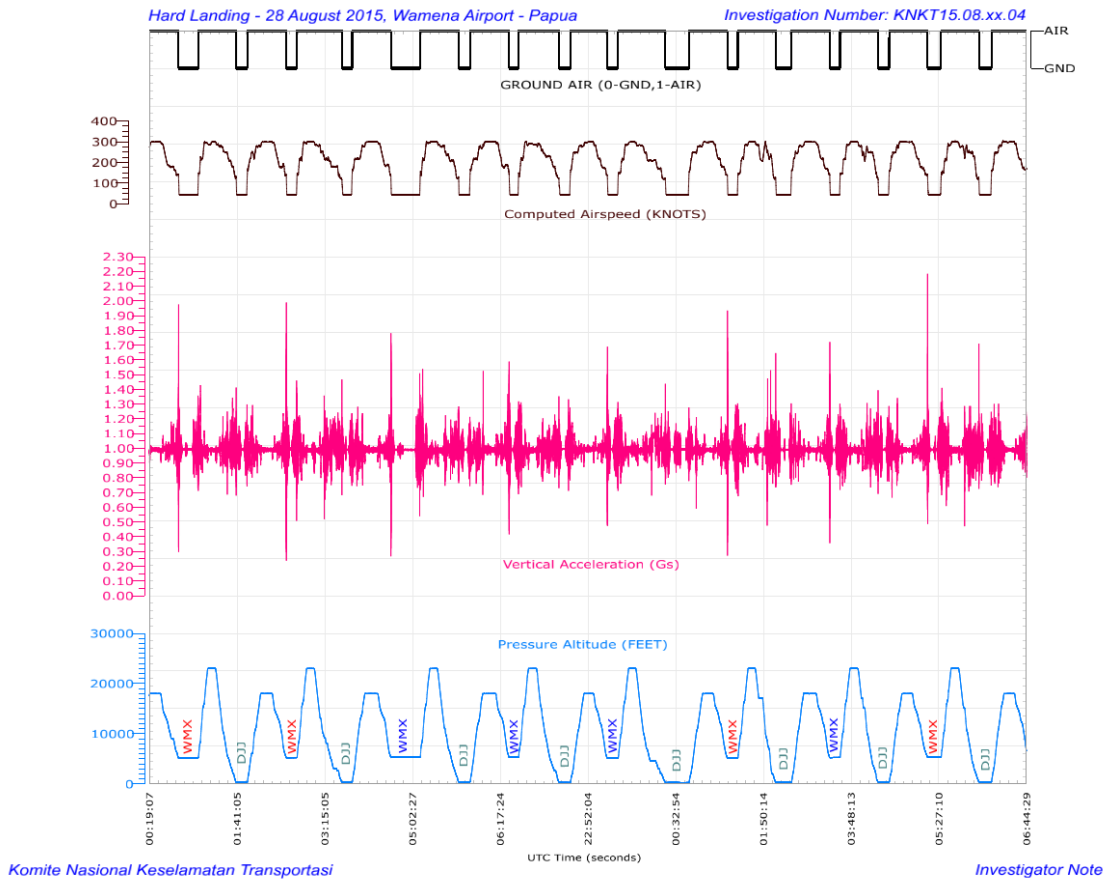
The vertical acceleration recorded on the DFDR when the aircraft touched down was 3.68 G.

**Figure 6: DFDR vertical acceleration previous flights recorded**

The DFDR data contained of 107 flight hours which recorded three times of the vertical acceleration of 2.1 G and event more during landing at Wamena.

- a. To monitor the flight crew performance.
- b. To review the maintenance interval related to the operating condition such as having frequent high vertical acceleration during landing.

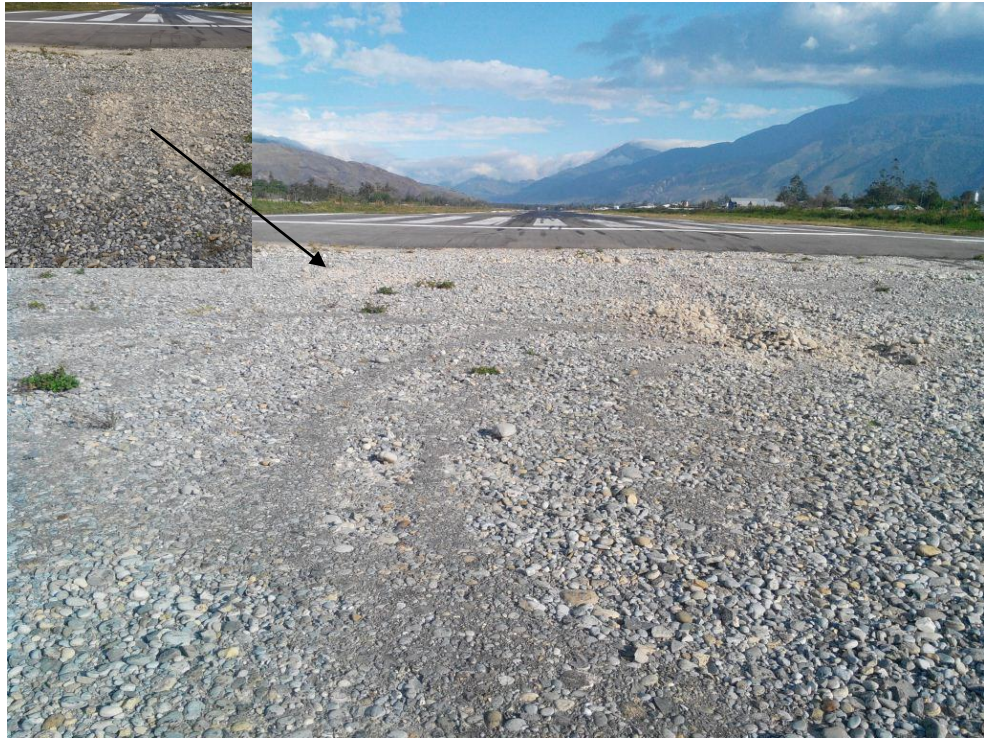
The aircraft touched down about 35 meter before the beginning runway 15 with vertical acceleration of 3.68 G and stopped at about 1500 meters from runway threshold. The left main landing gear collapsed and the left engine scratched the runway surface.

**Figure 7: Touchdown point**
